# Final report on the stage B of the ISTC project # 1648.2.

## Results of the integral reflood test QUENCH-12 with a VVER bundle

*presented by J. Stuckert,  
Forschungszentrum Karlsruhe*

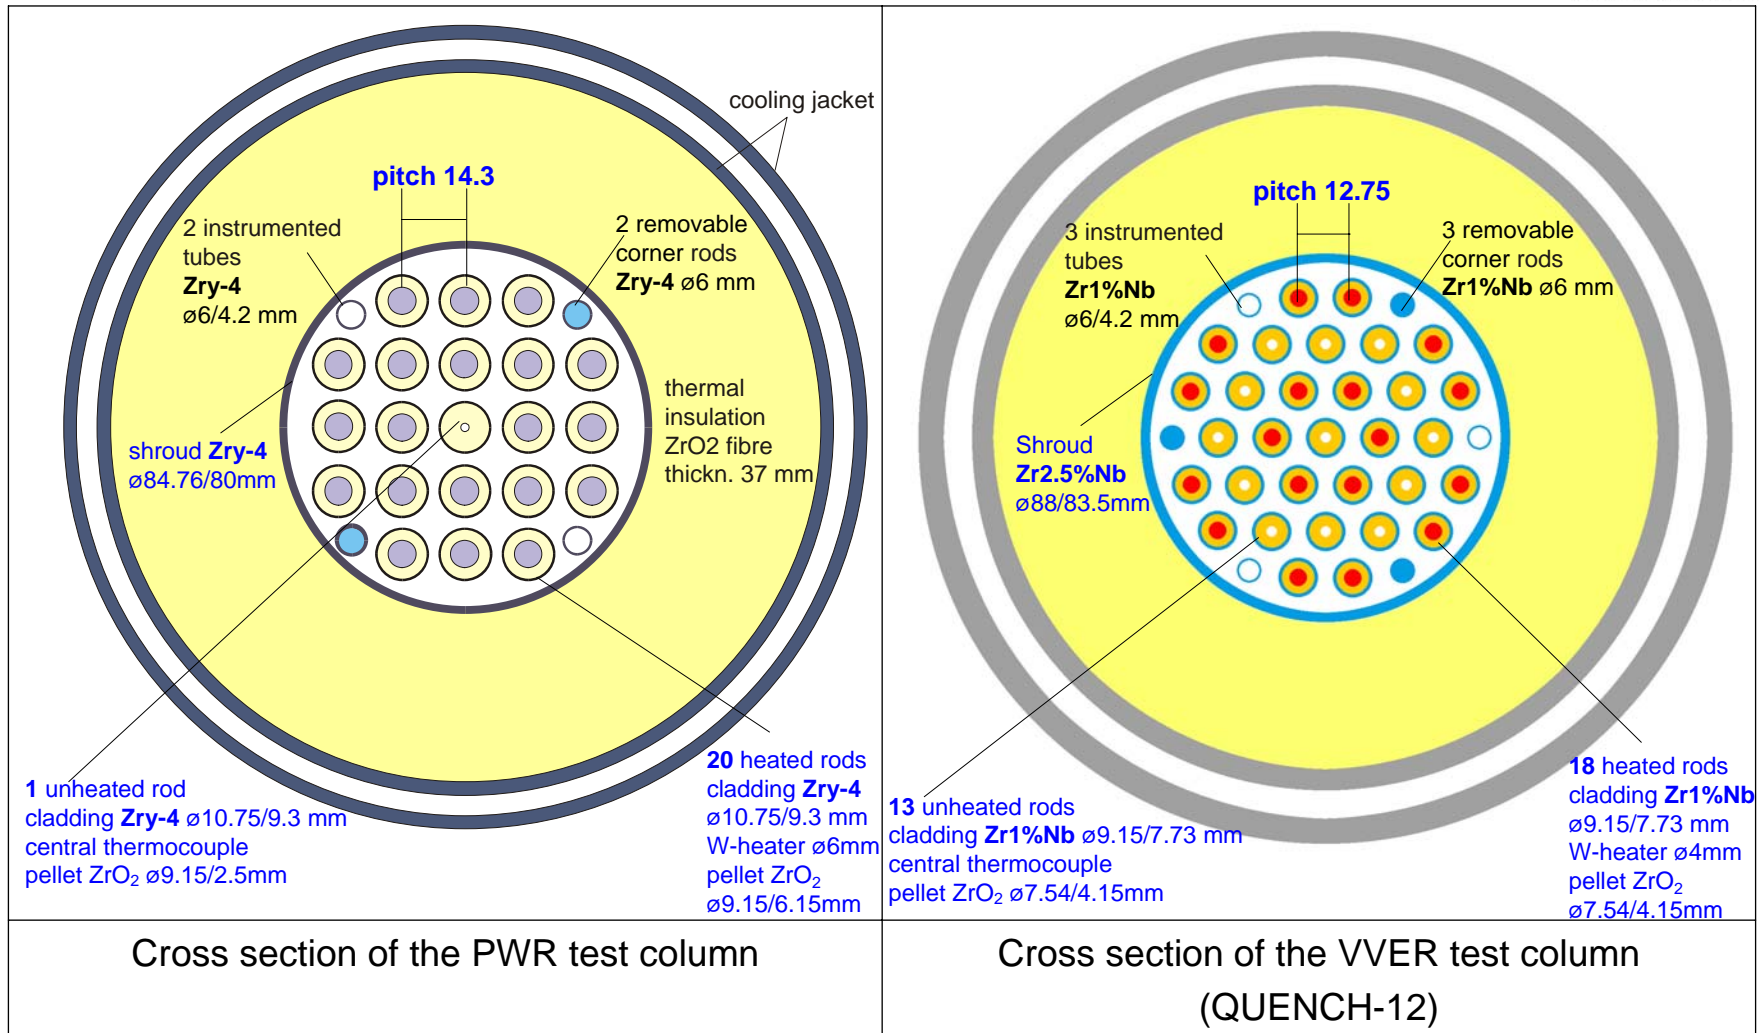
# Comparison of PWR and VVER test columns

- bundle metallic surface relationship  $Q_{12}/Q_{06} = 1.22$
- bundle material mass relationship  $Q_{12}/Q_{06} \sim 0.97$

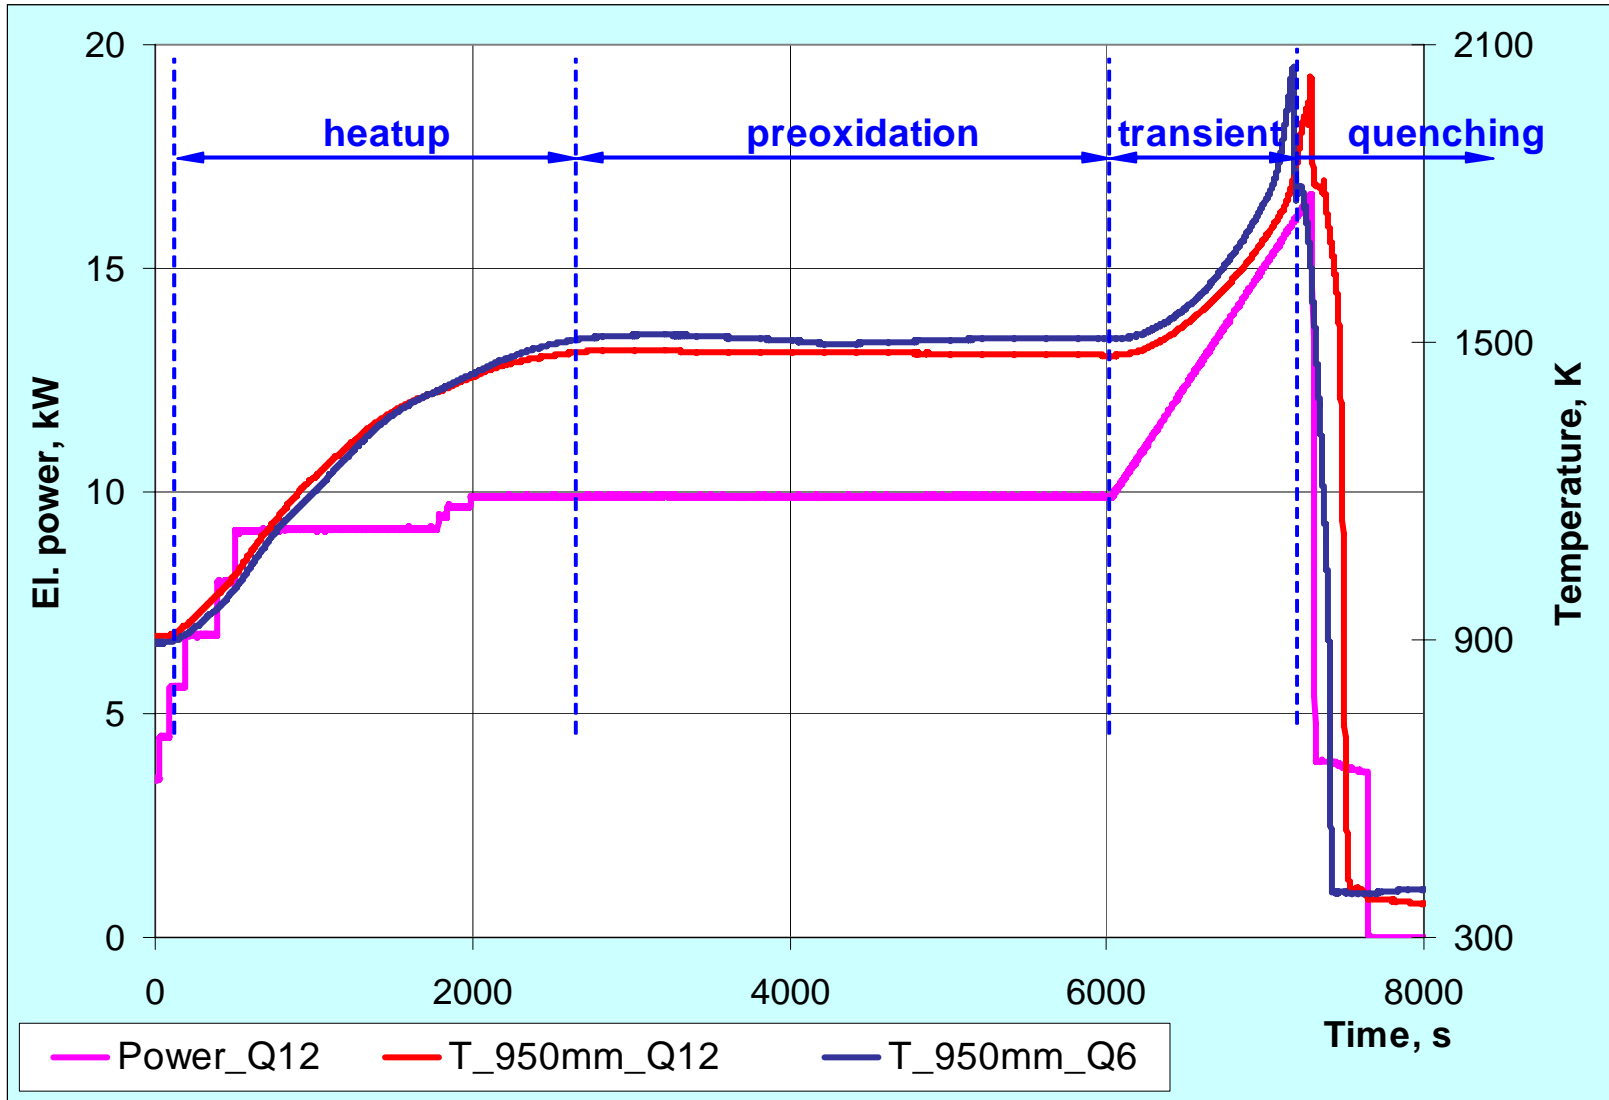
Test performance: el. power profile in accordance to the pre-test calculations provided good reproduction of temperature history in comparison with the reference test QUENCH-06

- The electrical power changing during the test corresponds completely to calculated values up to reflood phase. The temperatures at all bundle elevations during preoxidation are about 30 - 40 K lower than during corresponding phase of QUENCH-06.

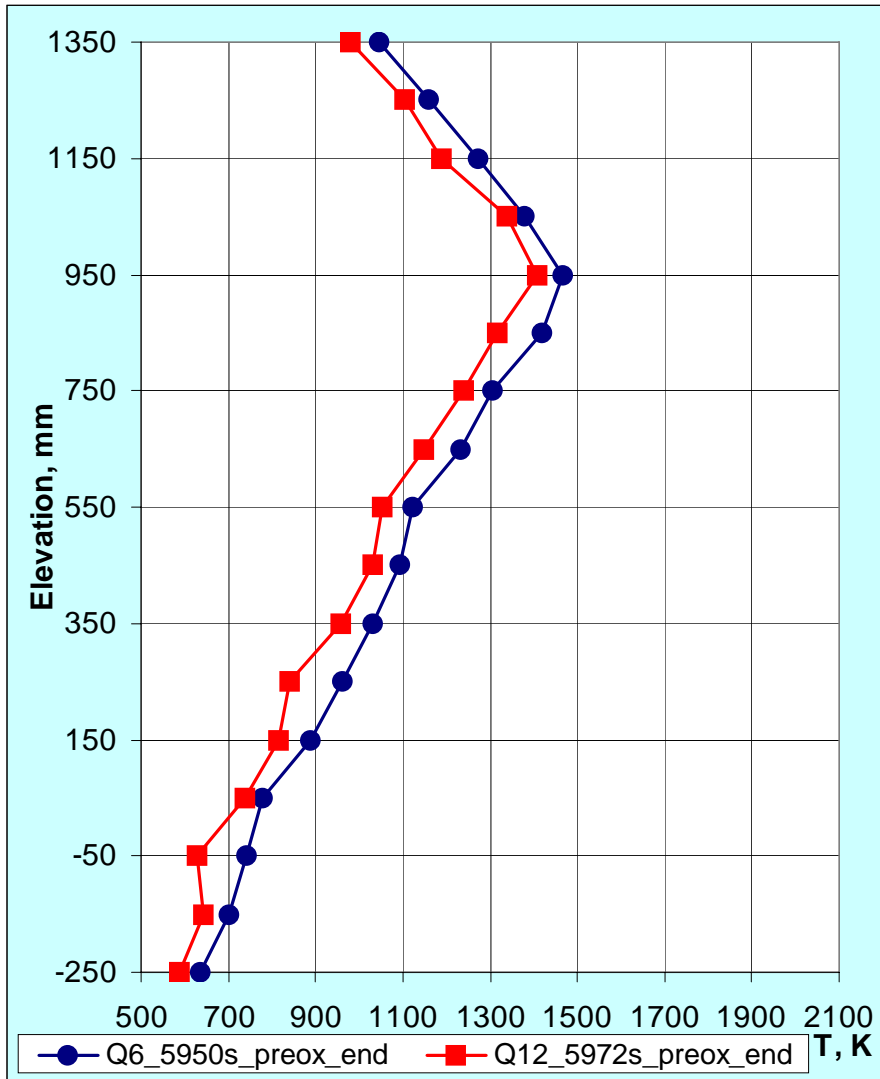
beginning of transient

# Axial bundle temperature profiles for QUENCH-06 and QUENCH-12 on beginning and end of transient phase

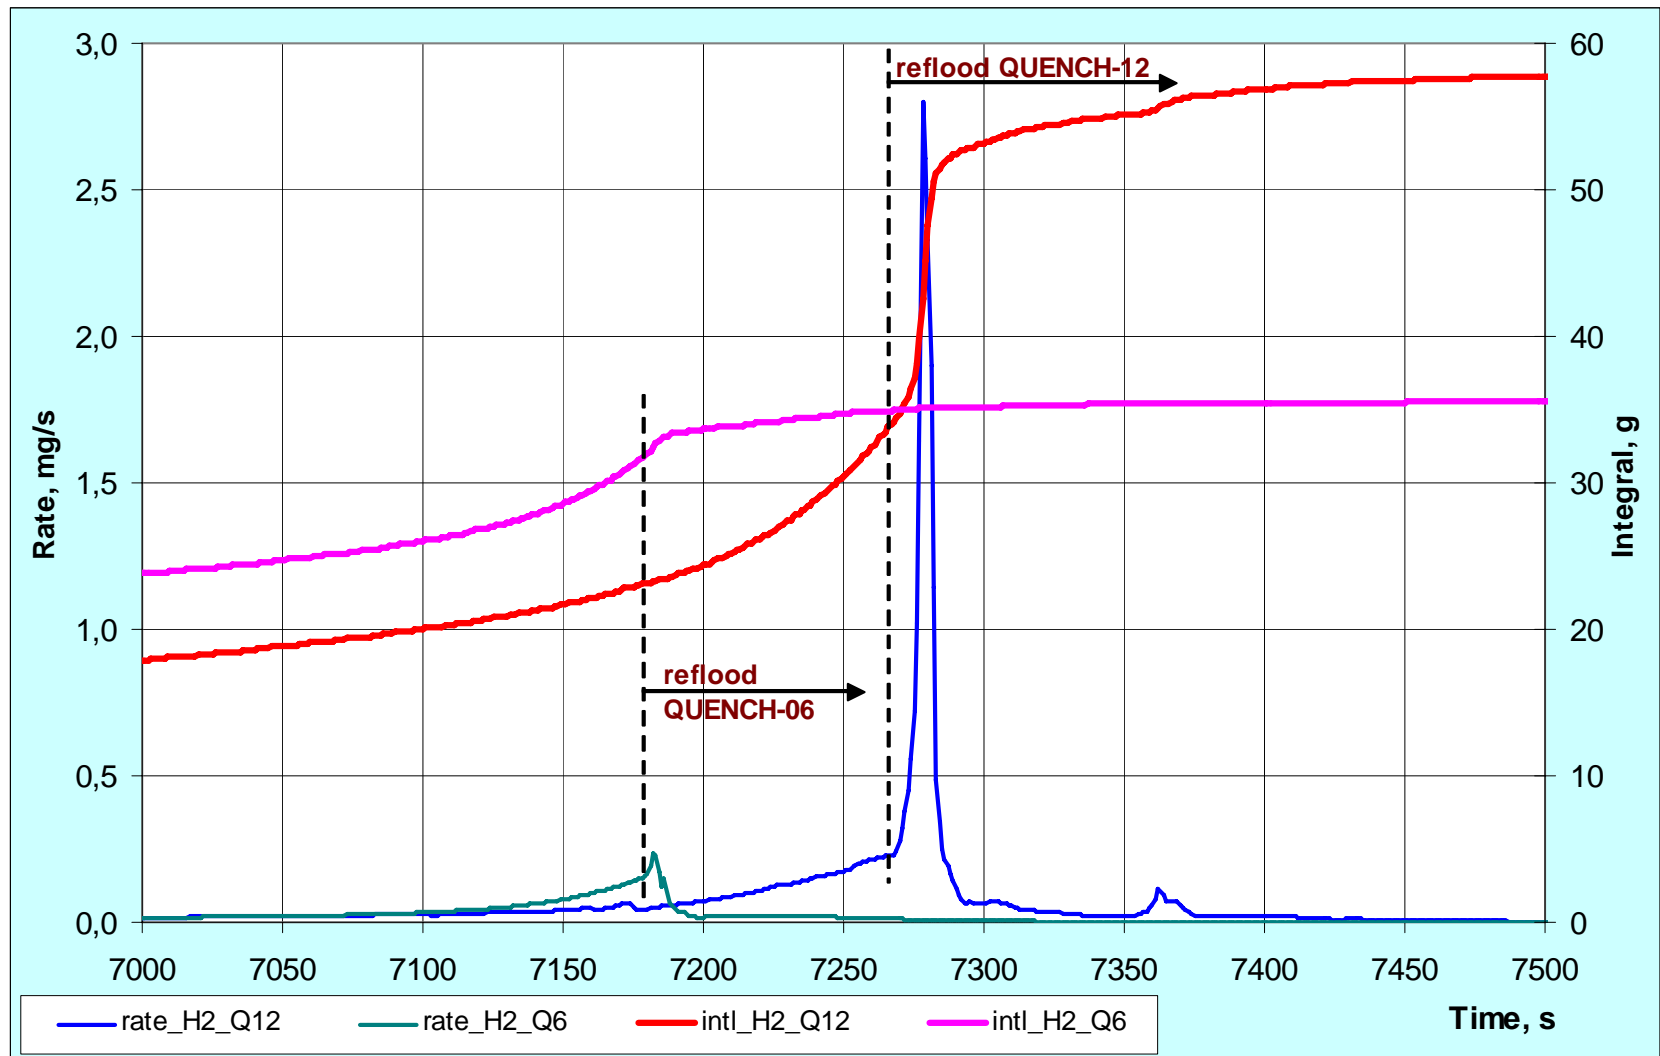
## Comparison of hydrogen release during **QUENCH-12** and **QUENCH-06**

- The hydrogen content in the corner rods reached a value more than 30 at% at the bundle elevations of 850 and 1100 mm.
- The total hydrogen production was 58 g (for QUENCH-06: 36 g), during the reflood was released 24 g hydrogen (for QUENCH-06: 4 g). This may be attributed partly to the longer excursion time in QUENCH-12. Other reasons for the increased hydrogen production may be extensive damaging of the cladding surfaces due to the breakaway oxidation and local melt formation with subsequent melt oxidation.

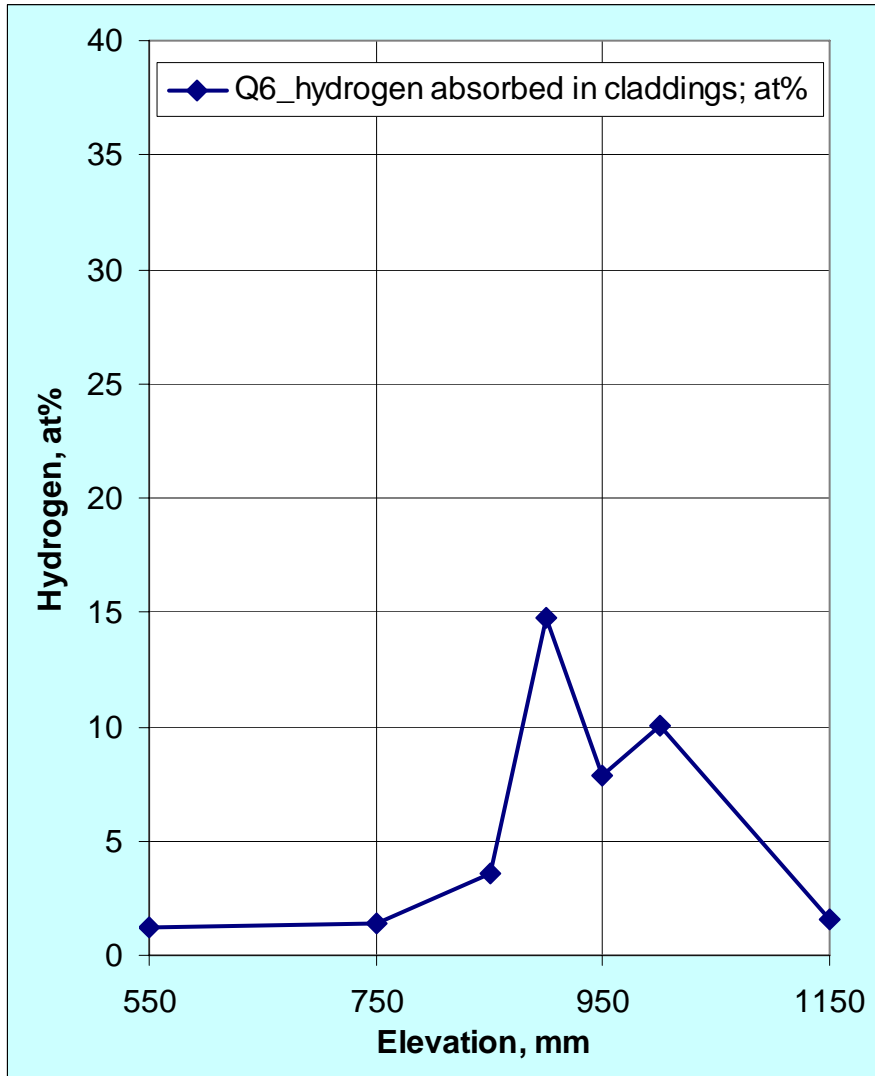
**Q-06: H<sub>2</sub> uptake in cladding measured by hot extraction**

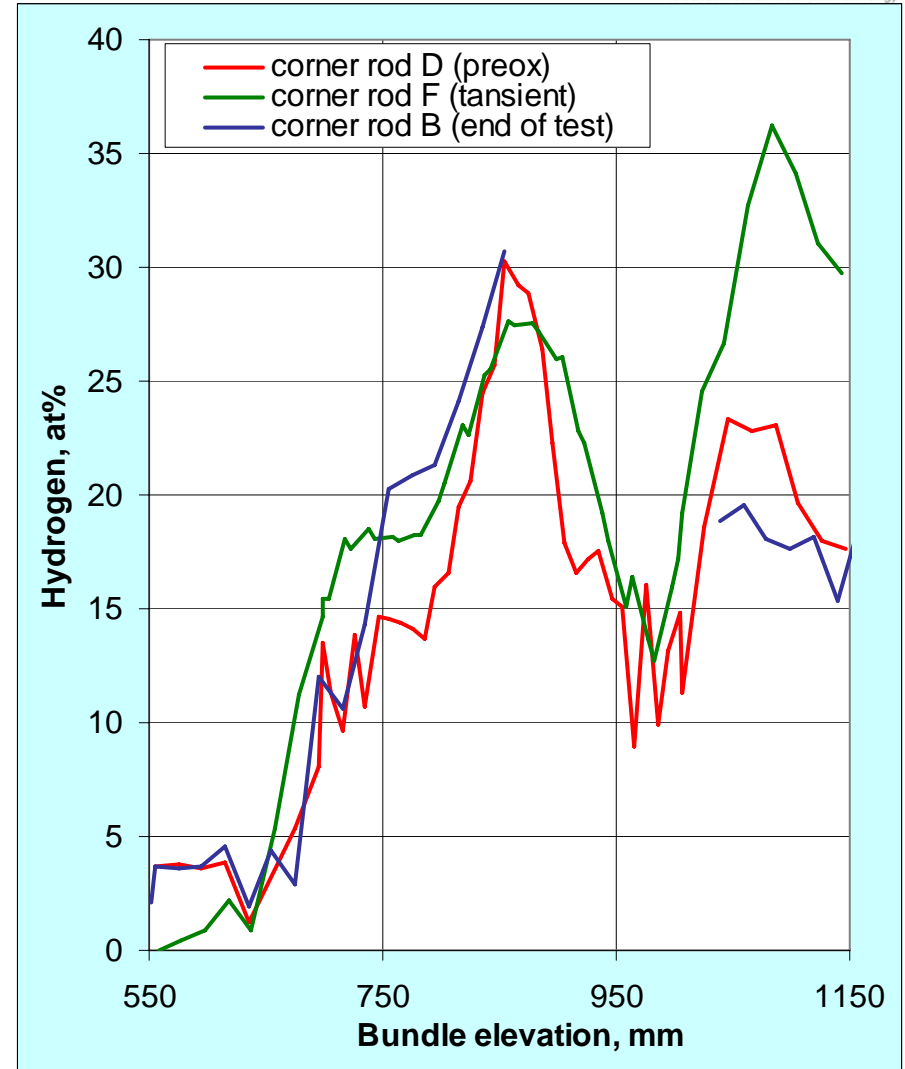
**Q-12: H<sub>2</sub> uptake in corner rods measured by neutron radiography**

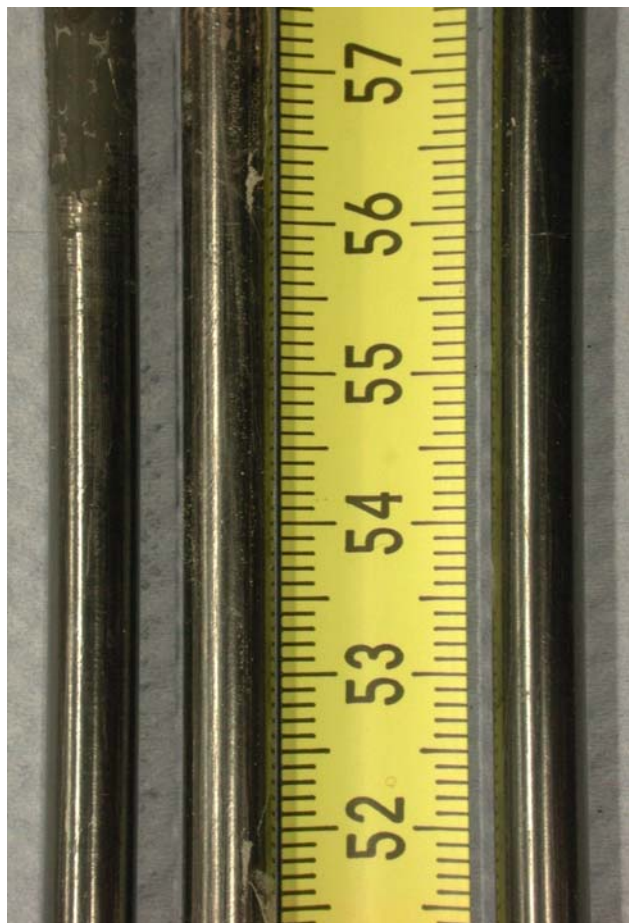
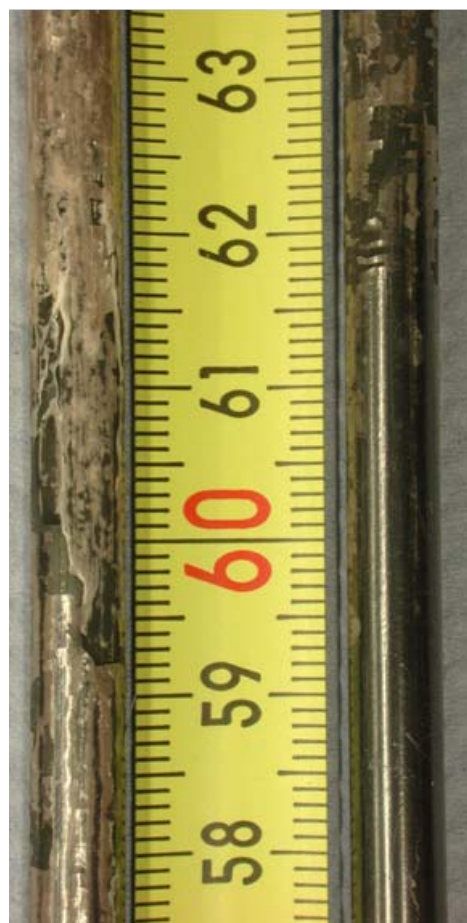
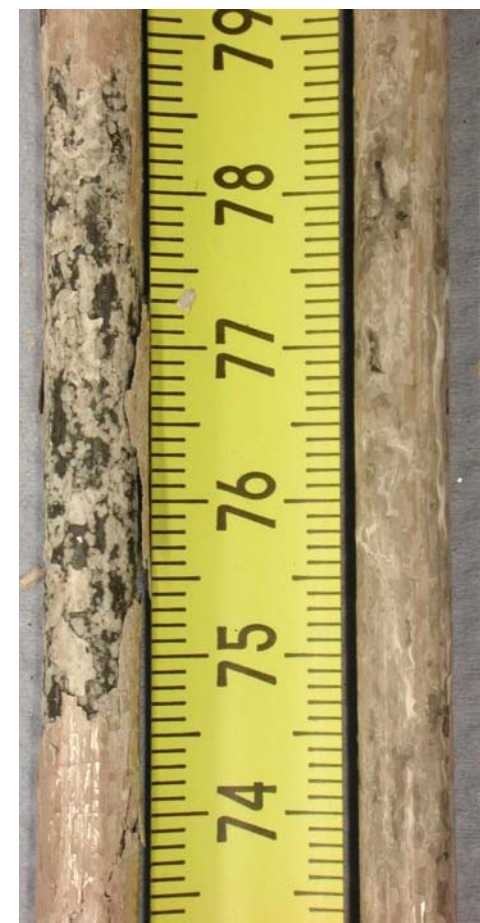
## QUENCH-12: axial sections of different ZrO<sub>2</sub> spalling intensity on corner rods withdrawn during the test

**B** after test  
**F** before reflow  
**D** after preoxidation

- Two corner rods were withdrawn at the end of preoxidation and transient phases correspondingly. The third corner rod was withdrawn after the test. The surface of the rods shows intensive traces of the break-away effect influence. Many oxide scales with thickness about 100  $\mu\text{m}$  were spalled during withdrawn. The reported findings on breakaway oxidation of the VVER-type cladding material strictly refer to long-term oxidation at temperatures between 850 °C and 1000 °C (not typical for reactor accident conditions).

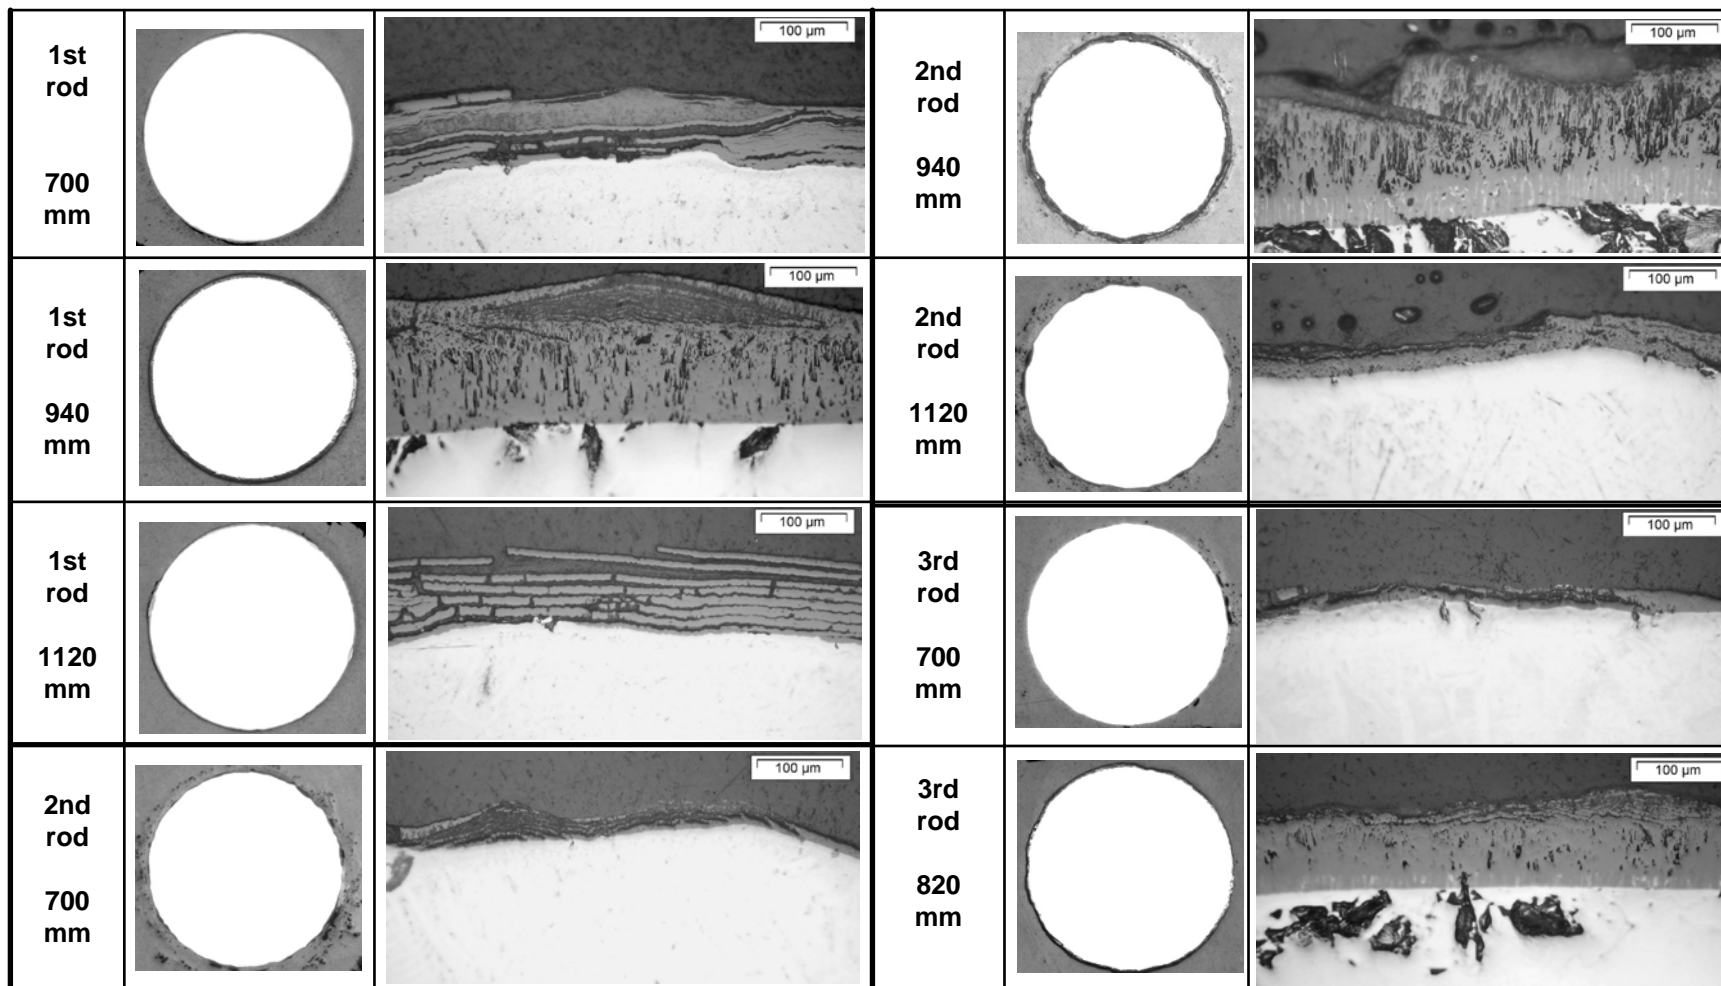
# QUENCH-12: Structure of the residual oxide layer on the surface of three withdrawn corner rods at different bundle elevations.

1<sup>st</sup> rod – after preoxid. phase, 2<sup>nd</sup> rod – before quench; 3<sup>rd</sup> rod – after test

**Breakaway structure was formed generally during pre-oxidation by temperatures about:  
850°C (@700 mm), 900°C (@1120 mm)**

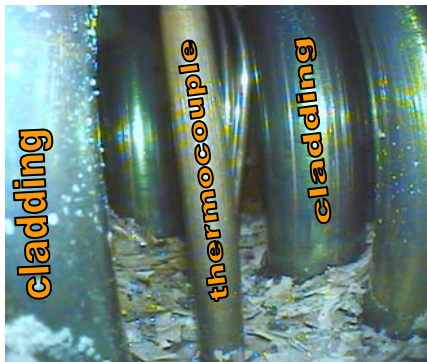
**-400mm:**  
spalled oxide scales  
as debris  
at the bundle bottom

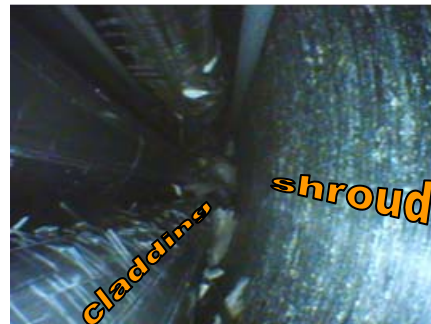
**400 mm:**  
circumferential spalling  
of the oxide layer  
on the surface  
of fuel rod simulator cladding

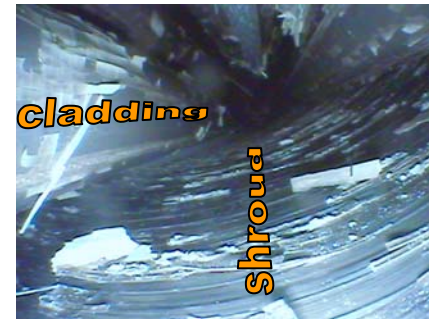
**650 mm:**  
spalled oxide scales  
at shroud and cladding

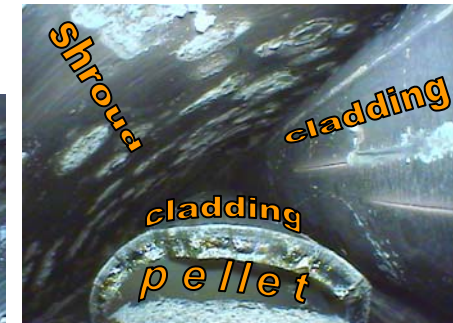
**900 mm:**  
circumferential  
and longitudinal cracks  
at the cladding;  
nodular breakaway  
corrosion  
at the shroud

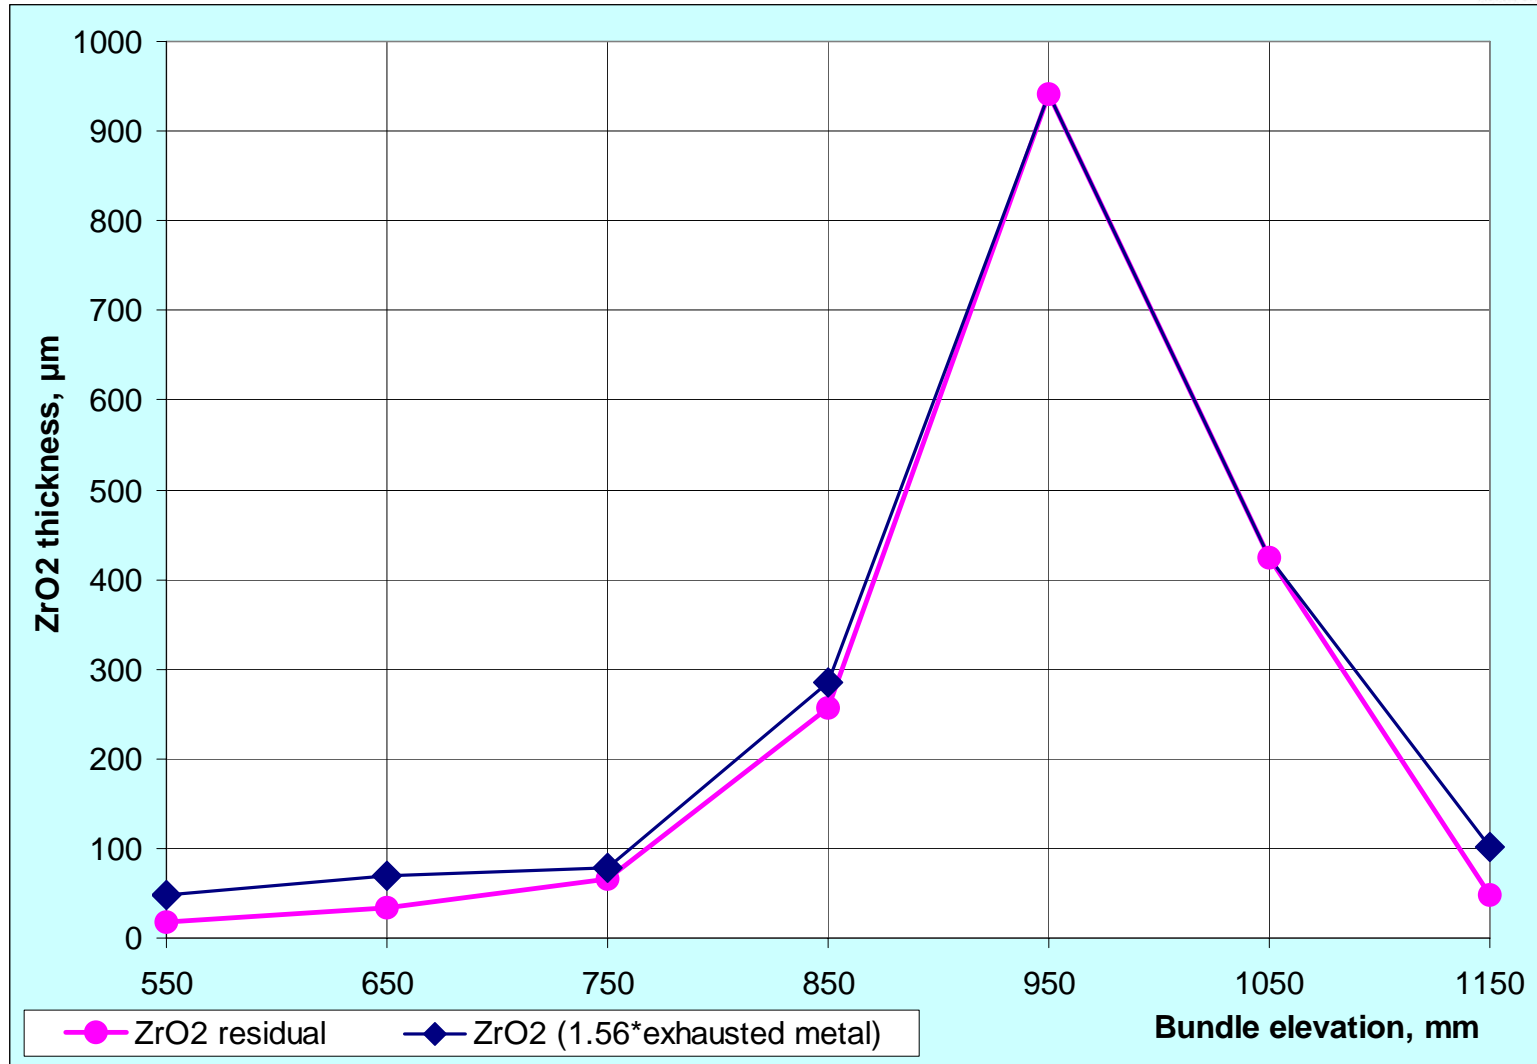
# QUENCH-12 : axial distribution of oxide layer

**Cladding oxidation: measured thickness of residual oxide and oxide thickness calculated on the base of residual metal**

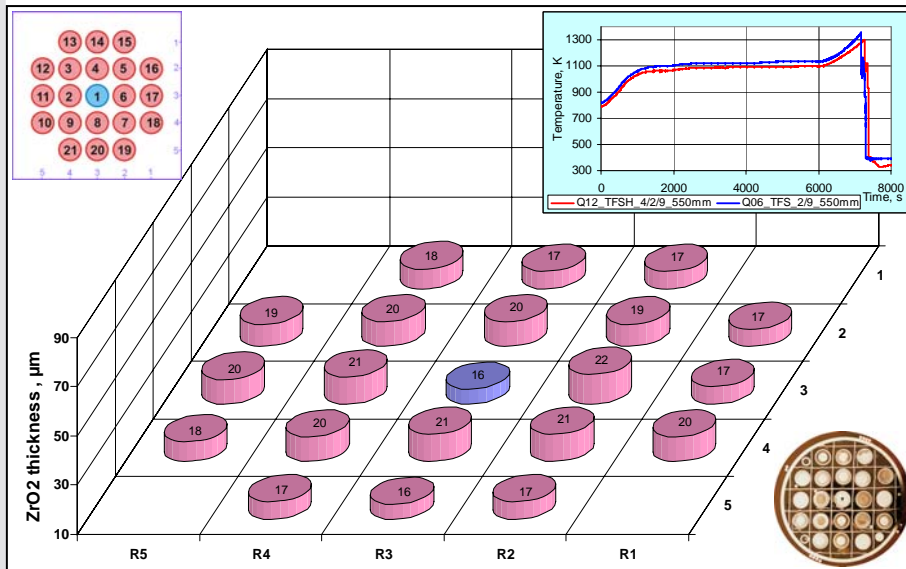
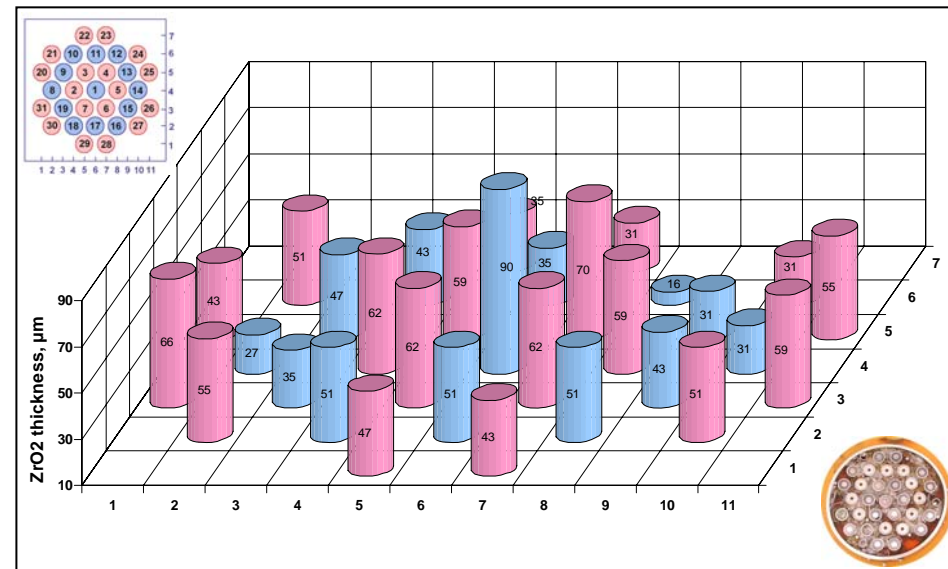
## Comparison of oxide cladding thicknesses for QUENCH-06 and QUENCH-12 at elevation 550 mm

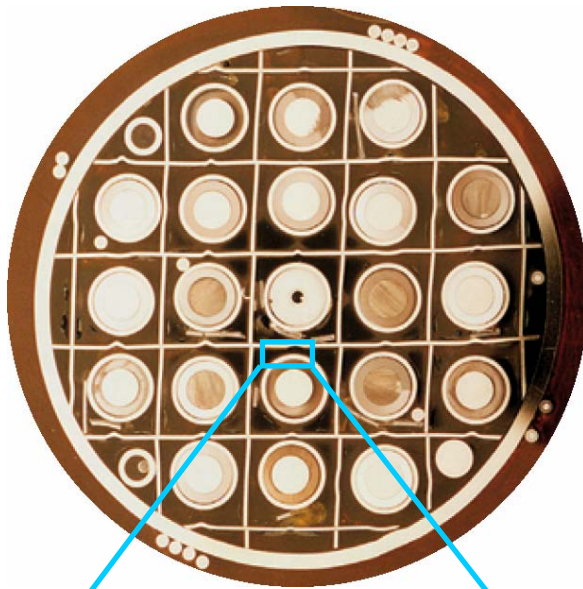
**Q06 cross-section**

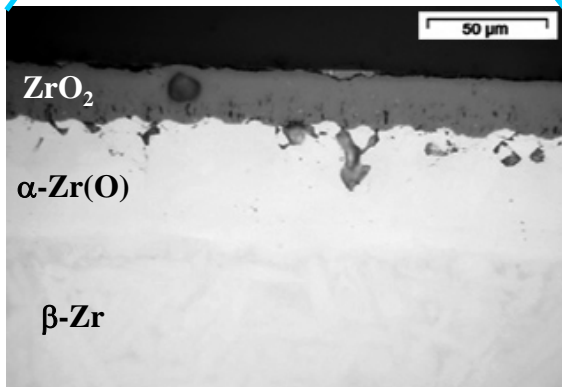
**Q06 oxidized cladding**

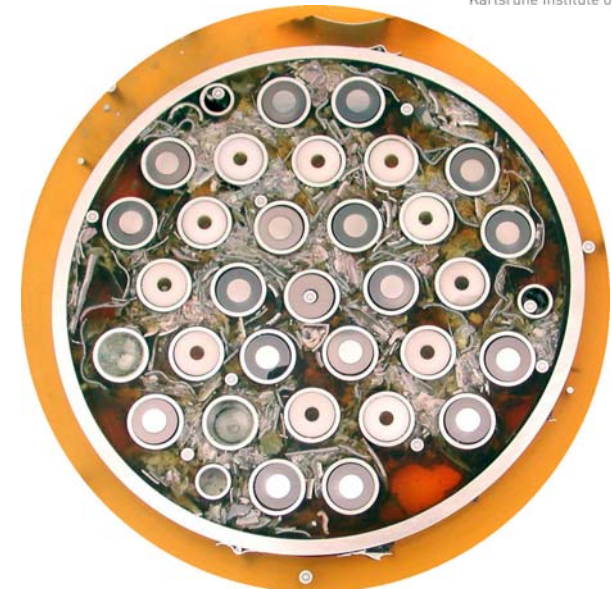
**Q12: rubble on spacer grid  
consists of spalled cladding scales  
and fragments of partially oxidized cladding**

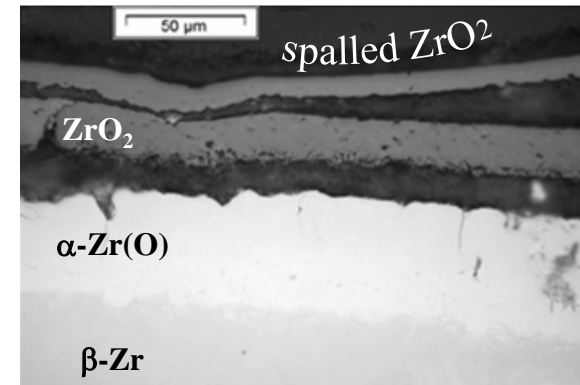
**Q12 cladding: spalling of oxide scales  
due to breakaway effect**

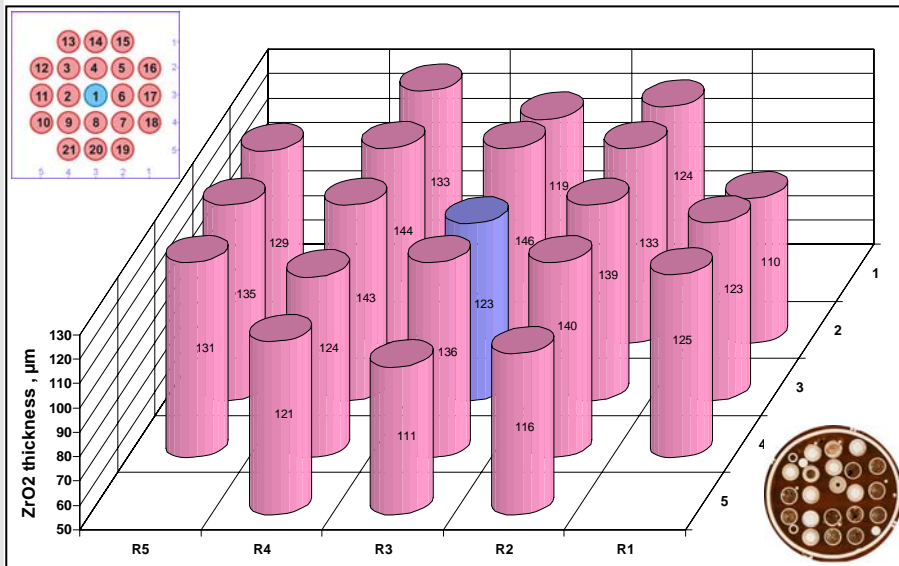
**QUENCH-06 (measured):**  
 average value and median deviation:  
 $129 \pm 9 \mu\text{m}$  for all rods,  
 $138 \pm 5 \mu\text{m}$  for inner heated rods,  
 $123 \pm 6 \mu\text{m}$  for outer heated rods

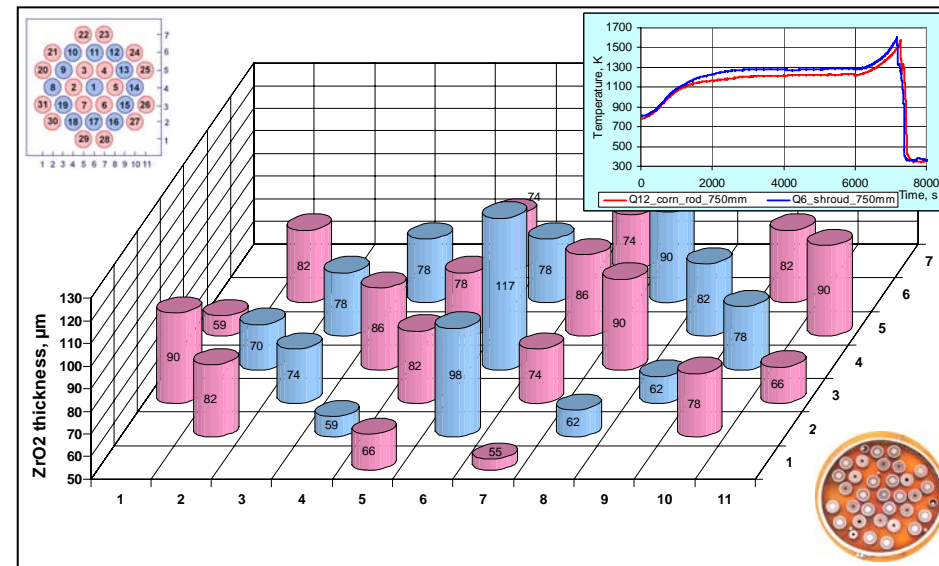
**QUENCH-12 (calculated from residual metal):**  
 average value and median deviation:  
 $79 \pm 11 \mu\text{m}$  for unheated rods,  
 $77 \pm 8 \mu\text{m}$  for heated rods

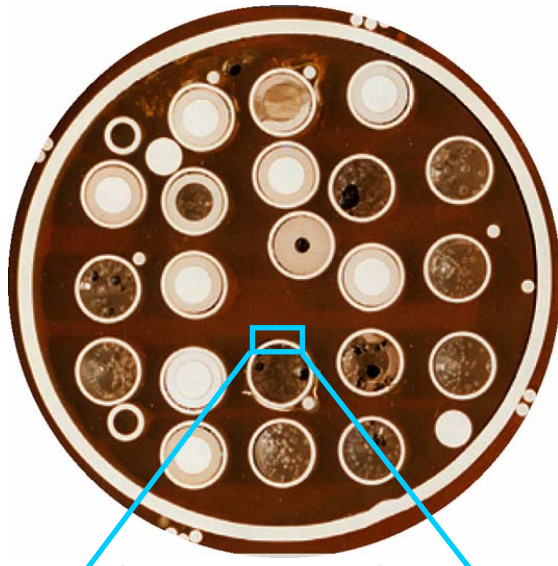
**Q06 cross-section;  
few bundle deformation**

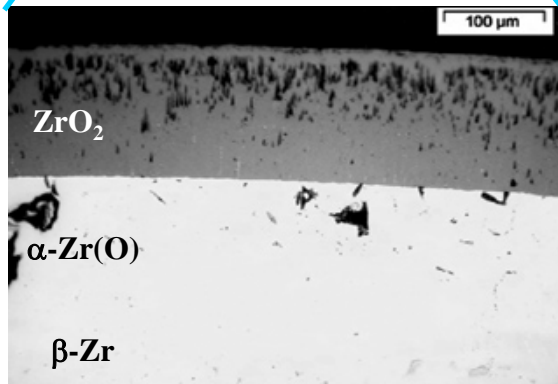
**Q06 oxidized cladding**

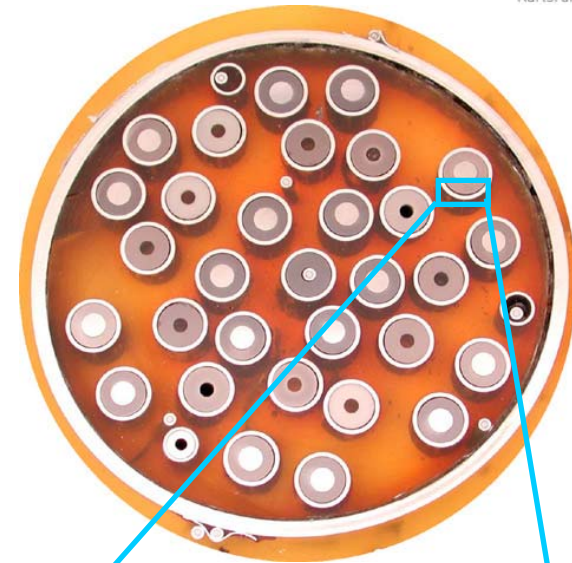
**Q12 cross-section;  
moderate bundle deformation**

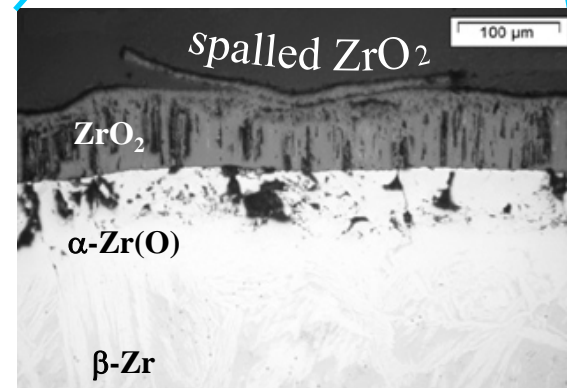
**Q12 cladding: spalling of oxide scales  
due to breakaway effect**

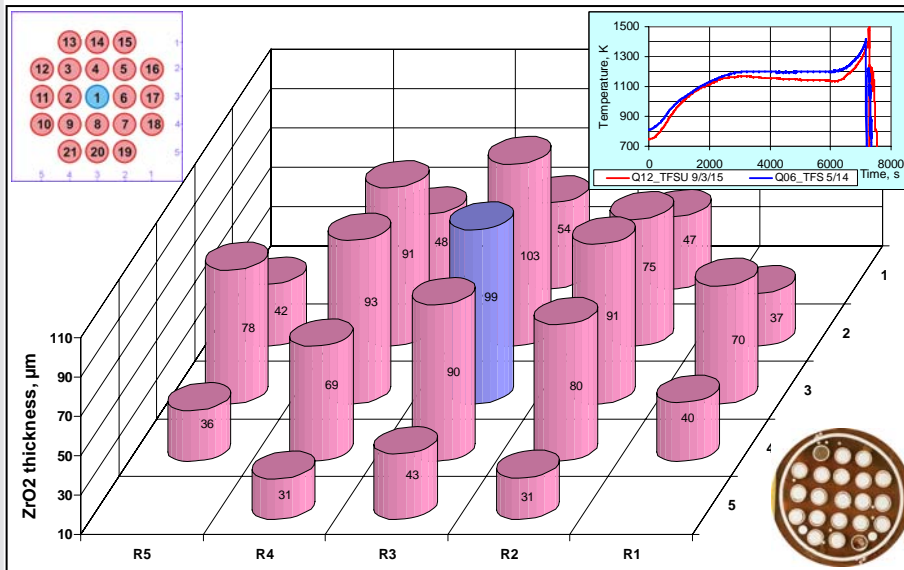
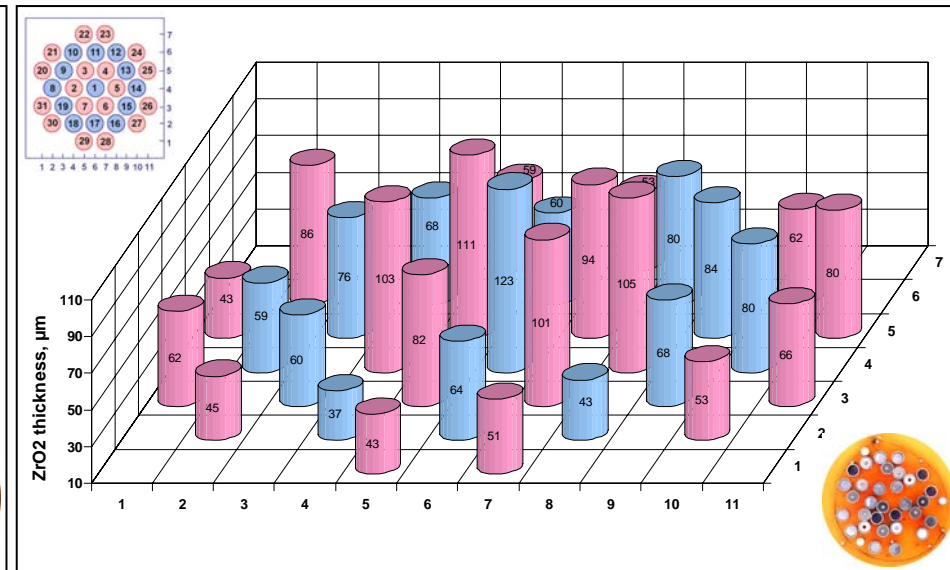
## Comparison of oxide cladding thicknesses for QUENCH-06 and QUENCH-12 at elevation 1150 mm

**QUENCH-06 (calculated):**  
 average value and median deviation:  
 $64 \pm 22 \mu\text{m}$  for all rods,  
 $86 \pm 9 \mu\text{m}$  for inner heated rods,  
 $46 \pm 11 \mu\text{m}$  for outer heated rods

**QUENCH-12 (calculated from residual metal):**  
 average value and median deviation:  
 $69 \pm 15 \mu\text{m}$  for unheated rods,  
 $72 \pm 21 \mu\text{m}$  for heated rods

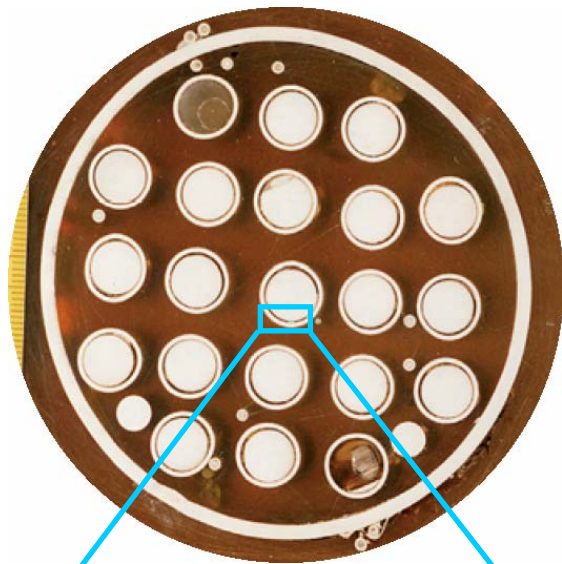
Q06 cross-section

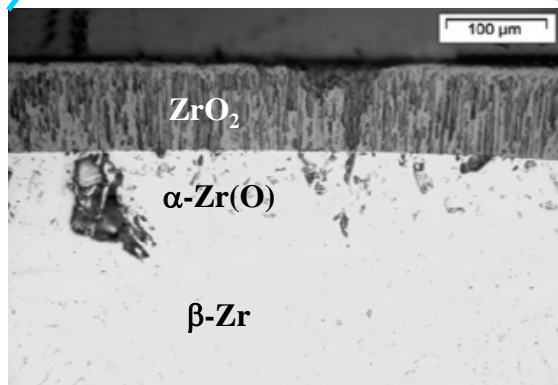
Q06 oxidized cladding

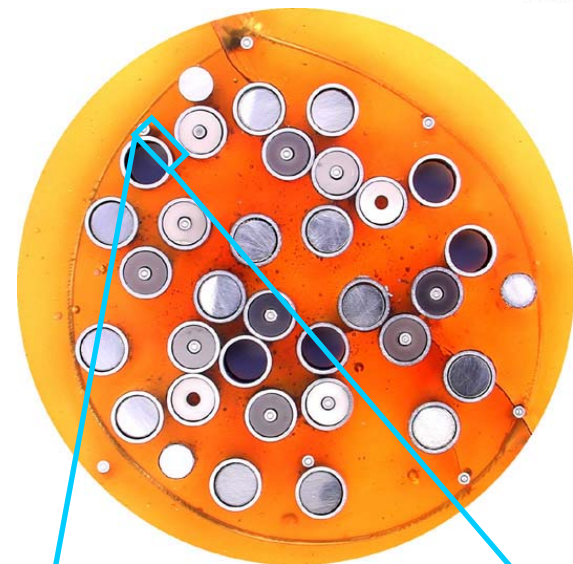
Q12 cross-section

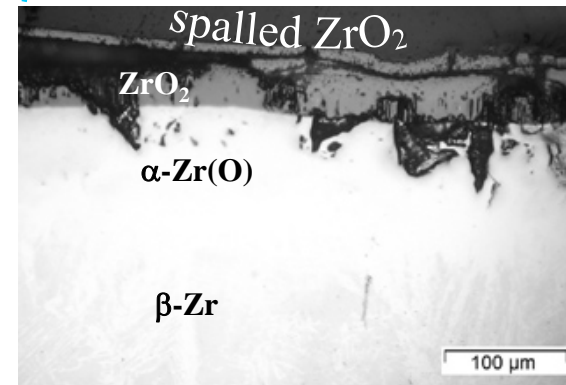
Q12 cladding: spalling of oxide scales  
due to breakaway effect

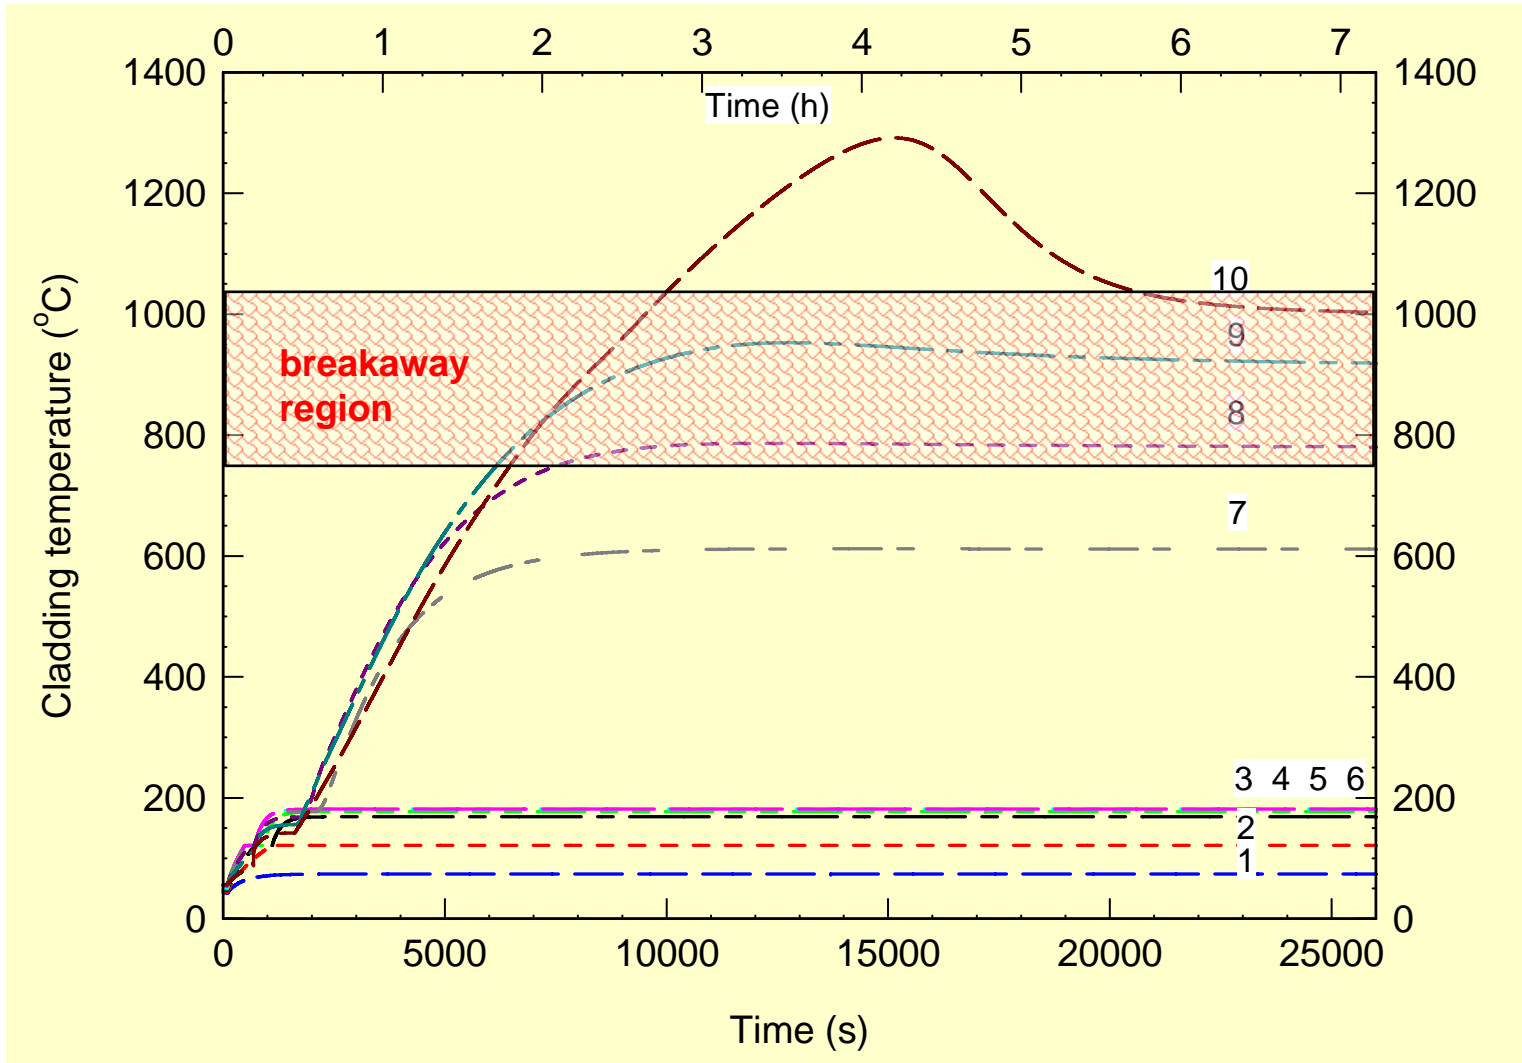
# Breakaway long-term oxidation during the Paks cleaning tank incident (destroying of 30 VVER fuel assemblies)

Results of modeling (FRAP-T6 code)
