# Final report on the stage B of the ISTC project # 1648.2.

## Results of the integral reflood test QUENCH-12 with a VVER bundle

*presented by J. Stuckert,  
Forschungszentrum Karlsruhe*

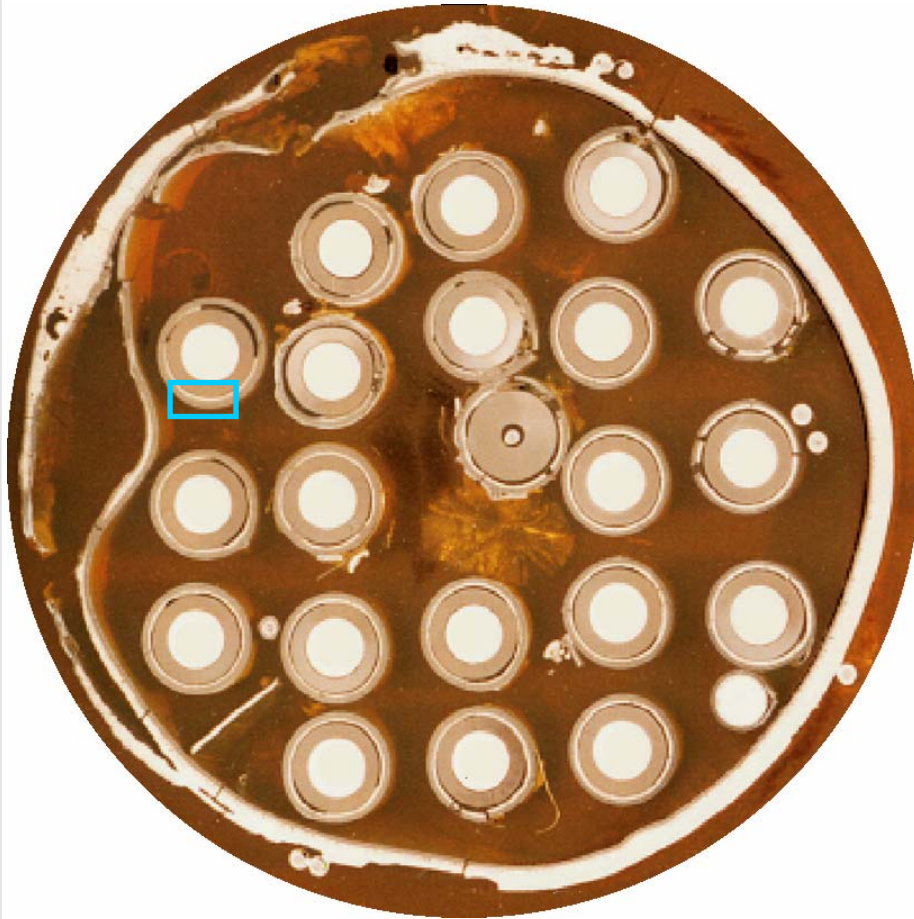
**Q06: melting of cladding internal metal layer  
and shroud external metal layer**

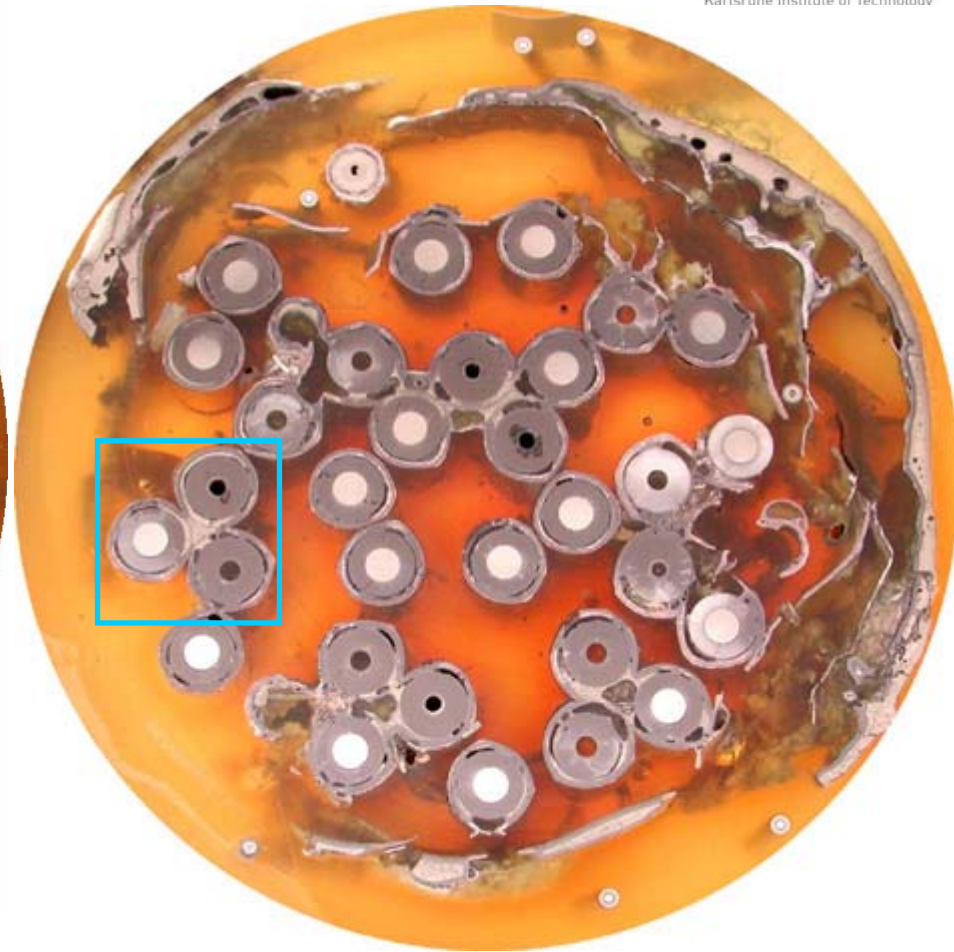
**Q12: melting of cladding internal player;  
oxide layer failure;  
molten pools formation between rods;  
shroud external metal layer melting**

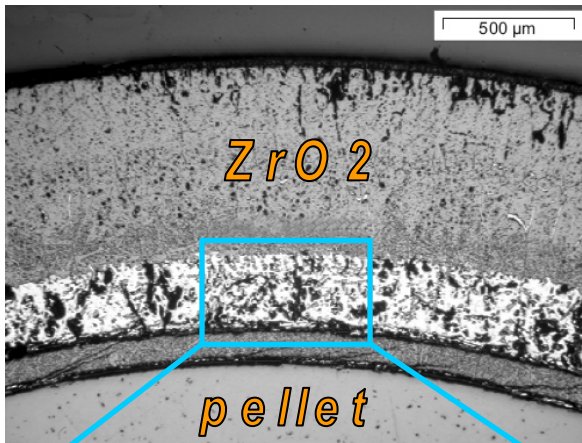
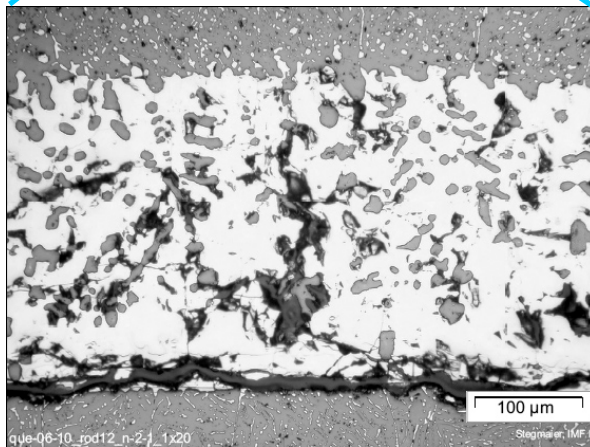
**Q06: melting of cladding metal layer**

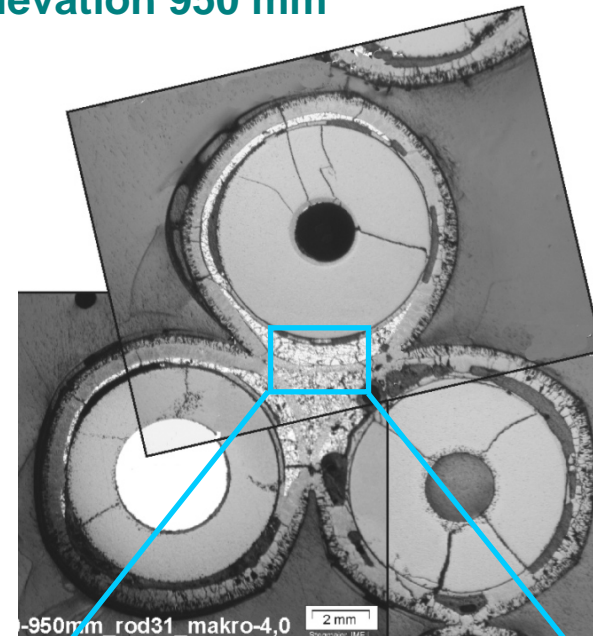
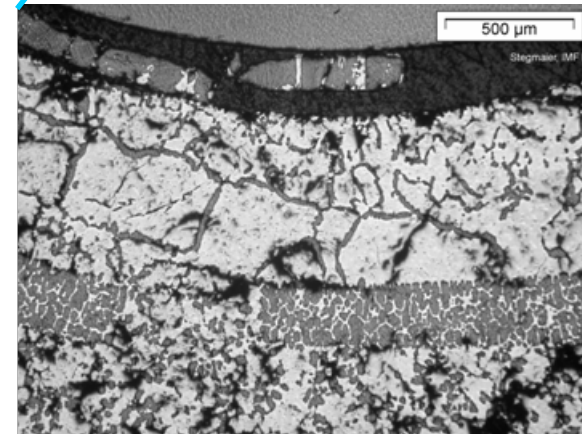
**Q12: molten pool between rods**

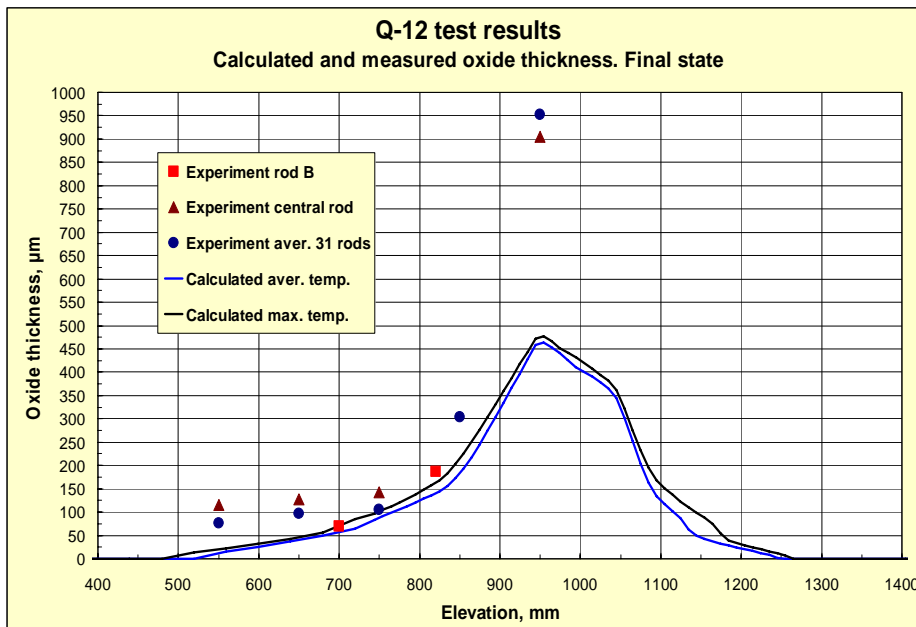
Measured oxide layer thickness profiles of the rod B (withdrawn from the bundle at the end of the test), central rod, averaged for 31 rods, all at final state, compared to the calculated oxide layer thickness profile of the central rod (final state).

- SVECHA/QUENCH code (IBRAE) was applied to the simulation of the QUENCH -12 bundle test. The calculations adequately reproduce temperature evolution of the central rod at different elevations during the whole test duration including quenching phase.
- The calculated oxide thickness at the end of the test was significantly underestimated, especially at 950 mm. This fact may be explained by more intensive oxidation during transient and quenching phases through friable cracked oxide structure formed due to break-away oxidation previously.
- The details of the experimentally measured time dependence of the hydrogen production rate are well reproduced by the calculations at the preoxidation and transient phases. Calculations underestimate hydrogen production rate at the end of transient and quenching phase of the test.

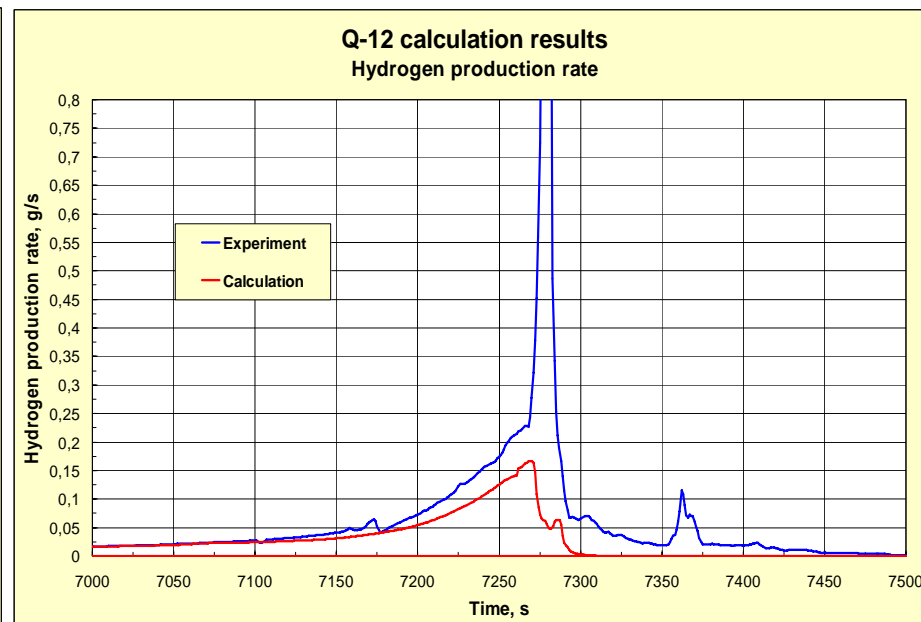
Experimentally measured and calculated hydrogen production rate.  
Quenching phase of the test.

Amount of hydrogen released during quenching: 24 g (exp); 9.9 g (calc.)
