**POST-TEST ANALYSIS OF MATERIAL STUDIES OF VVER-1000
MODEL ASSEMBLY TESTED AT THE PARAMETER-SF3 EXPERIMENT
UNDER THE CONDITIONS OF SEVERE ACCIDENT
WITH TOP FLOODING**

The studies were performed according to the Work Plan for ISTC Project No.3690 "Study of fuel assemblies under severe accident top quenching conditions in the PARAMETER-SF test series".

The report presents the results of material studies of a 19-rod model assembly of VVER-1000 after the PARAMETER-SF3 experiment under the conditions of initial stage of severe accident with the top quenching of FA overheated to 1600°C.

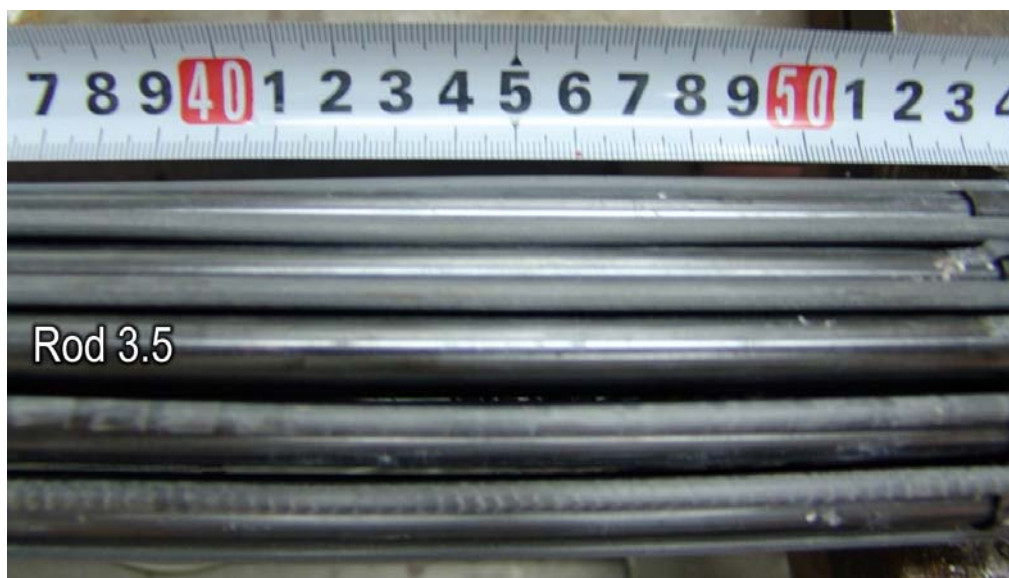
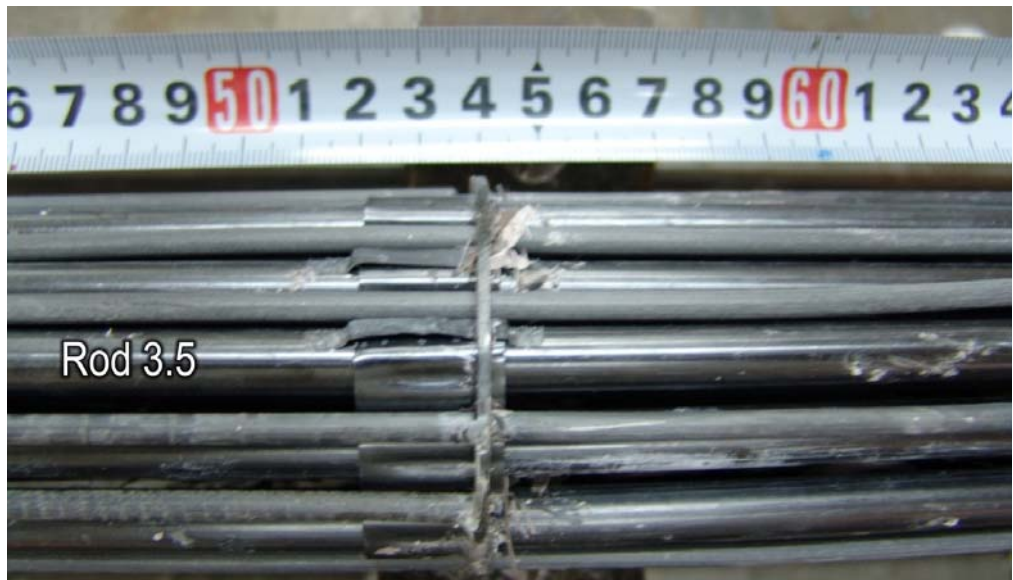
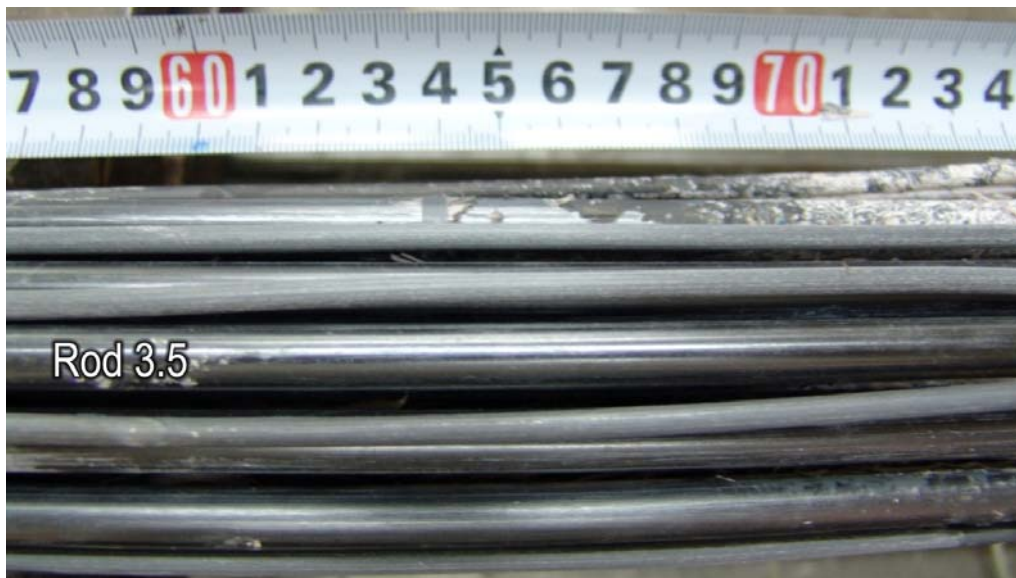
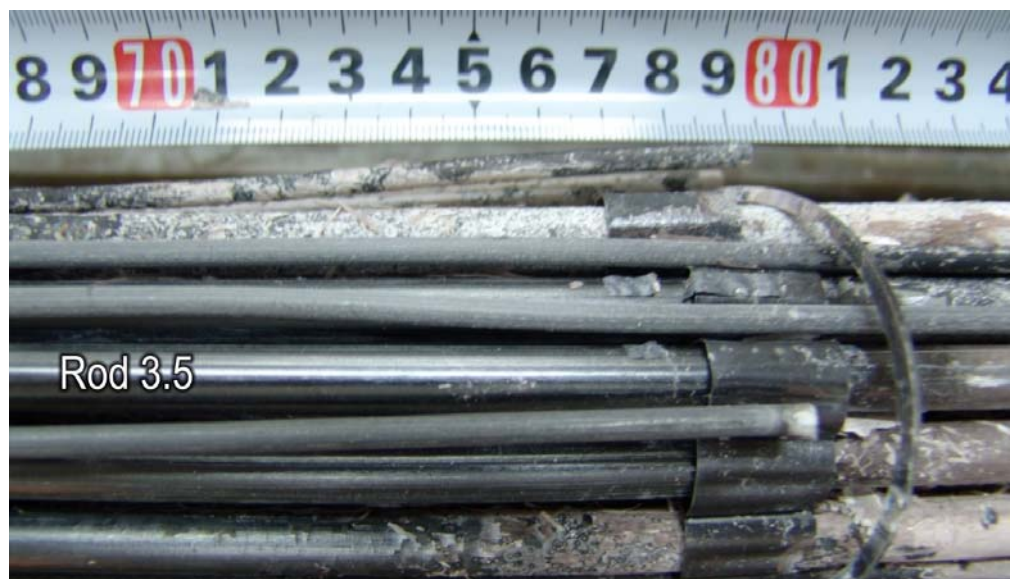
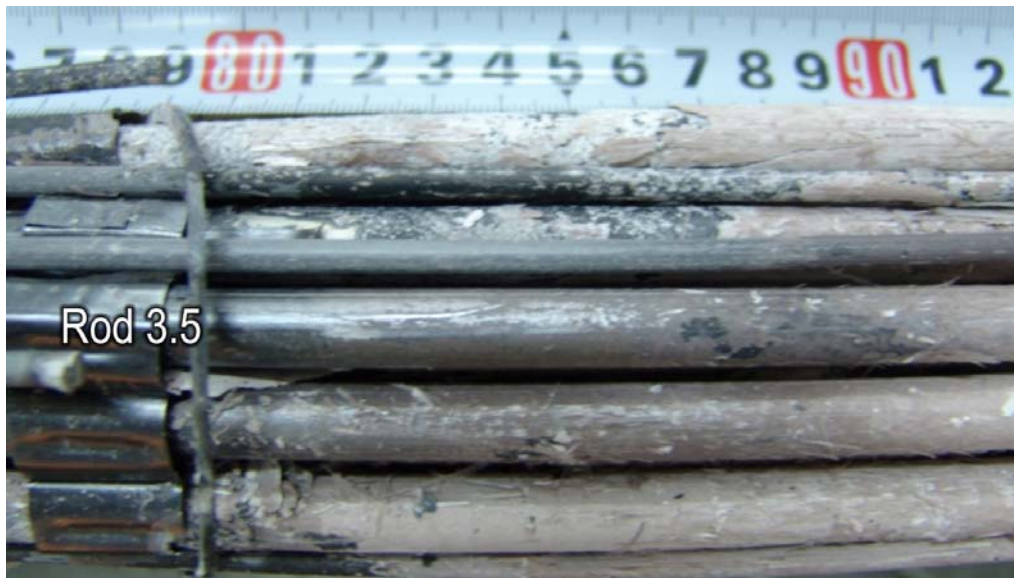
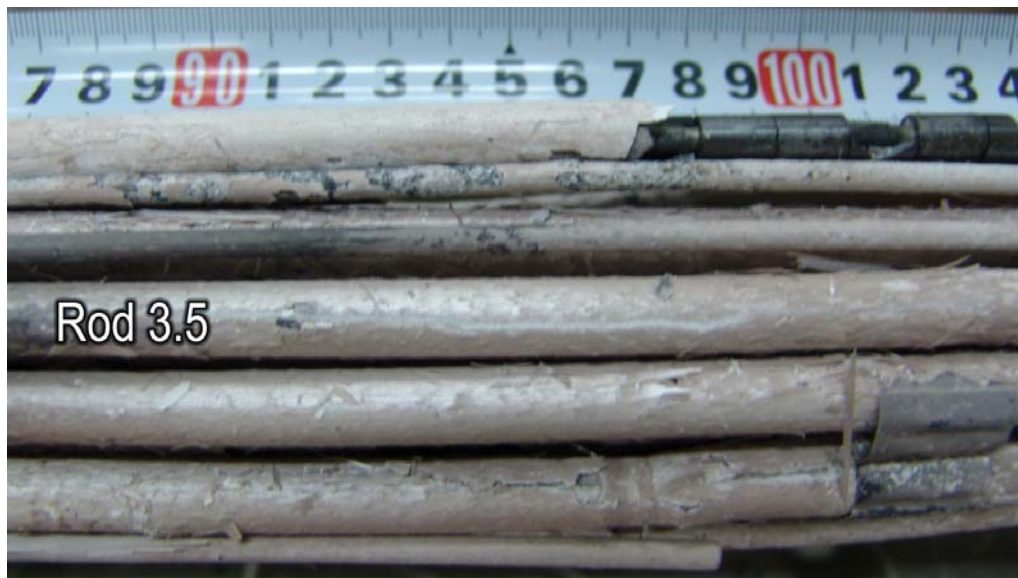
Fig. 1. The SF3 bundle appearance (Z = 400-1000 mm) after withdrawal from the shroud (fuel rod 3.5 is located in the centre).

- grid No.2 (Z = 1010-1030 mm), only 2 fragments are available. The main fragment around fuel rods 3.3 and 3.4, keeping the initial width (20 mm) (Figs.1f, 2a), is located 215 mm above grid No.3 (Z = 735-755 mm). A small fragment with width of 5...8 mm at fuel rod 3.2 is located 170 mm above grid No.3. No ring for spacing the given grid and the shroud is found;

- other seven periphery rods are damaged at the considerably lower elevations (approximately in the region of grid No.3, Fig.1d). Evidently, this is caused by the fact that periphery rods were fastened to grids rather tightly and due to complete damage of grids Nos 1 and 2 during withdrawal of the assembly their break occurred under bending.

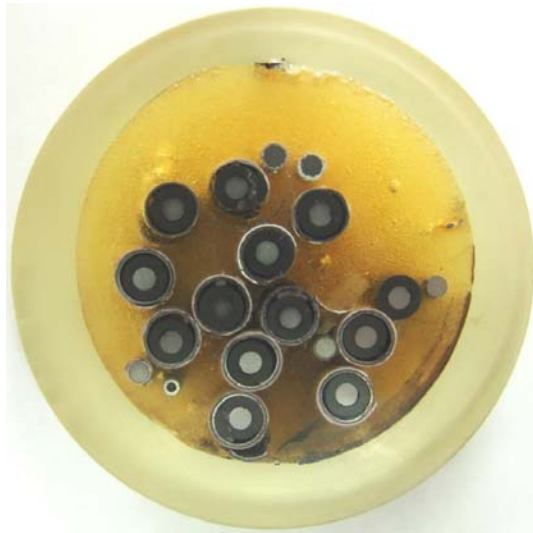
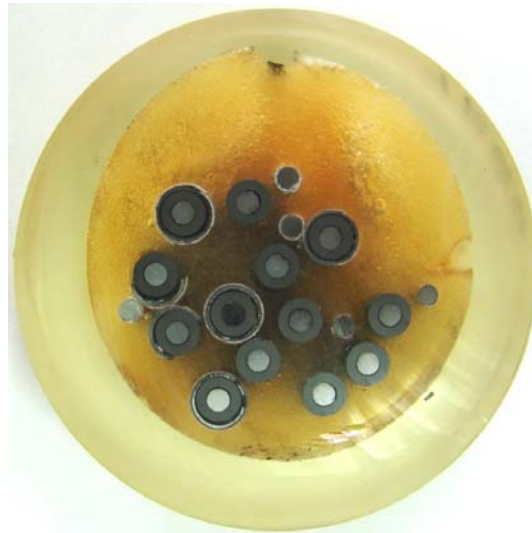
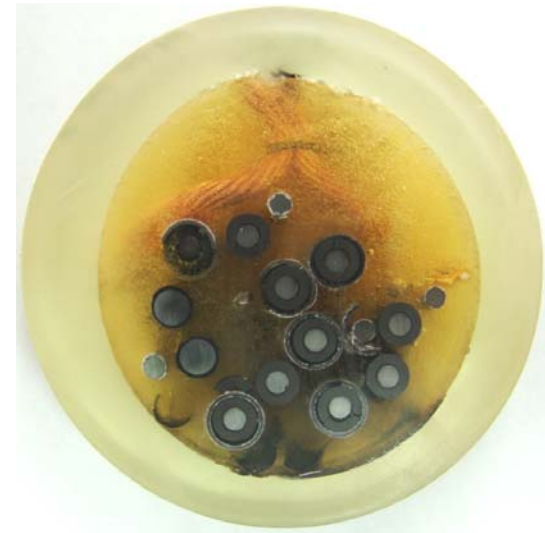
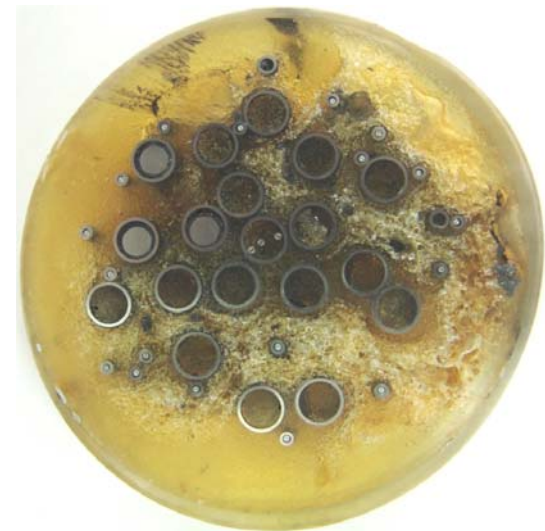
Fig. 4. Photos of the assembly cross-sections slabs within the range of Z ~ 1100...1500 mm elevations.

The macro photos of the ground cross-section slabs were taken by the digital camera SONY (8 mps) (Fig. 3, 4). Further on, the available macrographs were used for comparative evaluation of the degree of the assembly damage at different elevations.

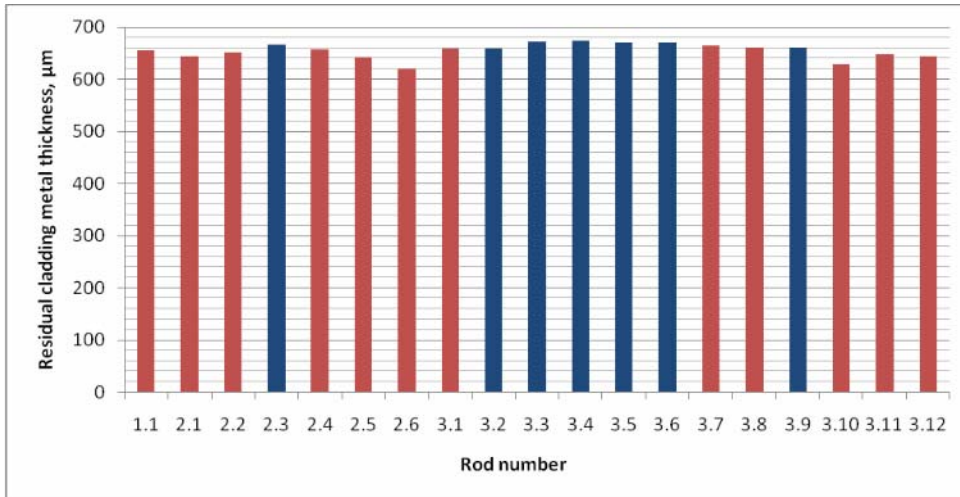
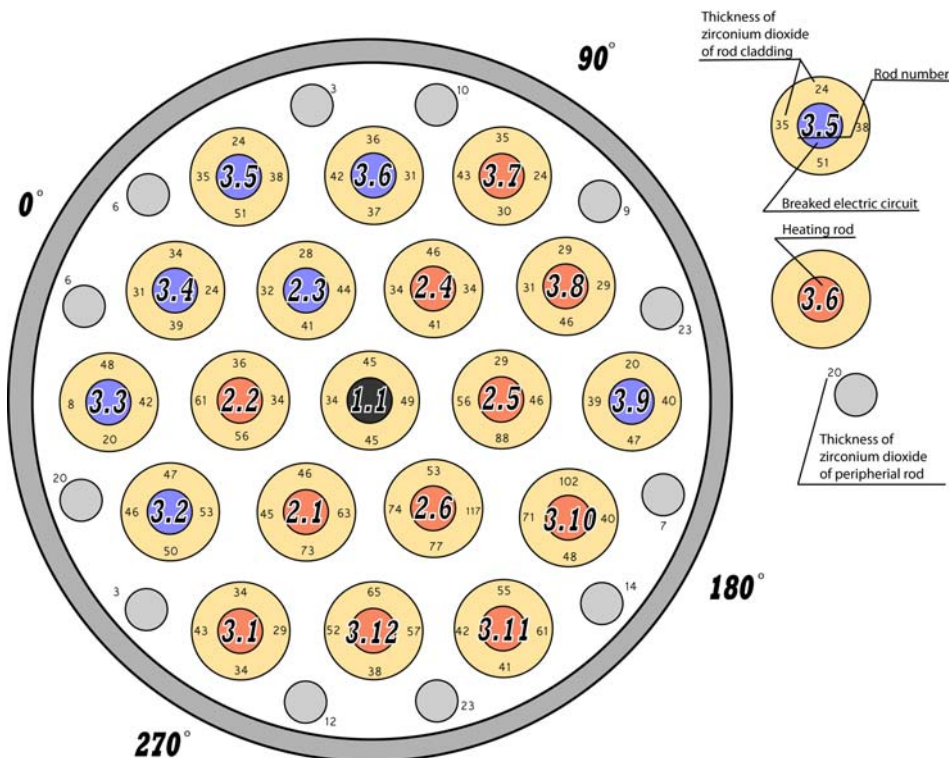
Fig. 10. a – Results of claddings residual metal layer thickness measurement at $Z = 500$ mm elevation (■ - heated fuel rod; ■ - fuel rod with failed heater),
 b – calculated values of oxide scale thickness on surfaces of claddings and periphery rods.

- calculated thickness of oxide scale on the cladding external surfaces is 10 - 60 μm (stronger oxidation was observed only on some fuel rods 2.5, 2.6, 3.10, 3.11, and 3.12 with spalled off scale);
- the measured thickness of zirconium oxide, tightly bound with cladding, varies within the range of 4 – 9 μm .

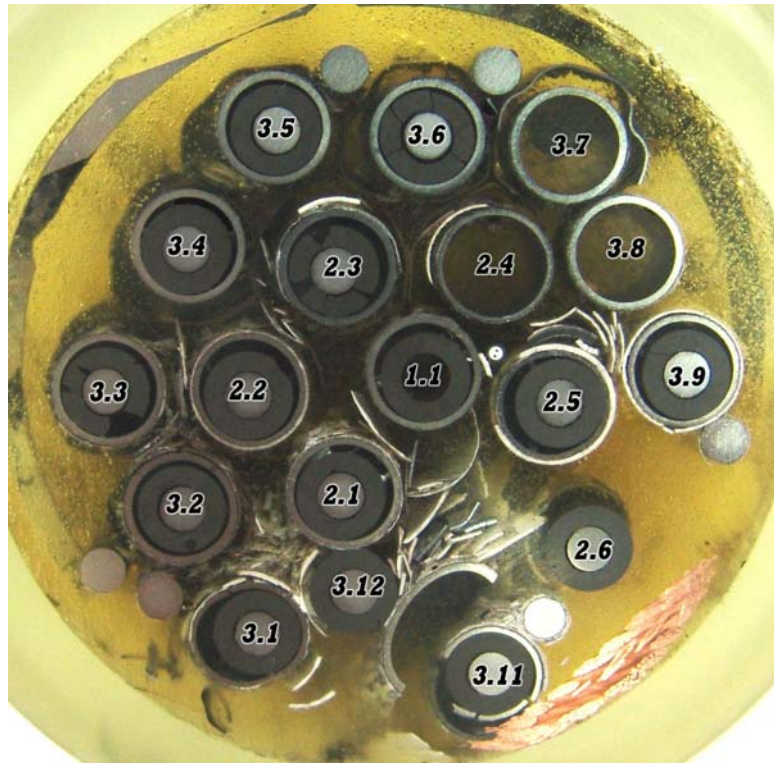
Fig. 11. Assembly cross-section at Z = 800 mm elevation (top view).

At $Z = 800$ mm elevation (*top view*) the bundle elements arrangement is distorted significantly (the displacement of fuel rods 3.12 and 2.6 as compared to their original location is observed, fuel rod 3.10 is absent due to break off, there are no heaters and fuel in fuel rods 2.4, 3.7 and 3.8 due to break off, there are five periphery rods, Fig. 11).

In the given section a fragment of spacer grid (on fuel rod 3.7), a fragment of fuel rod cladding (near fuel rod 3.11) were revealed, as well as many oxide scales remnants which fell down apparently from FA upper elevations. Fragmentation of some fuel rod claddings was observed – claddings of fuel rods 2.6 and 3.12 were damaged (i.e. practically absent in the given section), there are no fragments of claddings of fuel rods 3.1 and 3.11.

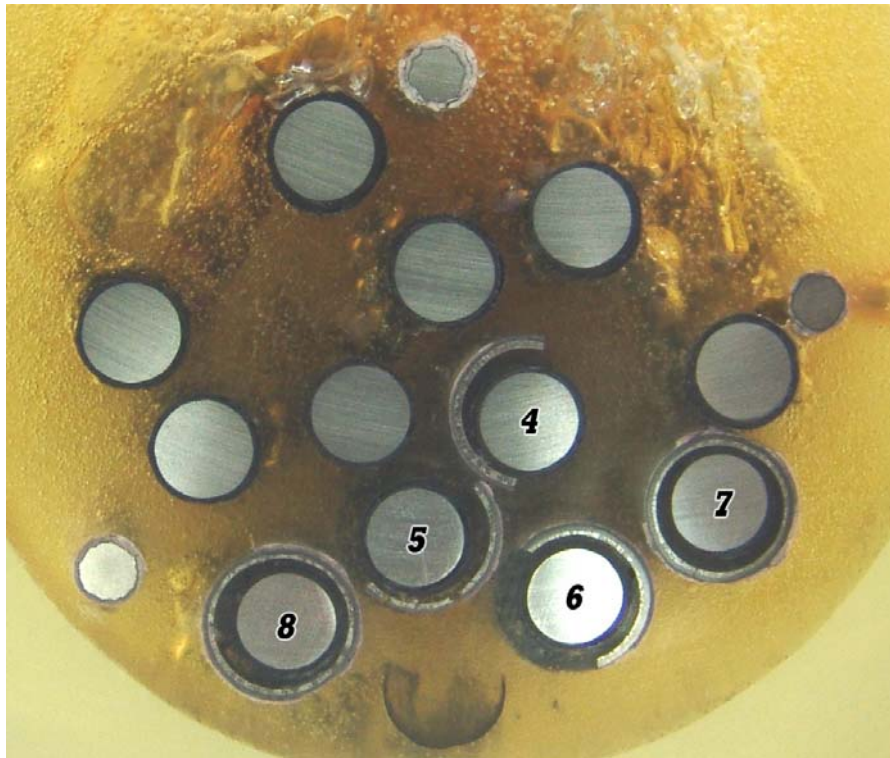
Fig. 27. Assembly cross-section at Z = 1300 mm elevation (top view).

At $Z = 1300$ mm elevation (top view) the maximum damages are observed because this is hottest zone (Fig. 27). In the cross-section three periphery rods and six fragments of claddings of fuel rods are available for measurements. Due to severe damages of FA and very strong arrangement distortion, available claddings cannot be identified. Maximum temperature of claddings at the pre-oxidation stage did not exceed

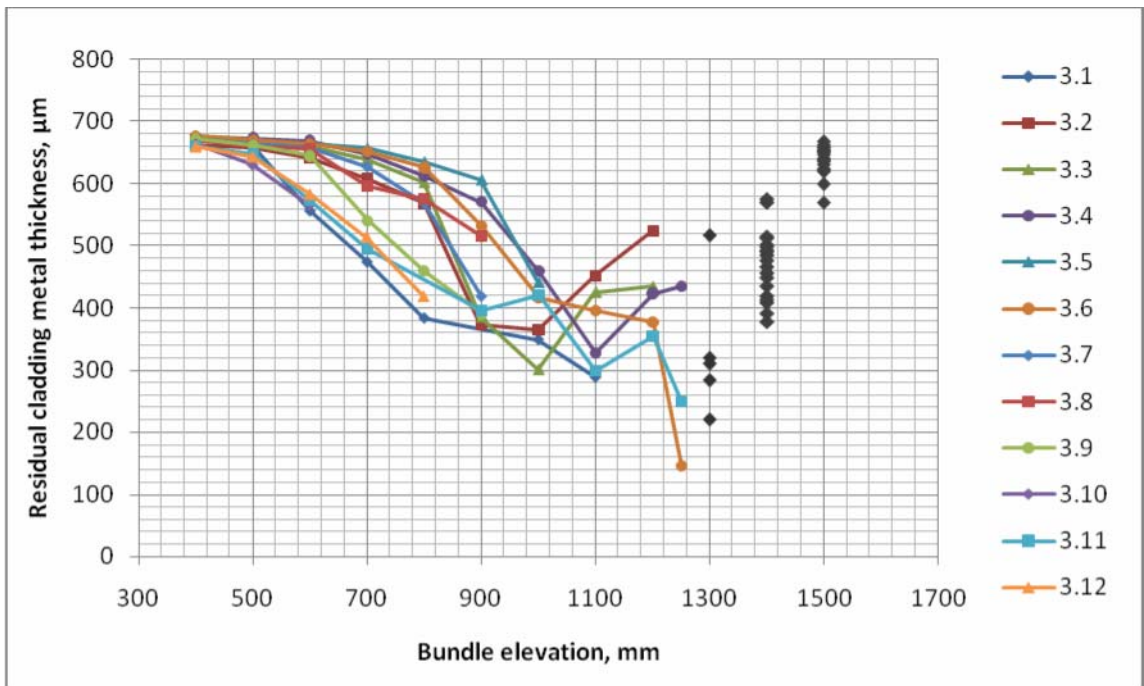
Fig. 34. Distribution of thickness of the remained metal part of claddings of fuel rods in the third row over the assembly height.

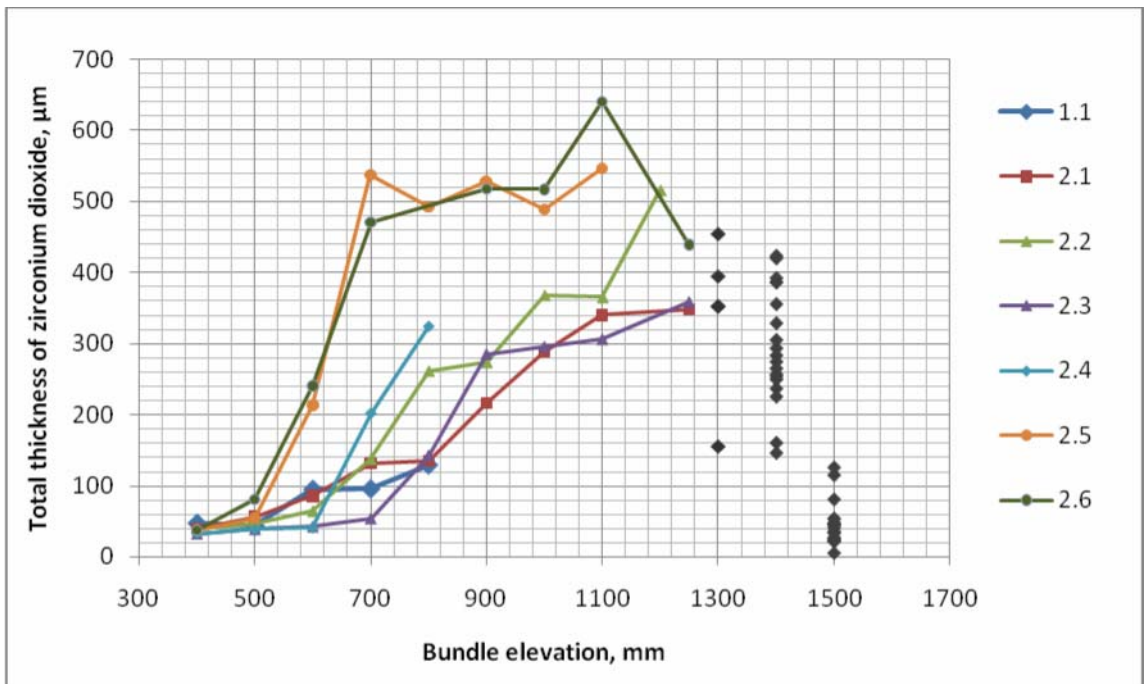
Fig. 37. Distribution of the calculated ZrO₂ thickness on external surfaces of fuel rods in the second row over the assembly height.
