PROJECT # 3194

"Fuel assembly tests under severe accident conditions"

PROTOCOL
on the results of the model FA
material studies
after the PARAMETER-SF1 experiment

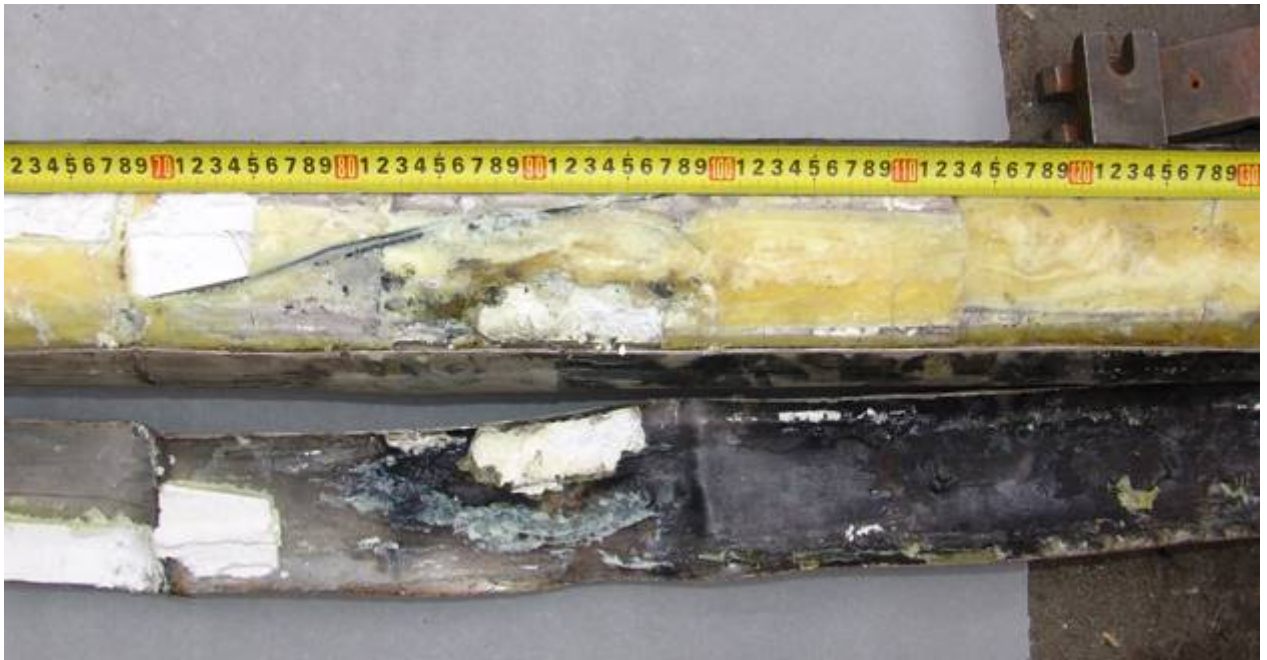
Fig. 1. External appearance of the thermal insulation housing inner surface at the level of 700-1300 mm.

On the housing inner surface (Fig. 1) and on the thermal insulation outer surface (Fig. 4) the local oxidized areas with peeling oxide scum and solidified melt were revealed.

On solidifying the epoxy resin the thermal insulation housing of the horizontally positioned model FA was uncovered (Fig. 1) and thermal insulation was removed mechanically. The external appearance of the model FA after removal of thermal insulation is presented in Fig. 2.

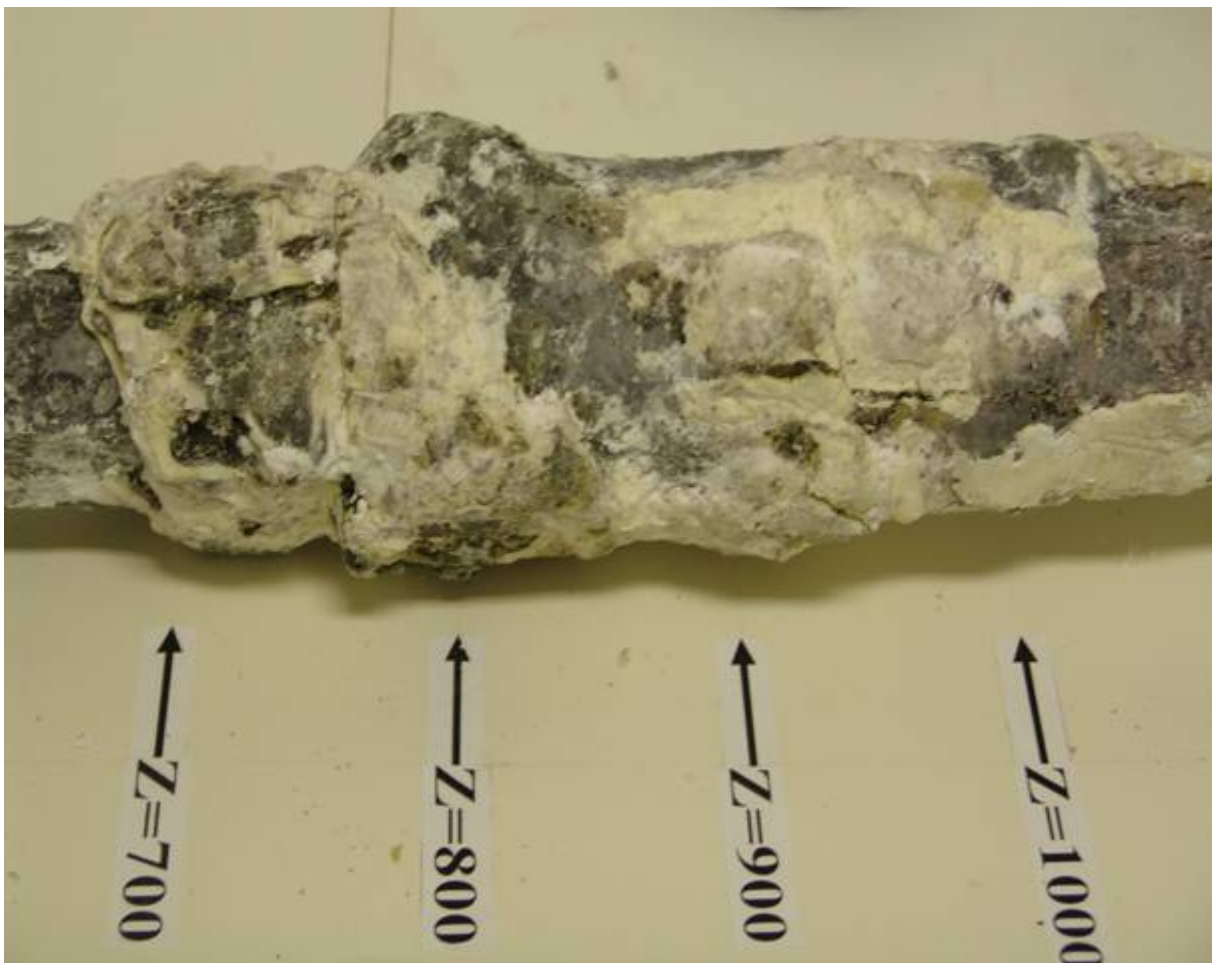
Fig. 2. External appearance of the shroud after the tests (level 700 – 1000 mm, 90° – 120°).

In Fig. 2 the external appearance of the model FA is given with the shroud at the level of 700 – 1000 mm on the assembly face 90° – 120° (fuel rods 3.7 – 3.9) after the experiment. The shroud is swelled, strongly oxidized and partially damaged.

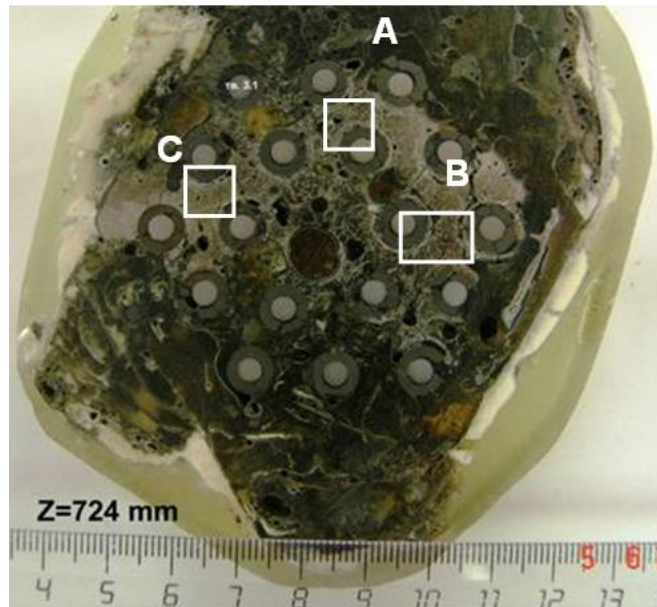
Fig. 23. Cross-section of the assembly at the level of 724 mm (top view).

Within the elevation range of $Z = 724 \dots 793 \text{ mm}$ the geometry of fuel rods arrangement in the assembly is kept although the FA shroud and fuel rod claddings are absent completely. Some fuel pellets are fragmented. The melted and run down masses made blockage of the FA flow area practically completely (Fig. 23).

At the level of $Z = 724 \text{ mm}$ (top view) the melt filled almost the whole space between fuel rods. Results of EDX analysis of the melt are presented in Table 7, and typical structures are given in Fig. 25. The obtained data are indicative of relative uniformity of the ceramic phase in the melt due to which it can be supposed that its formation occurred at higher level. Thickness of oxide phase on the melt surface in the given section does not exceed $400 \mu\text{m}$.

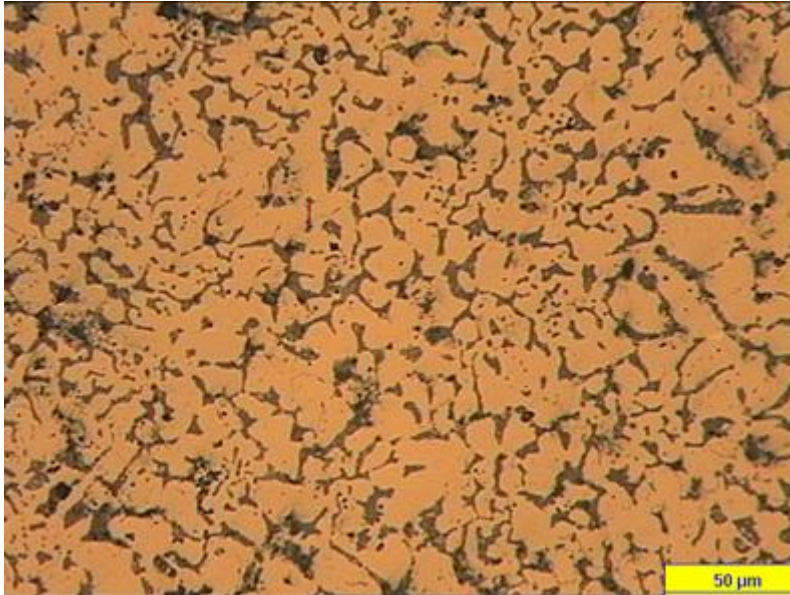
Fig. 31. Structures of melts from different zones of section 793 mm.

Melt (U,Zr,O)
Ceramic faze content
~ 34 % vol.

Ceramic (Zr,U)O₂

Melt (U,Zr,O)
Ceramic faze content
~ 64 % vol.

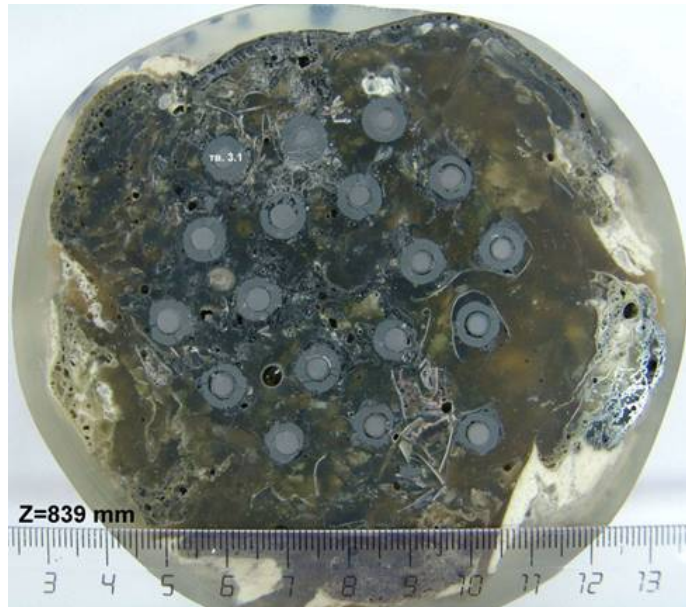
Fig. 32. Cross-section of the assembly at the level of 839 mm (top view).

The assembly state within the elevation range of $Z = 839 - 1066 \text{ mm}$ (Fig. 32, 34, 36, 38, 42) is characterized by complete absence of zirconium structural components (FA

shroud, fuel rod claddings, spacing grids, thermocouples jackets) that is indicative of the level of temperatures considerably exceeding the zirconium melting temperature within the given elevation range. Apparently, the melt, formed within this elevation range, caused the considerable blockage below. Integrity of the remaining fuel columns is kept only at the expense of tantalum heaters playing the role of the assembly skeleton that reflects adequately the behaviour of the full-scale FA under similar conditions. In some of the regions of each of the sections studied for the given elevation range the fragments were revealed of the through-oxidized fuel rod claddings, or the oxide scums peeled from the fuel rod claddings (Fig. 38, 40). Their presence could be also caused by transfer of brittle fragments from the upper levels (crumbling) or transfer from the low levels when filling the assembly with epoxy resin (lifting).

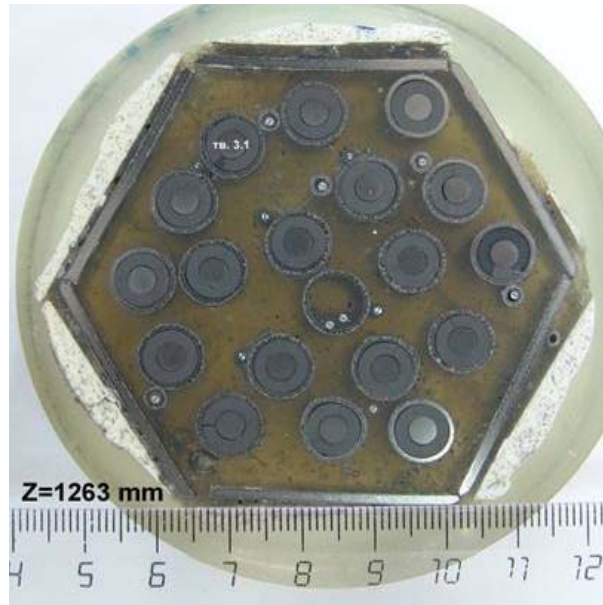
Fig. 49. Cross-section of the assembly at the level of 1263 mm (top view).

At the level of $Z = 1263$ mm (top view) the thickness of oxide scum on the outer surface of claddings is ~ 200 μm , the oxide is of columnar structure without laminations. With this, all fuel rods at the given level are intact but have the through cracks (Fig. 51) with the edges not oxidized that is indicative of the fact that they were formed under flooding. In claddings of fuel rods 3.12 and 3.6 the traces of eutectic fuel-clad interaction were revealed (Fig. 51, thickness of α - $\text{Zr(O)} + (\text{U,Zr})$ layer is ~ 100 μm , thickness of (U,Zr) layer is ~ 70 μm). Thickness of oxide on the shroud outer and inner surfaces is ~ 150 μm .

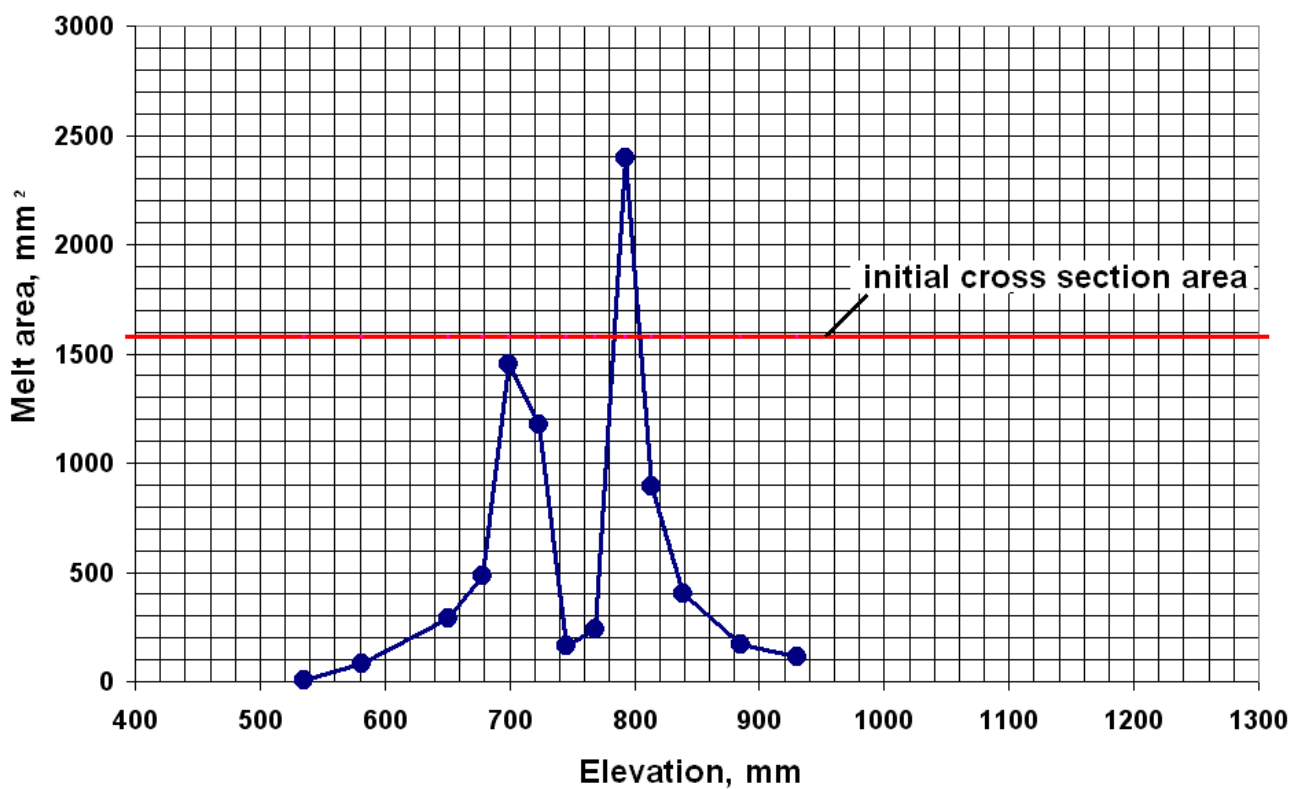
Fig. 53. Profile of the melt solidified in the model assembly PARAMETER-SF1.

Profile of the solidified melt in the assembly is presented in Fig. 53.

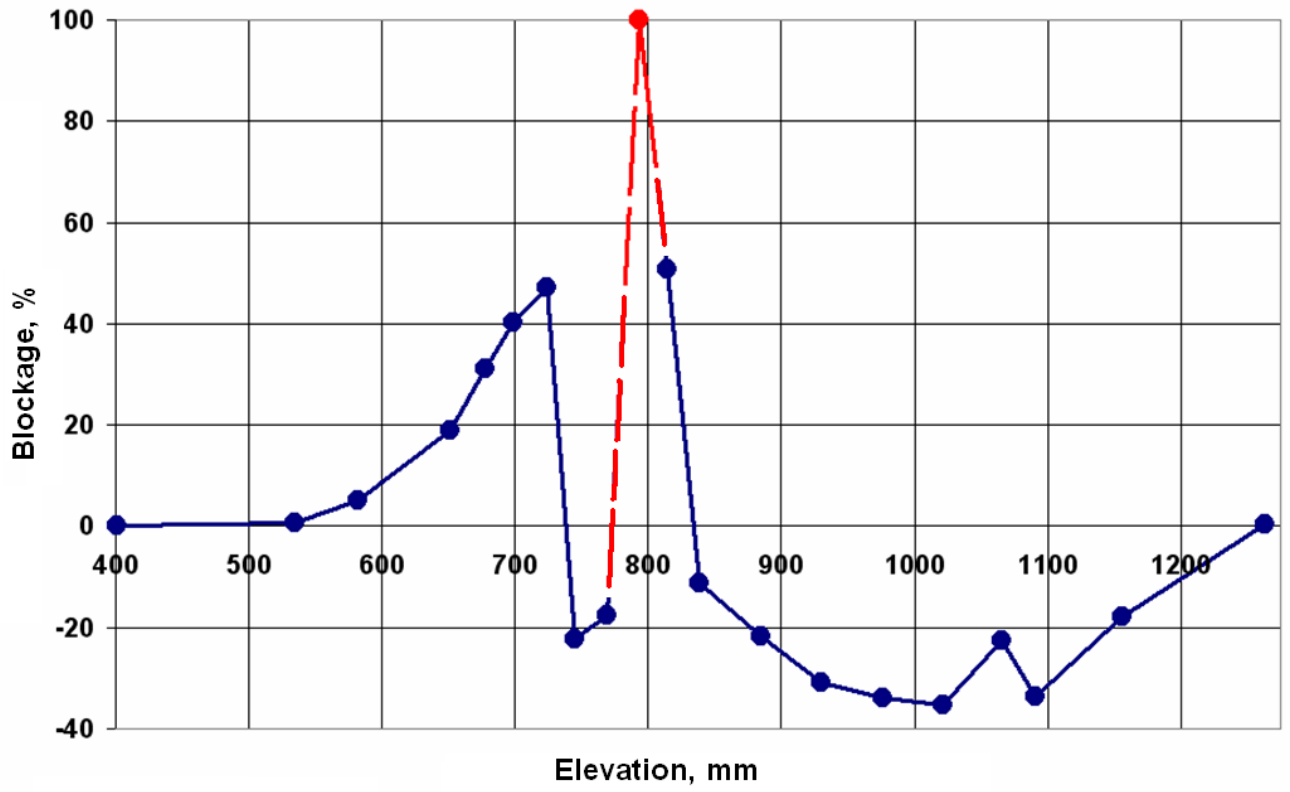
Fig. 54. Distribution of flow area blockage in the model assembly PARAMETER-SF1.

For calculation of the assembly flow area blockage in each cross-section the area of the whole material available was calculated, except for the shroud and remains of thermal insulation. Using the obtained result the change of the flow area in the assembly and COB were calculated. It should be noted that the blockage was calculated in respect to the initial flow area. In this connection the COB in section $Z = 793$ mm reaches 100% (Fig. 54), although visually (Fig. 29) it is seen that the flow area remains.
