FEDERAL STATE UNITARIAN ENTERPRISE
"SCIENTIFIC RESEARCH INSTITUTE
SCIENTIFIC INDUSTRIAL ASSOCIATION "LUCH"
FSUE "SRI SIA "LUCH"

**ANALYSIS OF MATERIAL STUDIES OF WWER-1000 MODEL ASSEMBLY
TESTED AT THE PARAMETER-SF2 EXPERIMENT
UNDER THE CONDITIONS OF SEVERE ACCIDENT
WITH TOP AND BOTTOM FLOODING**

Report
on scientific work
under ISTC Project No.3690

2008

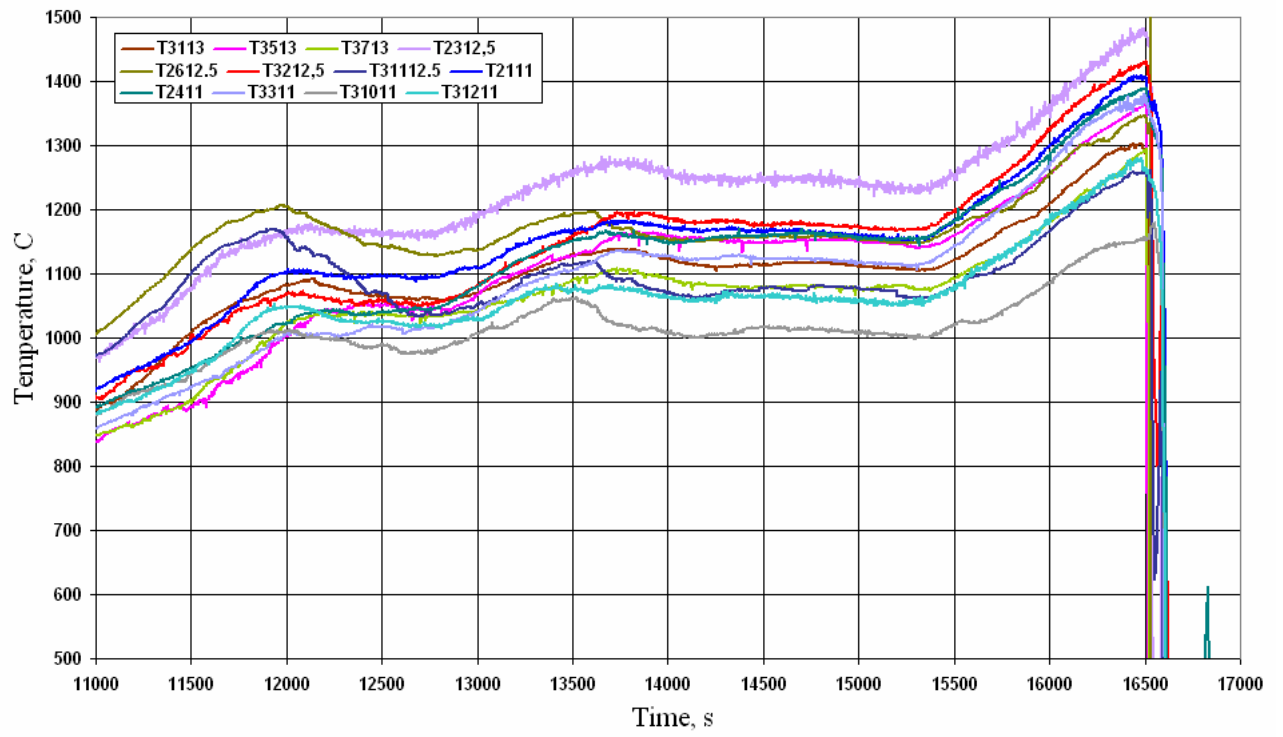
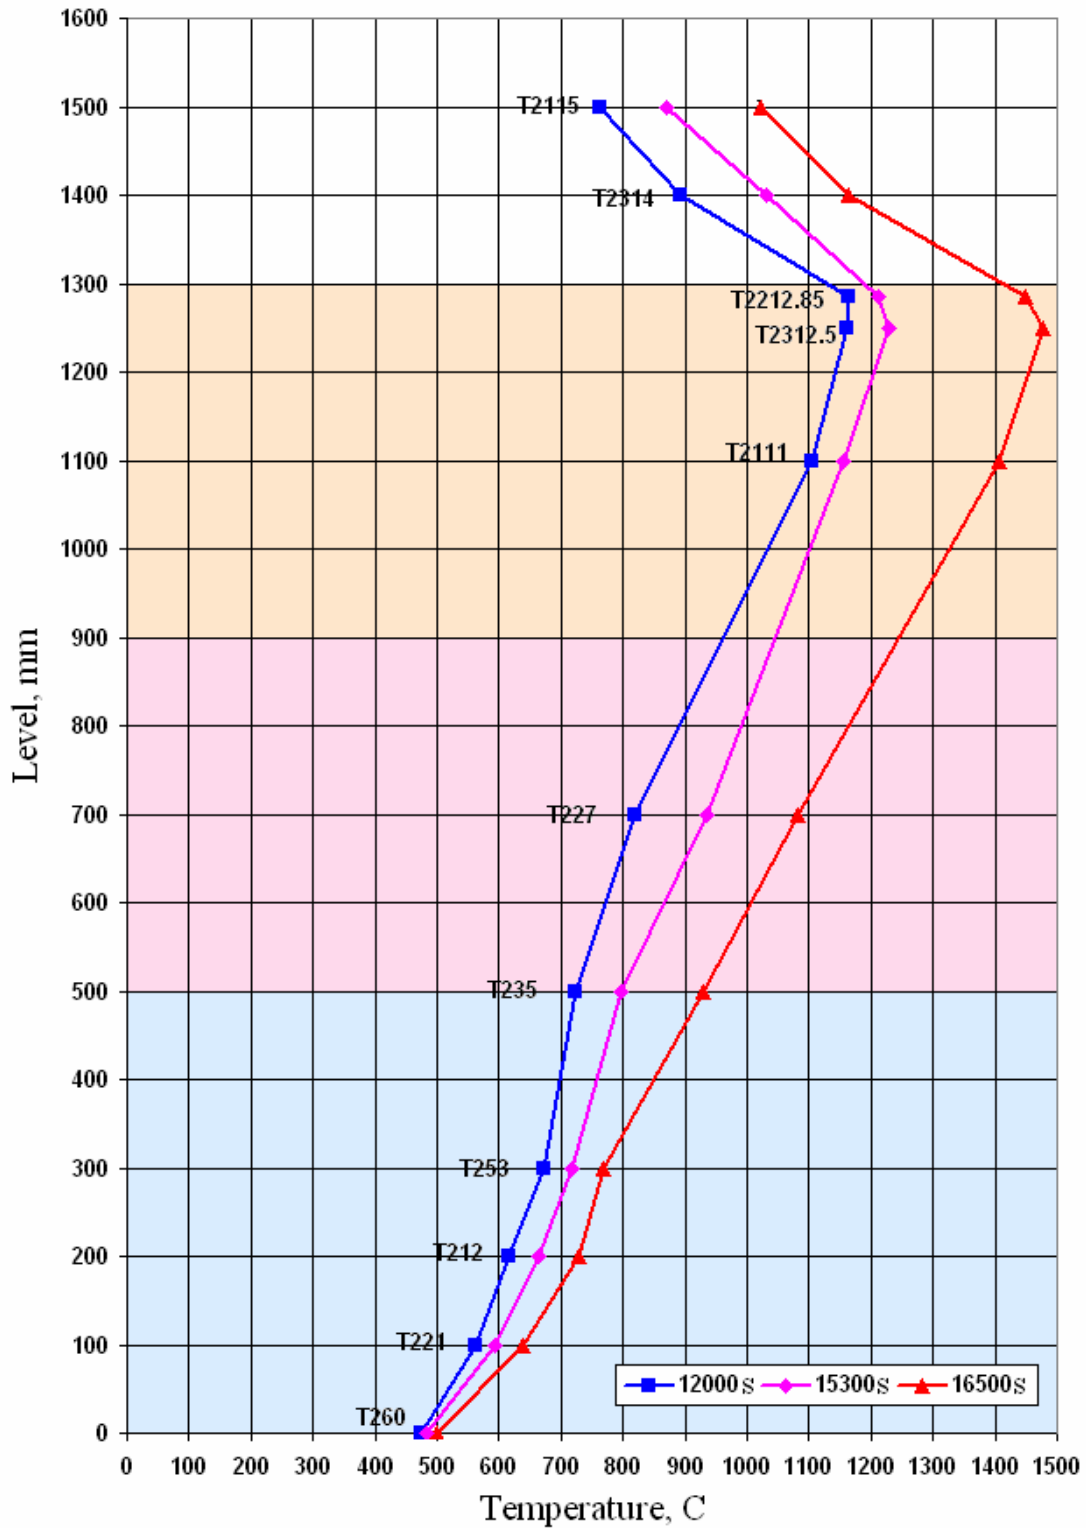
Fig. 1. a – indications of thermocouples fixed on fuel rod claddings at Z = (1100 – 1300) mm elevations of the model FA; b – claddings temperature in the second row over heated zone at the beginning of pre-oxidation (t=12000 s), at the beginning of the transient stage (t=15300 s) and before flooding onset (t=16500 s).

Methodical approaches to material studies of the assembly are developed on the basis of the analysis of results of measurement of fuel rod cladding temperature (see Fig. 1 a) in the PARAMETER-SF2 experiment, [1]. The highest temperatures in the assembly were reached on claddings of fuel rods of the second row. Fig. 1 b presents temperature distribution over the bundle height for the 2nd row claddings restored by the method of interpolation by indications of thermocouples, at the beginning of pre-oxidation stage (moment $t=12000$ s), at the beginning of the transient stage (moment $t=15300$ s), and directly before the filling (moment $t=16500$ s). Temperature points at the elevations correspond to thermocouples indications at the corresponding time moments.

In the middle part (500 – 800 mm) of the assembly the maximum temperatures of the 2nd row fuel rods did not exceed 1170°C (Fig. 1 b). Thermocouples show the pre-oxidation of claddings of the fuel rods of the 2nd row occurred at temperatures $800\text{--}950^\circ\text{C}$. According to the data of [2, 3, 4], the alloy E110 show breakaway at temperature below 1100°C and long-term exposure. Therefore in this area of the assembly one should expect the dioxide of layered structure with trend to separate from the cladding. Information on the state of the assembly components in this area can be also used for understanding of intermediate states of the assembly components located at higher elevations. For metallographic measurements of thickness of oxide and metal layers on cladding surfaces four cross section slabs were chosen at 513, 605, 702 and 769 mm elevations (Table 1, Fig. 2). Description of the state of the assembly components in this area was performed for 513 mm and 702 mm elevations.

According to the thermocouple readings, the hottest zone location corresponds to the assembly upper part at $900 \dots 1300$ mm elevations (Fig. 1 b). So, in this part of the assembly, one should expect the highest degree of oxidation of the shroud and claddings. Therefore, the metallographic measurements of layers thickness in this area were done with more detail (for the elevations of 902, 951, 1033, 1103, 1203, 1246 and 1296 mm, Table 1, Figs. 2, 3). High temperature (at pre-oxidation and transient phases) allows expecting under external layered oxide compact oxide well connected with metallic layer.

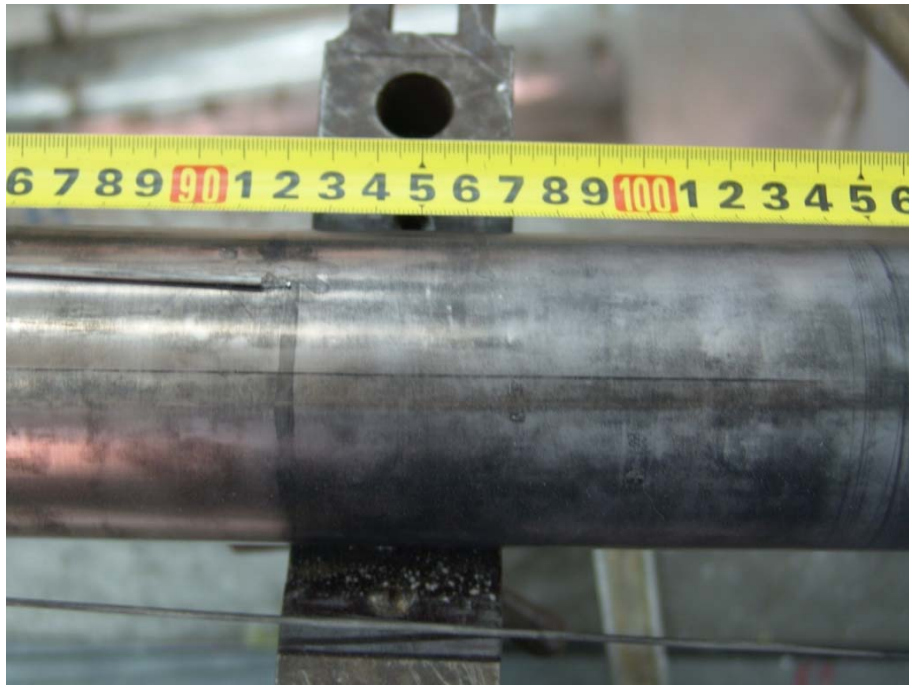
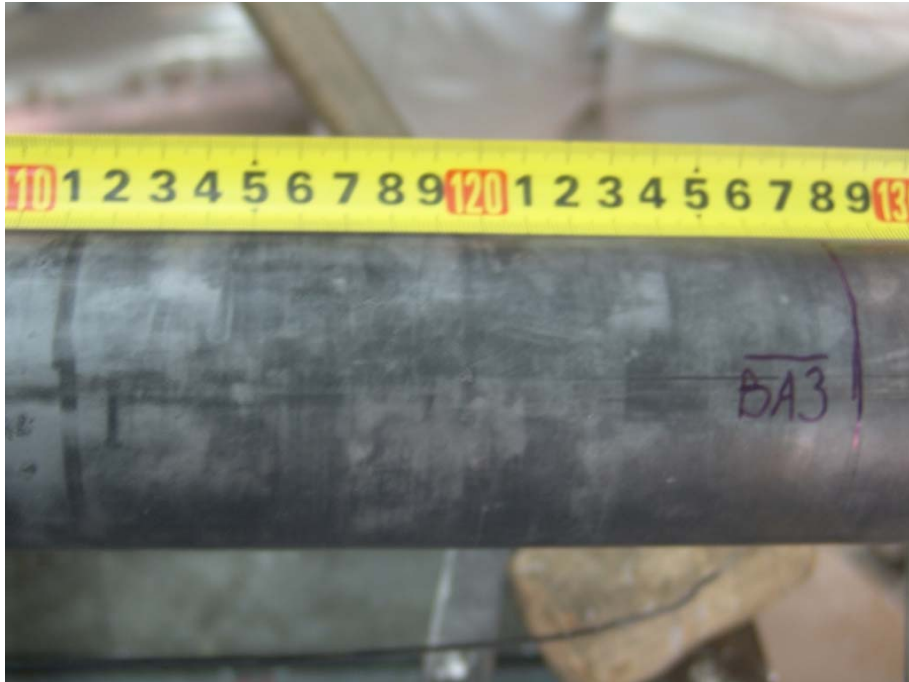
Visual examination of the model FA shroud after removing of the encapsulated assembly from the test section showed that its external surface is covered with firm black zirconium oxide (Fig. 4), and its post-test integrity is fully kept (no blowholes, deformation and cracks).

Fig. 4. Post-test appearance of the shroud of the model FA SF2:
a – elevations of $Z = 850 - 1050$ mm; b – elevations of $Z = 1100 - 1300$ mm.

However in the course of the assembly sectioning into slabs (when it is chucked in Delta-Abrasimet machine) the shroud brittle crack occurred over the generatrix (opposite fuel rod 3.4), that is indicative of a considerable saturation of metal with oxygen and possible formation of zirconium hydrides.

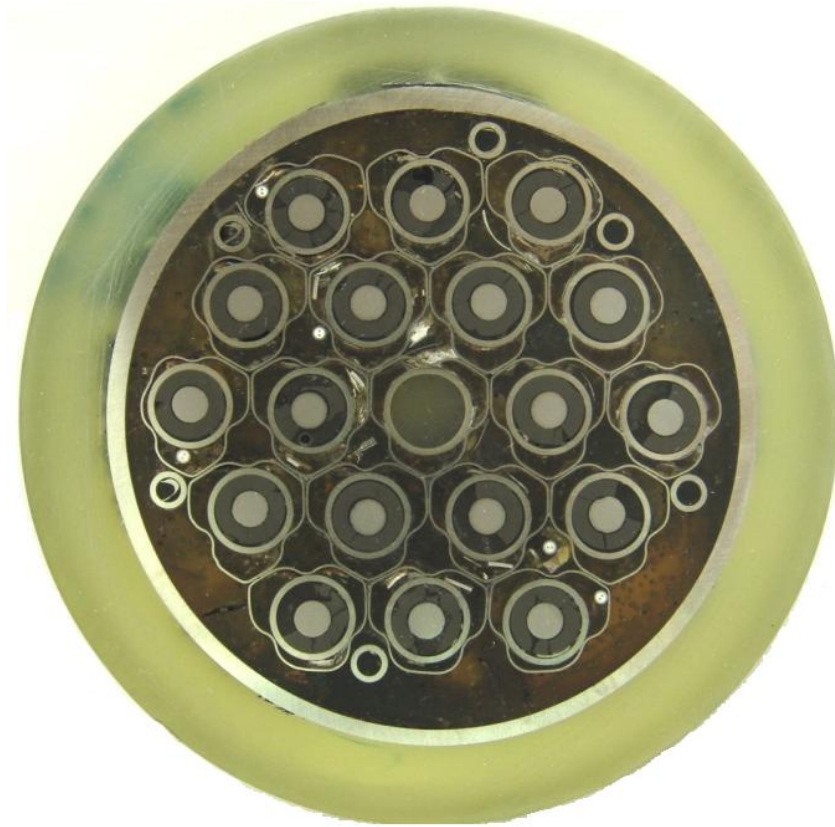
At $Z = 513$ mm elevation (top view, location of spacer grid (SG) No. 4) there are practically no visible damages of the assembly (Fig. 5). Maximum temperature of claddings at this elevation at the pre-oxidation stage did not exceed $\sim 820^{\circ}\text{C}$, and before flooding onset $\sim 950^{\circ}\text{C}$ (Fig. 1). There are cracks on some pellets of uranium dioxide. In some pellet there are no fuel fragments. However crumbling of pellets occurred probably in the course of the assembly sectioning or following preparation of cross section slabs for metallographic examinations.

Fig. 5. Assembly cross-section at Z = 513 mm elevation (top view).

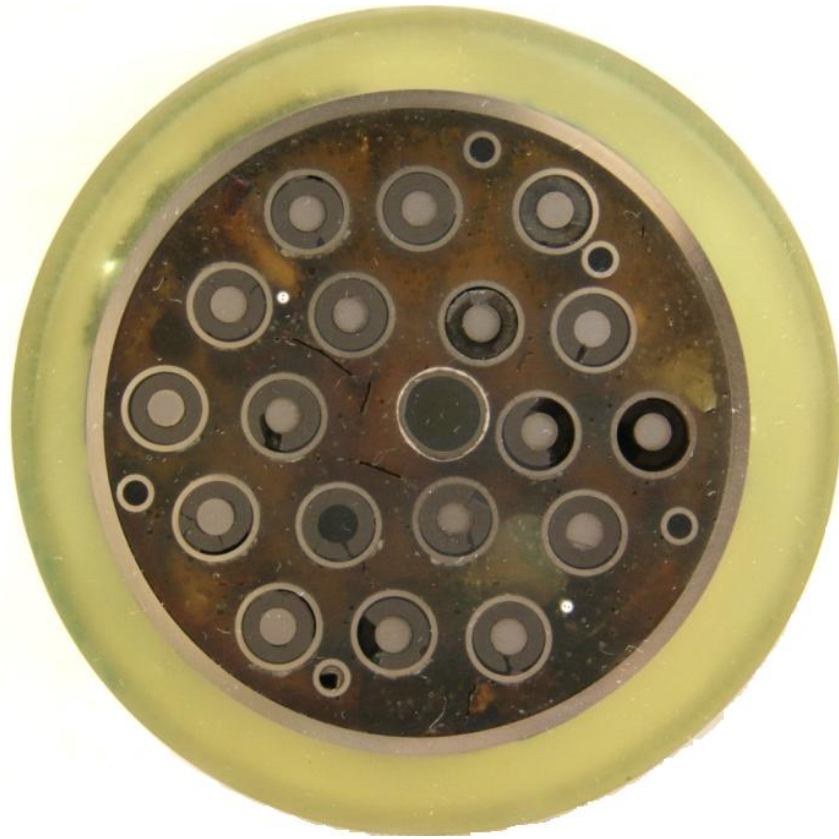
At $Z = 702$ mm elevation (top view) the cross-section geometry changed insignificantly (the displacement of fuel rod 1.1 in respect to its initial position is observed, Fig. 9). Maximum cladding temperatures at this elevation at the pre-oxidation stage did not exceed $\sim 970^\circ\text{C}$, and before flooding onset $\sim 1100^\circ\text{C}$ (Fig. 1). A considerable difference is revealed in the oxidation degree between the central fuel rod (fuel rod 1.1) and the other fuel rods, namely the cladding of fuel rod 1.1 is oxidized considerably stronger (Fig. 10), on its surface there is a thick multilayered oxide scale (Fig. 11 a, c), whereas the other simulators are covered with the oxide consisting of only a few or several layers. On all fuel rods the essential spallation of oxide from the surface of fuel rod claddings is observed (Fig. 11 b, d). No fuel-clad interaction, internal claddings oxidation and through wall cracks are revealed in claddings. Thickness of metal part of claddings varies from 630 to 660 μm , in the central fuel rod 1.1 – 510 μm .

Fig. 9. Assembly cross-section at Z = 702 mm elevation (top view).

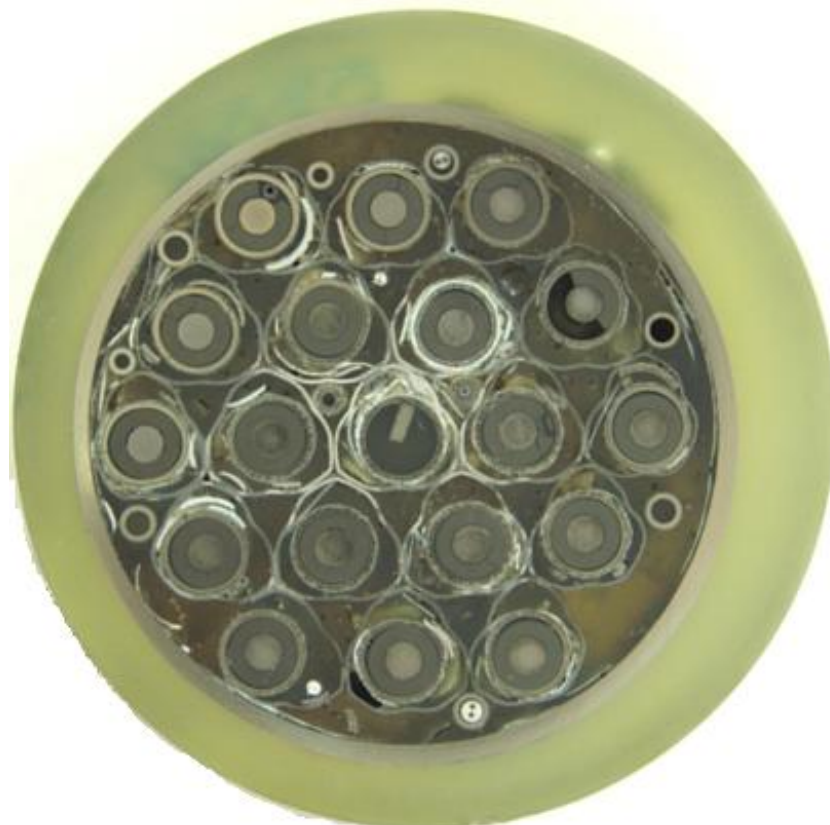
At $Z = 1033$ mm elevation (top view, arrangement of SG No.2) the considerably higher degree of oxidation of fuel rod simulators is observed as compared to the described lower elevations (Fig. 13). Maximum cladding temperatures at this elevation at the pre-oxidation stage did not exceed $\sim 1150^\circ\text{C}$, and before flooding $\sim 1370^\circ\text{C}$ (Fig. 1). It should be noted that approximately in this area the long-term assembly cooling took place, however it did not influence principally the cladding structures. Typical state of fuel rod simulators is shown in Fig. 14. On their surface there is an easily spalled off oxide ZrO_2 , under which the layer of compact, zirconium oxide with columnar microstructure well

Fig. 13. Assembly cross-section at Z = 1033 mm elevation (top view).

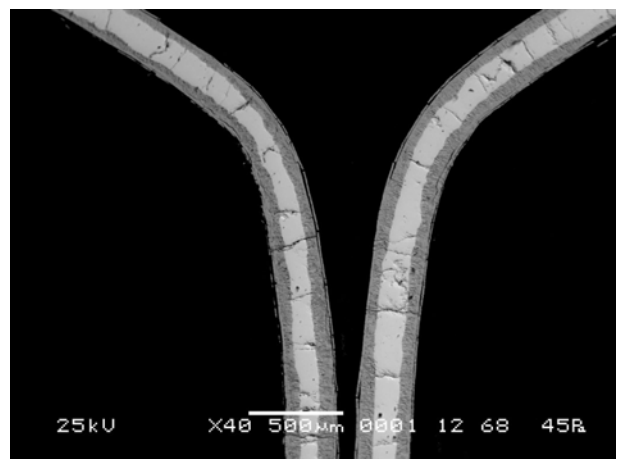
In the spacer grid cells there is a considerable number of fragments of oxide scales. The cells themselves also have the through wall cracks (Fig. 16) and is oxidized completely (for the second row of fuel rods).

Fig. 16. State of spacer grid at Z = 1033 mm elevation: a – area of the second row of fuel rods; b – area of the third row of fuel rods.

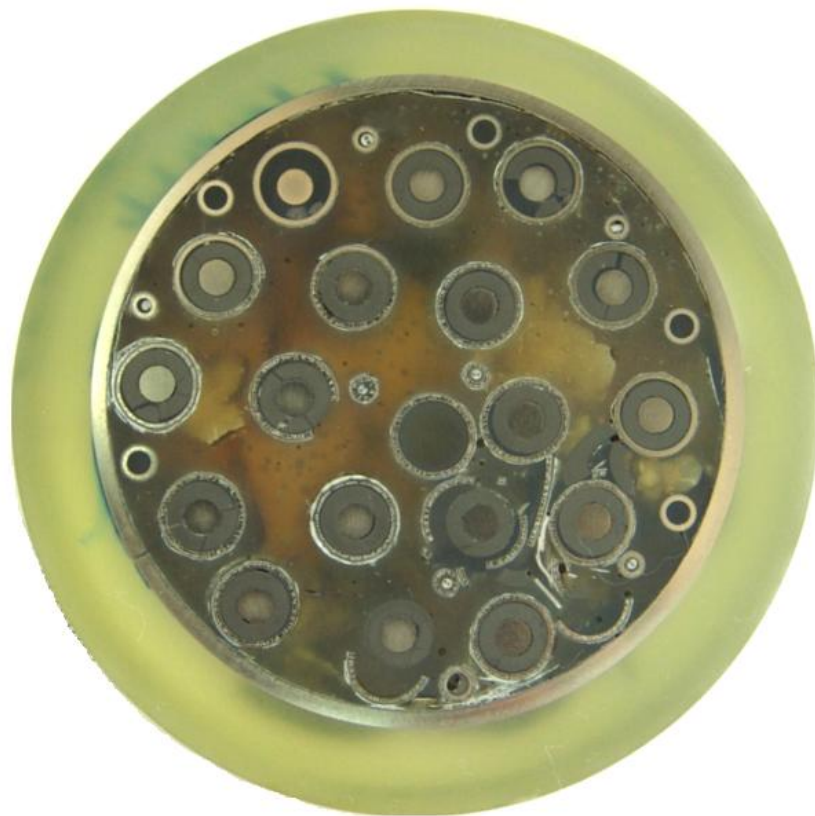
At $Z = 1103 \text{ mm}$ elevation (top view) further increase in the oxidation degree of fuel rod simulators and their displacements relative to the initial positions are observed (Fig. 19). Maximum cladding temperatures at this elevation at the pre-oxidation stage did not exceed $\sim 1180^\circ\text{C}$, and before flooding onset – $\sim 1400^\circ\text{C}$ (Fig. 1). Typical state of fuel rod simulators is shown in Fig. 20. On their surface there is also an easily spalled off oxide ZrO_2 , under which the layer of compact, zirconium dioxide with columnar structure well attached to metal substrate is located (Fig. 21). It should be pointed out that compact oxide tends to split (Fig. 21 a). Owing to brittleness of suboxide layer all fuel rods practically have a large number of non-oxidized cracks (Fig. 22), and some of the fuel rods (fuel rods 2.1, 2.3 and 3.2) are fragmented. However no fuel crumbling and fuel-clad interaction are revealed also.

Fig. 19. Assembly cross-section at Z = 1103 mm elevation (top view).

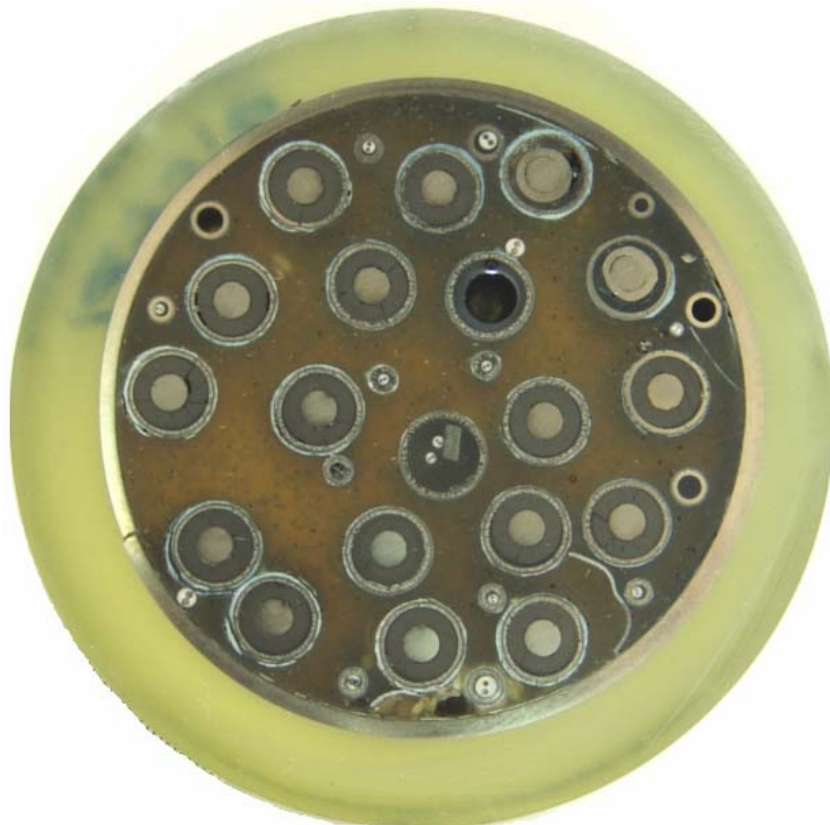
At $Z = 1246 \text{ mm}$ elevation (top view) the rods arrangement is distorted significantly (Fig. 24). This is hottest zone of the assembly. Maximum cladding temperatures at this elevation at the pre-oxidation stage did not exceed $\sim 1250^\circ\text{C}$, and before flooding onset $\sim 1500^\circ\text{C}$ (Fig. 1). Typical state of fuel rod simulators is shown in Fig. 25. The fuel rod claddings have the through wall cracks, but they are not fragmented.

Fig. 24. Assembly cross-section at Z = 1250 mm elevation (top view).

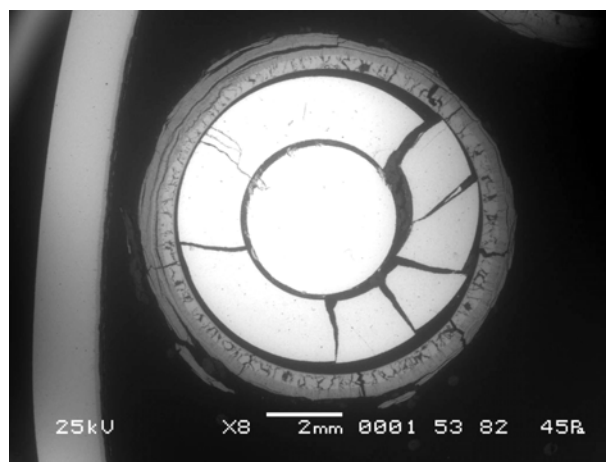
Fig. 25. Cross-section of fuel rod simulators (a – fuel rod 1.1; b – fuel rod 2.1; c – fuel rod 3.1; d – fuel rod 3.5) at Z = 1250 mm elevation.
