Results of the QUENCH-12 reflood experiment with a VVER-type bundle

J. Stuckert, L. Sepold, M. Steinbrück Forschungszentrum Karlsruhe, Institute for Materials Research

Objectives of the QUENCH-12 test

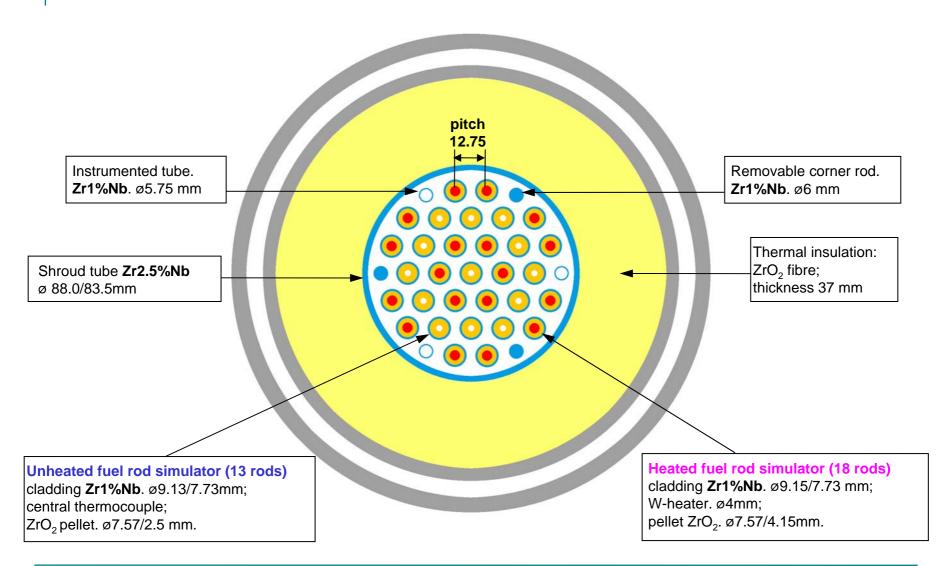
QUENCH-12: Cross section of the VVER-column.

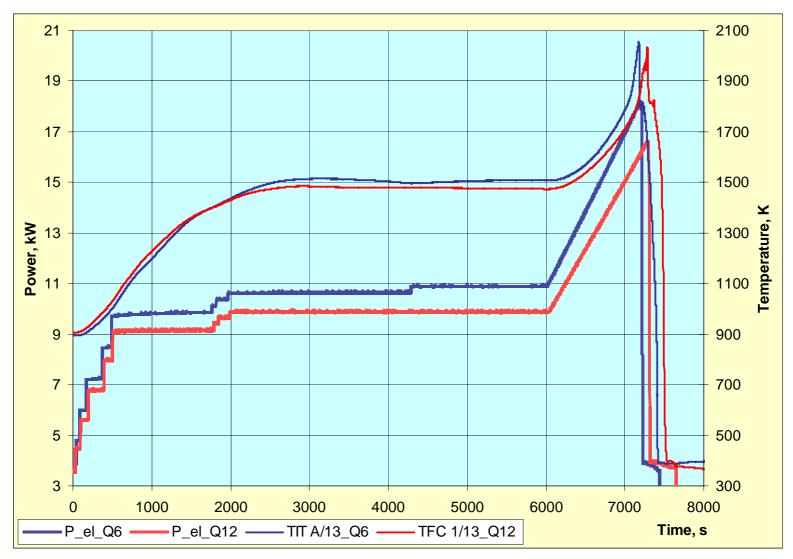
Comparison of temperature and power profiles for QUENCH-12 and QUECH-06.

- The electrical power changing during the test corresponds completely to calculated values up to reflood phase. The temperature history during preoxidation is very similar to the QUENCH-06 temperature history.

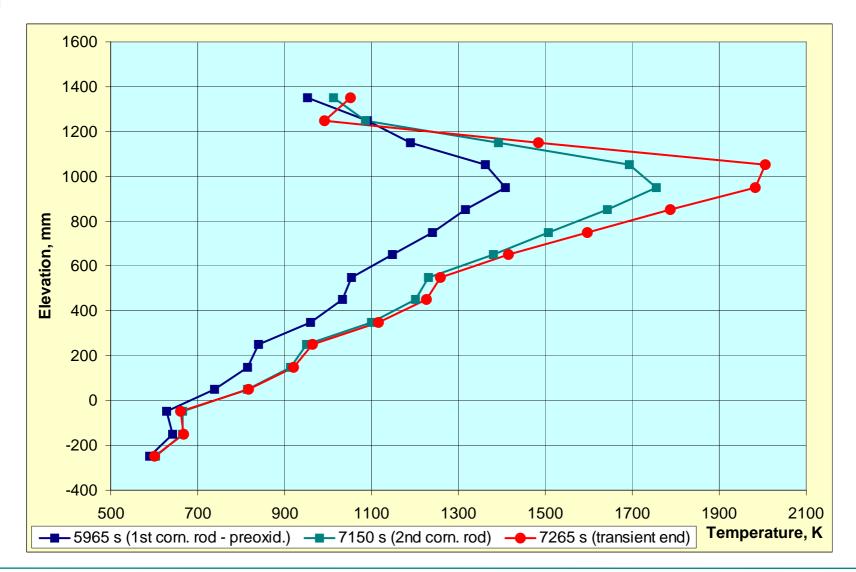
QUENCH-12: axial temperature profiles during pre-oxidation and transient phases

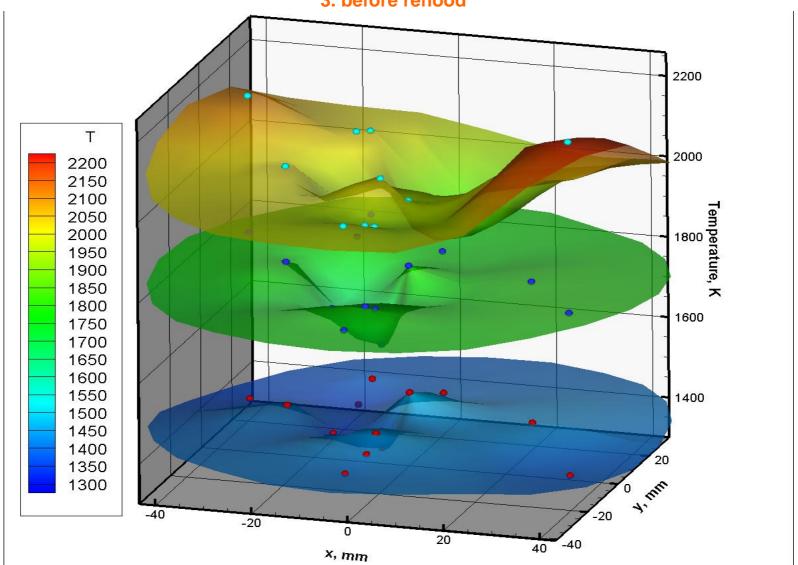
bundle temperature field: 1. during preoxidation, 2. after transient begin, 3. before reflood

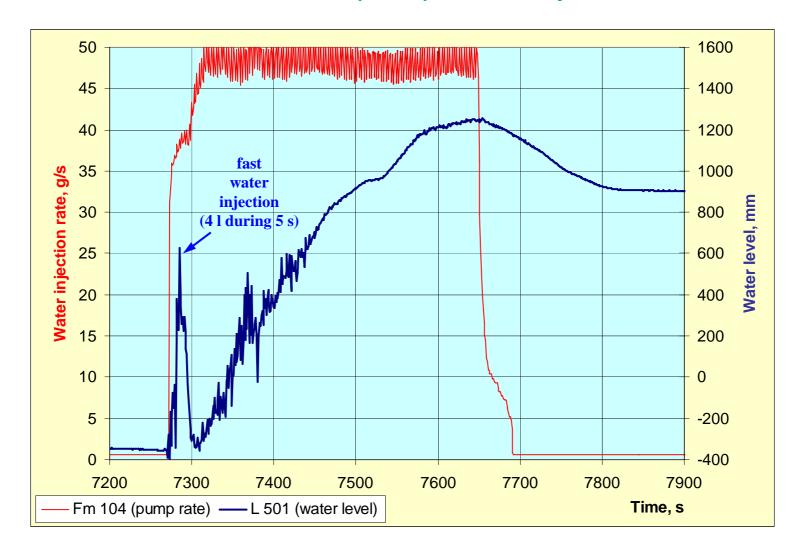
QUENCH-12, quench phase: water injection

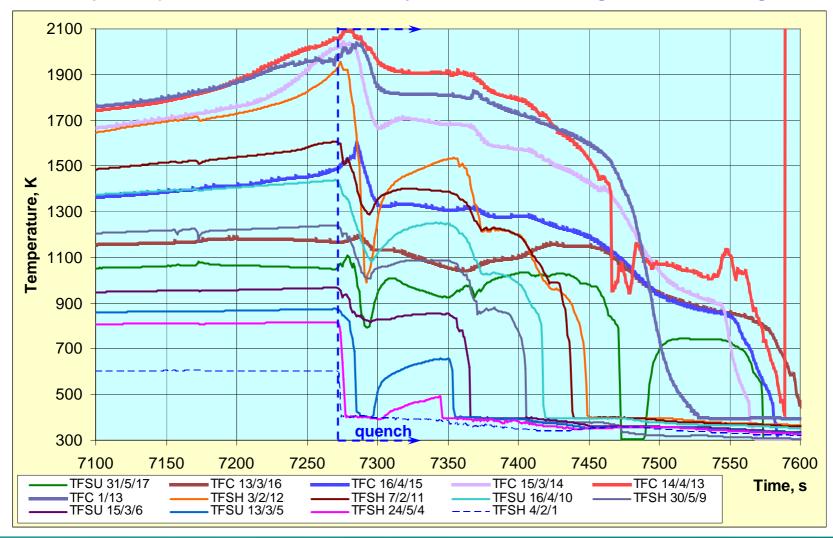
QUENCH-12, quench phase: selected reading of the bundle thermocouples.

Temporary sharp decrease of the cladding surface temperature as reaction on the fog from the water fast injection system. Pellet internal thermocouples show smooth cooling of the bundle during ~350 s.

- •Following reflood initiation, a moderate temperature excursion of ca. 50 K was observed, over a longer period than in QUENCH-06. The temperatures at elevations between 850 mm and 1050 mm exceeded the melting temperature of β -Zr.
- The hydrogen content in the corner rods reached a value more than 30 at% at the bundle elevations of 850 and 1100 mm.
- The total hydrogen production was 58 g (for QUENCH-06: 36 g), during the reflood was released 24 g hydrogen (for QUENCH-06: 4 g). This may be attributed partly to the longer excursion time in QUENCH-12. Other reasons for the increased hydrogen production may be extensive damaging of the cladding surfaces due to the <u>breakaway oxidation</u> and local melt formation with subsequent melt oxidation.

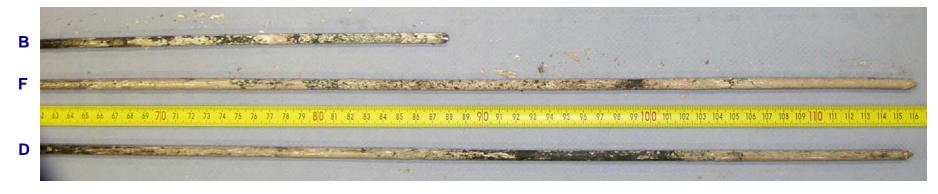
corner rod B after pre-test (800 °C, oxide layer thickness less of 5 µm)

corner rods D, F, B after pre-test: spalling of the outer skin of oxide layer.

D – withdrawn after pre-oxidation,

F – withdrawn before reflood,

B - withdrawn after test.

- Two corner rods were withdrawn at the end of preoxidation and transient phases correspondingly. The third corner rod was withdrawn after the test. The surface of the rods shows intensive traces of the break-away effect influence. Many oxide scales with thickness about 100 µm were spalled during withdrawn.

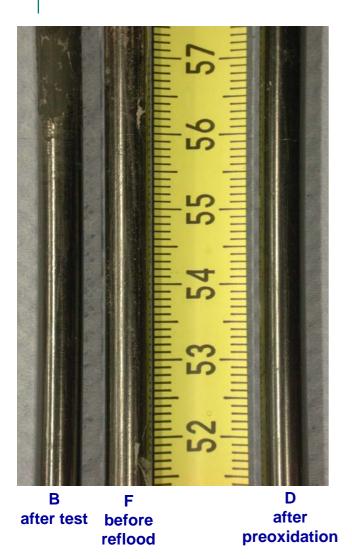
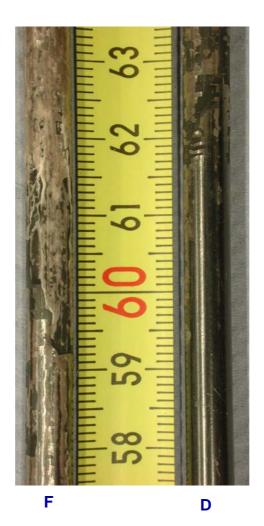
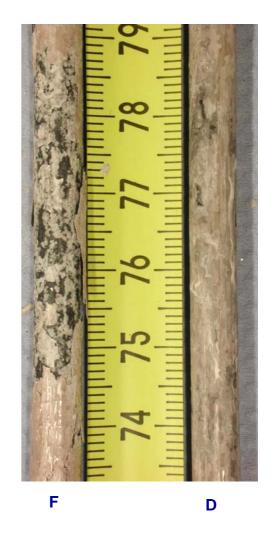
QUENCH-12: axial sections of different ZrO₂ spalling intensity on withdrawn corner rods

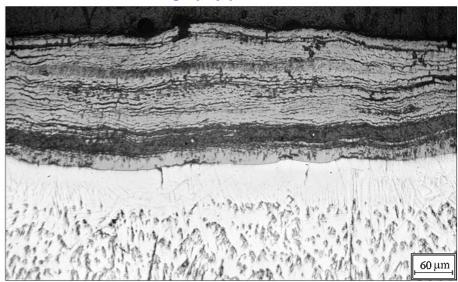
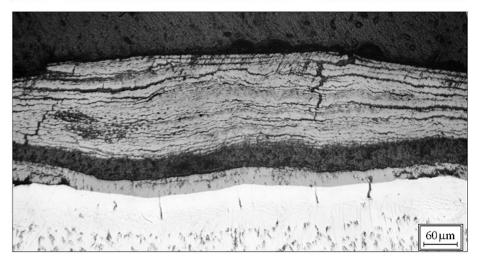
rod F: cross-section at elevation of <u>1120 mm</u>, total diameter 6050 μm

formation of multilayer oxide structure due to breakaway oxidation

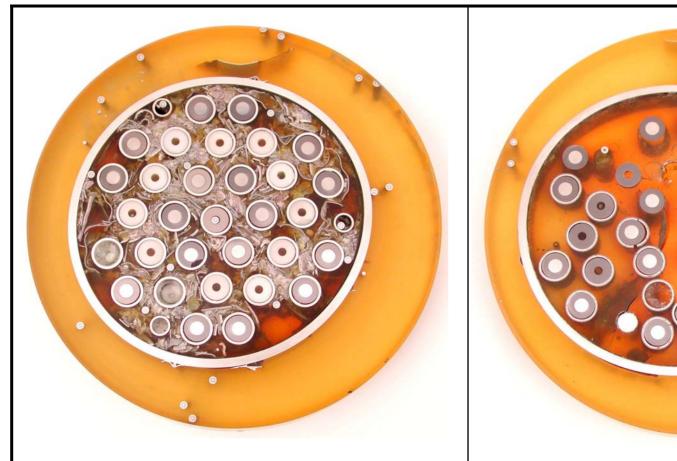
QUENCH-12: cross-sections of the bundle (top view)

Elevation 550 mm: debris bed on spacer grid

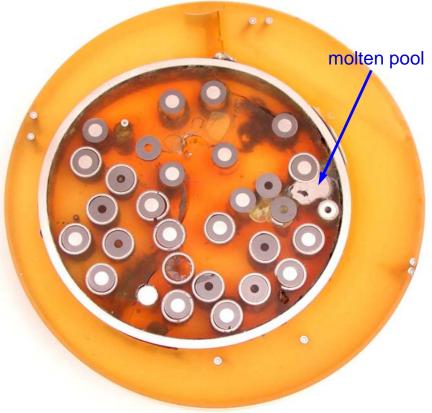
Elevation 854 mm: loss of bundle geometry and melt formation

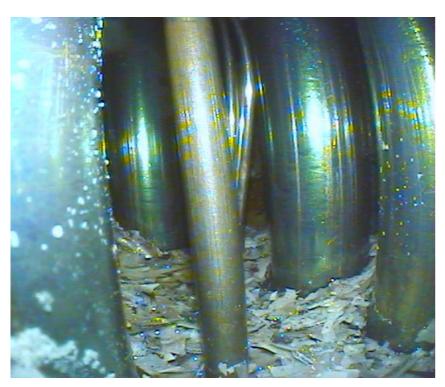
QUENCH-12, videoscope analysis: intensive oxide scale spalling inside of bundle

side view from corner rod B on the top of the first spacer (-150 mm)

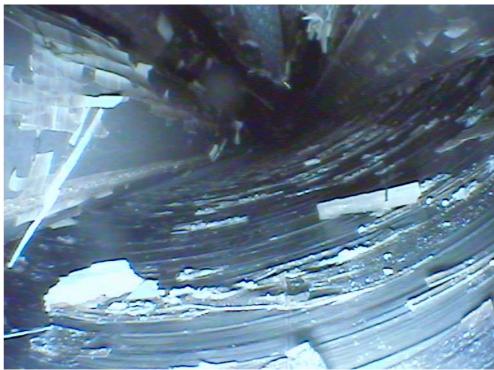
camera in position of corner rod D at 650 mm: spalled oxide scales at shroud and cladding

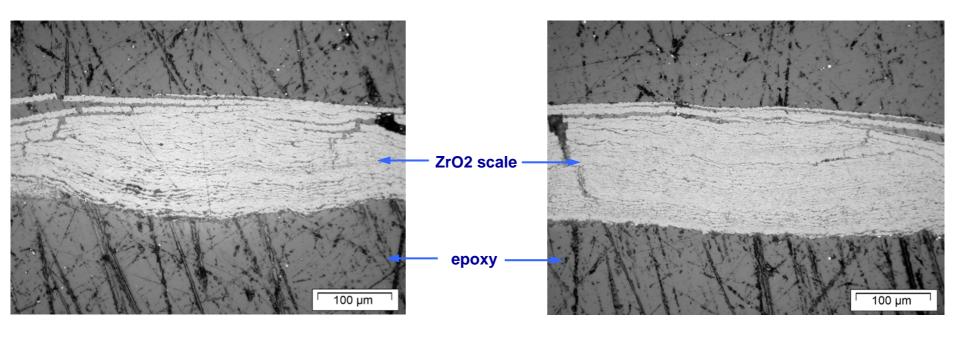
QUENCH-12: laminated structure of spalled oxide scales

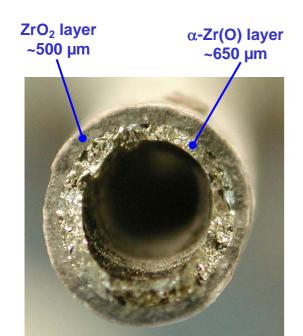
QUENCH-12: melt formation at 850 mm on the position of withdrawn corner rod B.

upper part of the rod B: is the absent central part the melted β-Zr?

neutron radiography (M. Große) shows the deep hole with irregular diameter

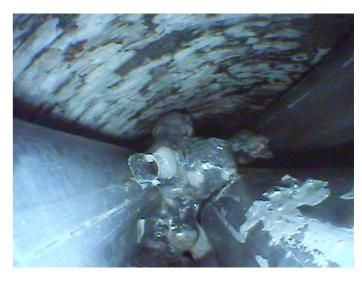
melt formation in bundle at the break position of the corner rod B (850 mm)

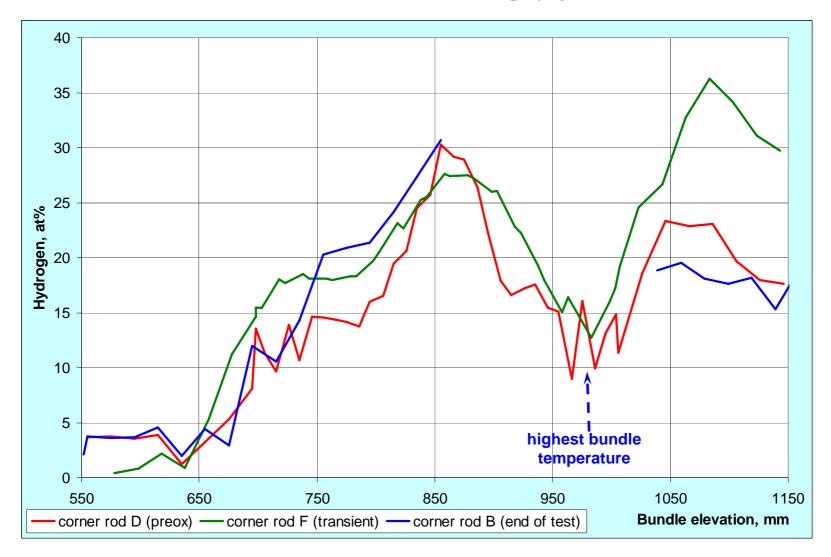
QUENCH-12: hydrogen uptake by corner rods /results of neutron radiography/

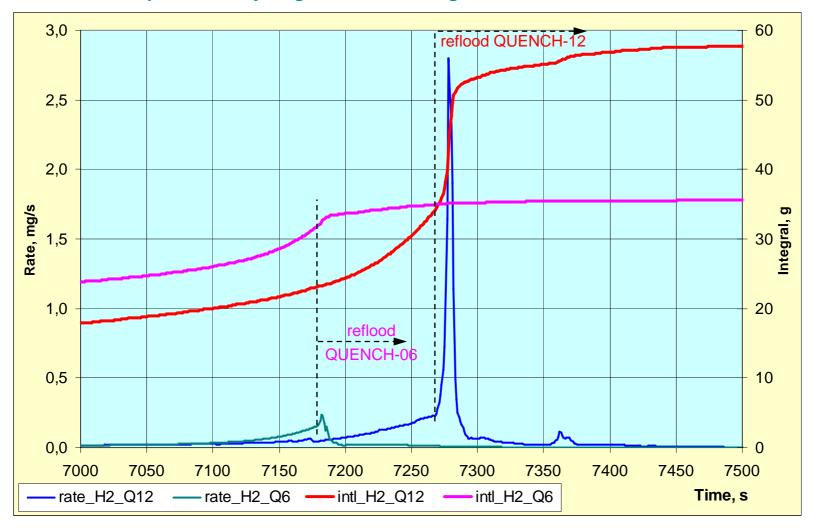
Comparison of hydrogen release during QUENCH-12 and QUECH-06.

QUENCH-06: H₂ production before reflood 32 g, during reflood 4 g

QUENCH-12: H₂ production before reflood 34 g, during reflood 24 g
