Results of PARAMETER-SF2 material investigations

*14th International QUENCH Workshop
Karlsruhe, 4-6 November, 2008*

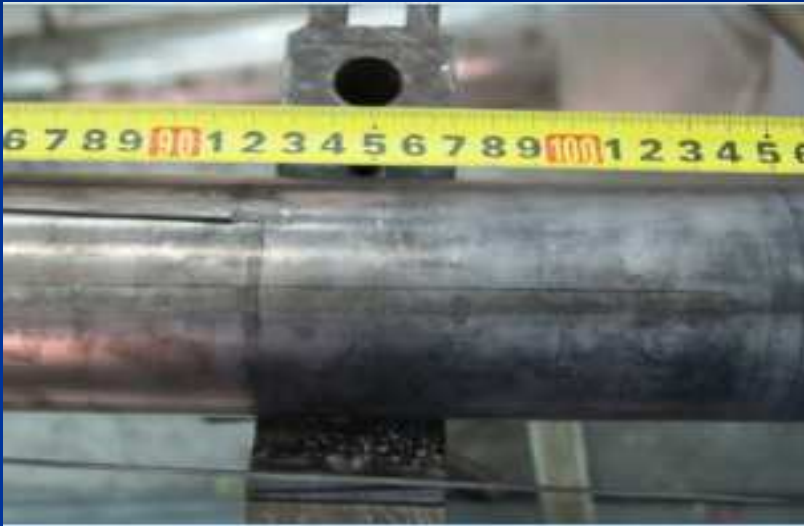
Z = 850-1050 mm

Post-test appearance of the shroud

- Shroud kept its integrity
- Thin oxide scale on the outer surface

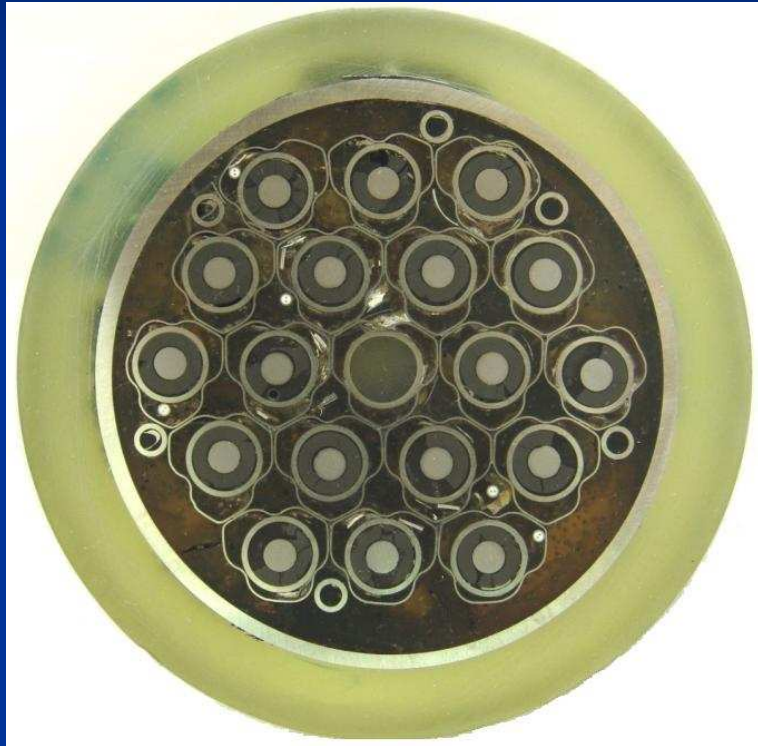
Metallographic examination of the cross - section at Z=513 mm

- Rods are in an original arrangement and undamaged
- Intact spacer grid and shroud
- Some pellets have cracks

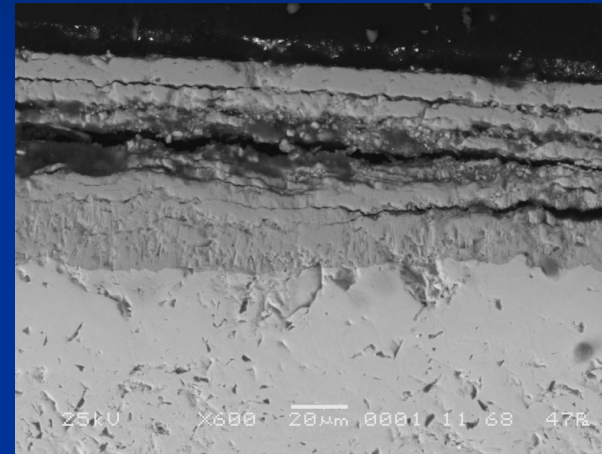
Rod 2.1

Metallographic examination of the cross - section at Z=513 mm

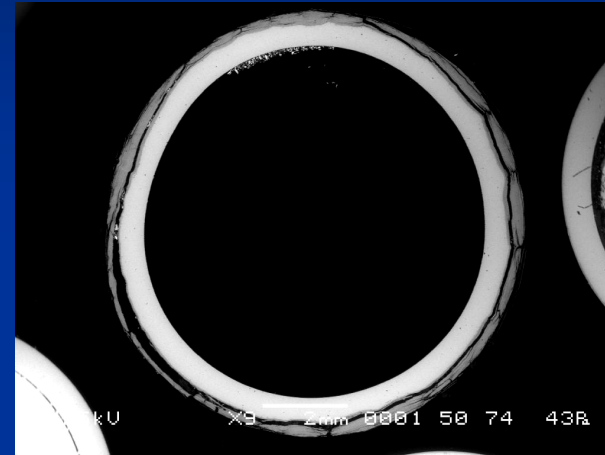
Rod 1.1

Metallographic examination of the cross section at Z=702 mm

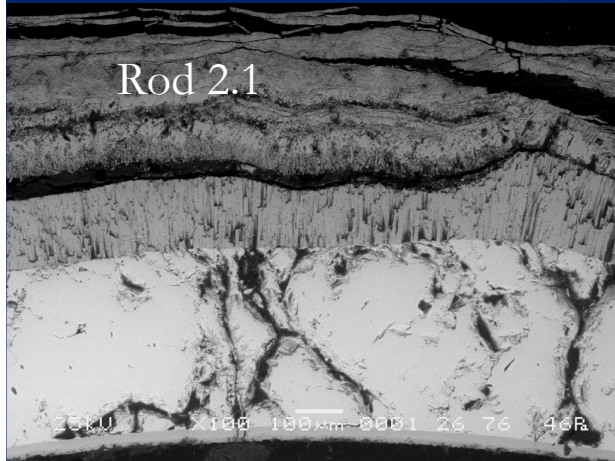
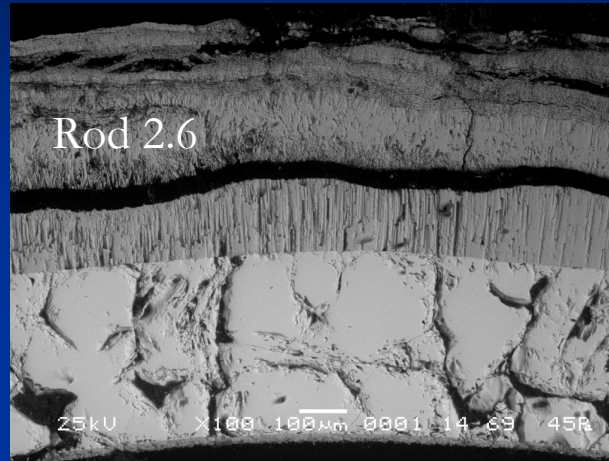
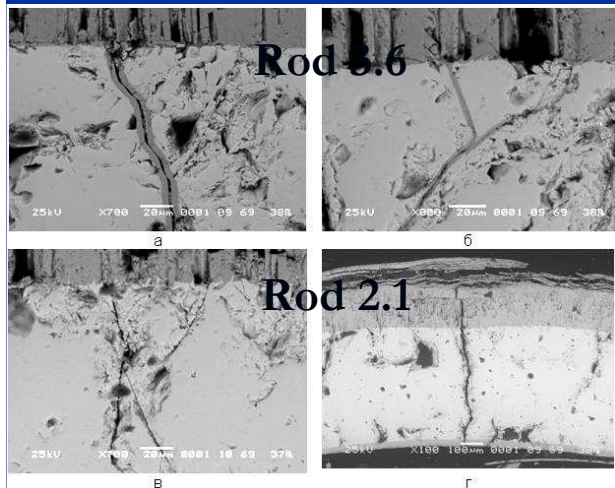
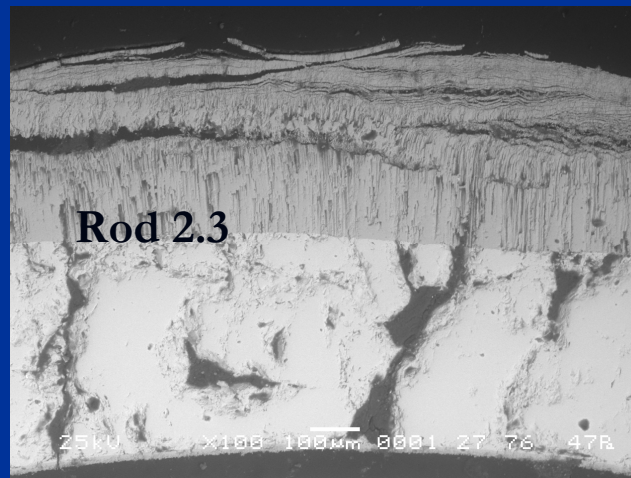
Layers structure at Z=1250 mm

- split inner compact oxide with columnar structure and spalled off layered outer oxide
- weak inner cladding oxidation of some rods (30-50µm)
- complete $\beta \rightarrow \alpha$ transformation
- no fuel relocation or fuel-cladding interaction

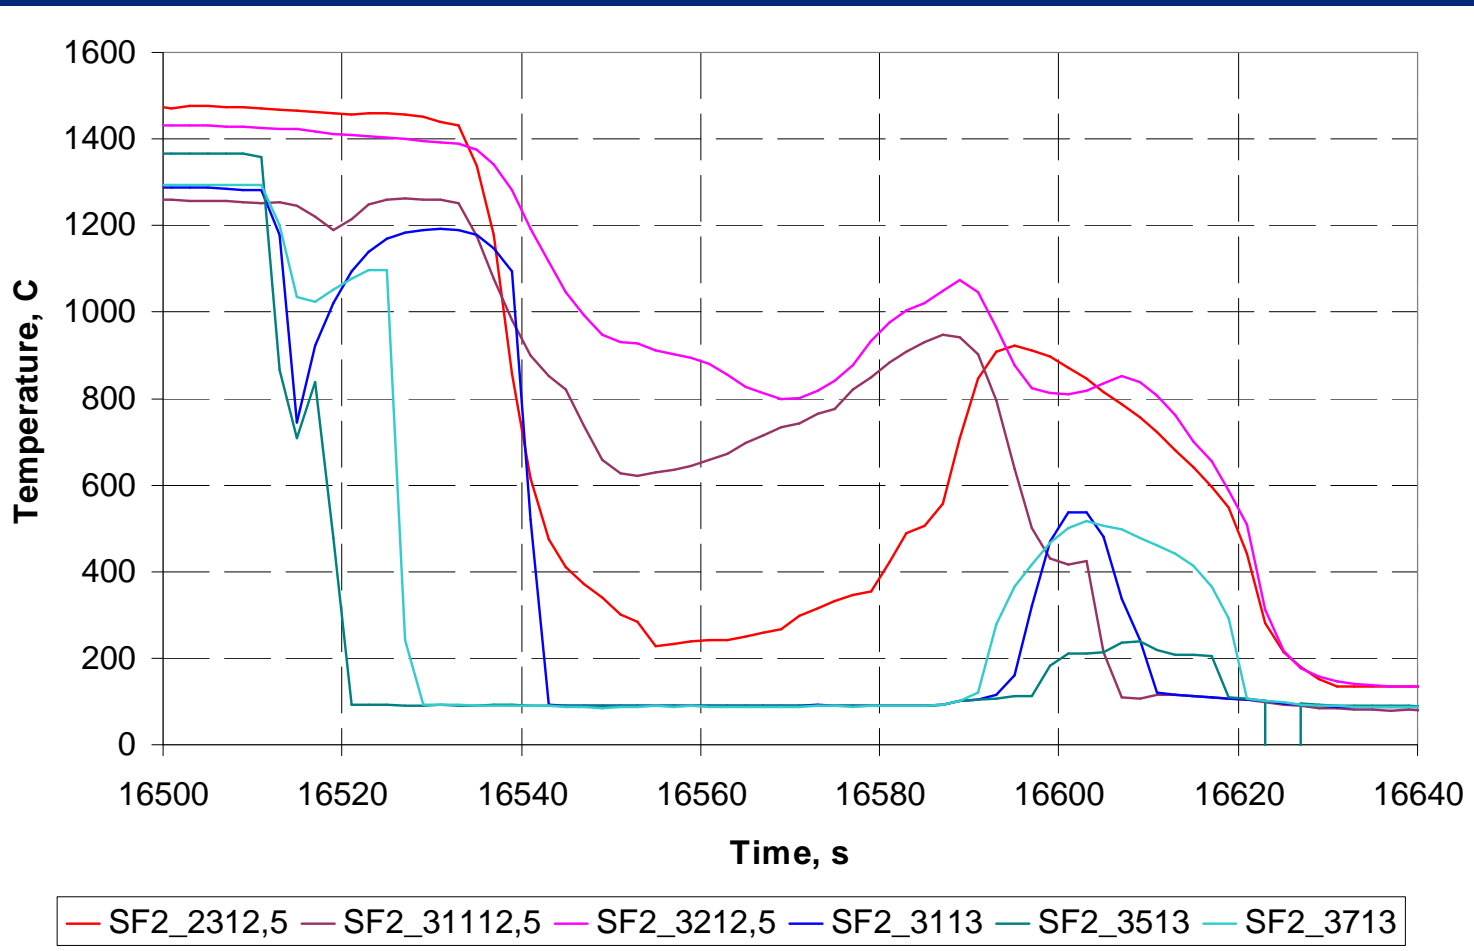
Temperature evolution during quenching

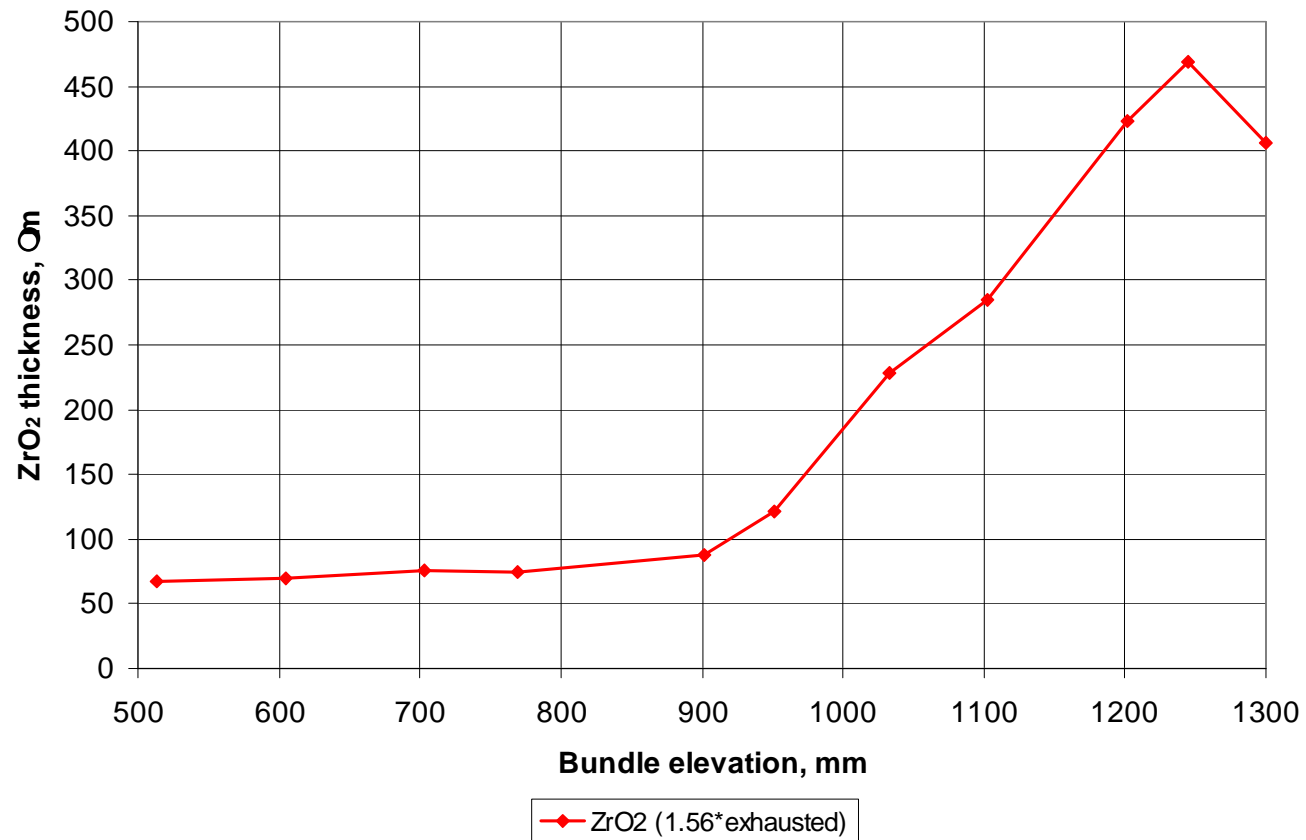
Averaged oxide scale thickness

- SF2 bundle reveals pronounced breakaway oxidation over 500-1300 mm;
- cladding oxide scale over 900-1300 mm includes inner compact oxide with columnar structure on the metallic layer and external multi-layer spalled off oxide;
- over 1100-1300 mm inner compact oxide is split or tends to split; possible reason could be cool down and heat up cycle during combined quenching
- maximum calculated cladding oxide scale thickness corresponds to the hottest elevation (1250 mm);
- inner cladding oxidation over 900-1300 mm is weak;
- cladding fragmentation is non-pronounced;
- no fuel relocation.
