Results of metallographical post-test examinations by RIAR

A. V. Goryachev, I. A. Ivanova
FSUE "SCC-RIAR", Dimitrovgrad

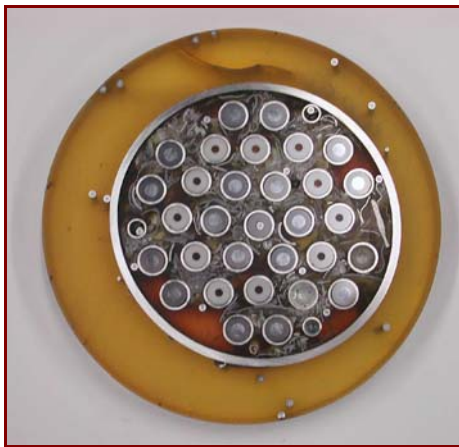
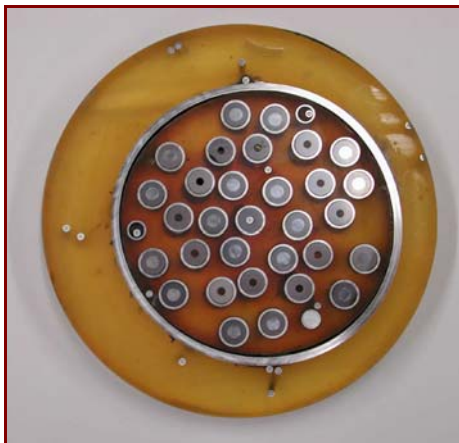
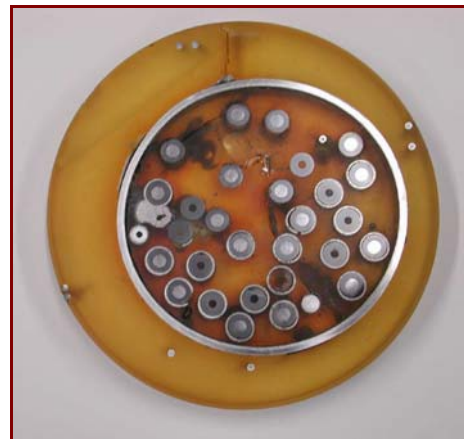
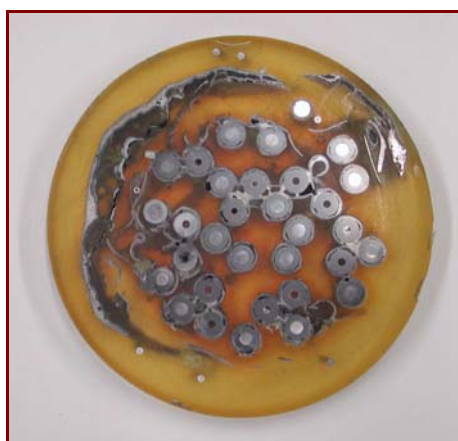
Fig. 1. Appearance of the examined sections.

Pictures of the examined samples are demonstrated in Fig. 1.

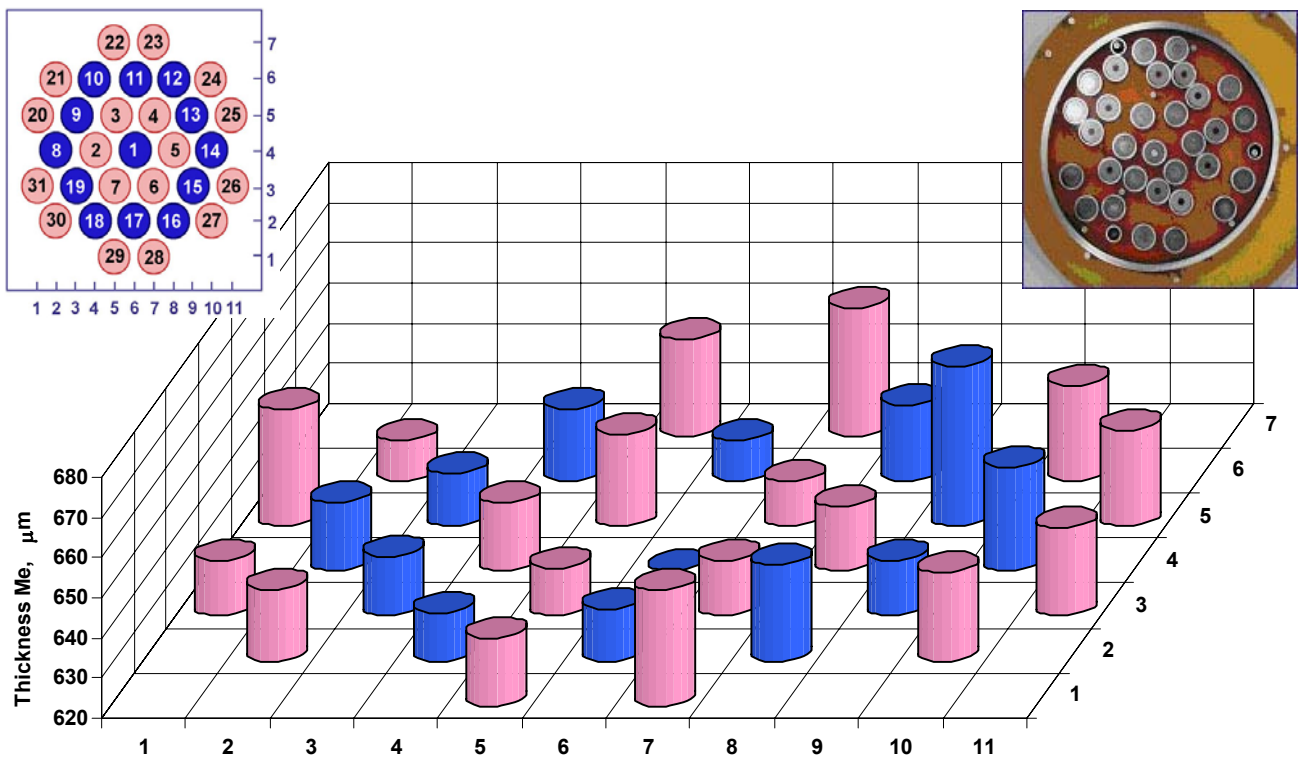
Fig. 4. Diagram of change in the thickness of metal part of the simulator claddings in section 654 mm.

In section 654 mm (the cladding temperature measured by TC during preliminary oxidation was 1050-1150 °C) the bundle is deformed. The outer surface of the simulator claddings is uniformly oxidized. In this section there are no fragments of the claddings in the space between the simulators. Results of measurements of the layer thickness in this section are summarized in Table 2. Fig. 4 and 5 show the diagrams of the averaged thickness of the measured layers and typical structures of the claddings.

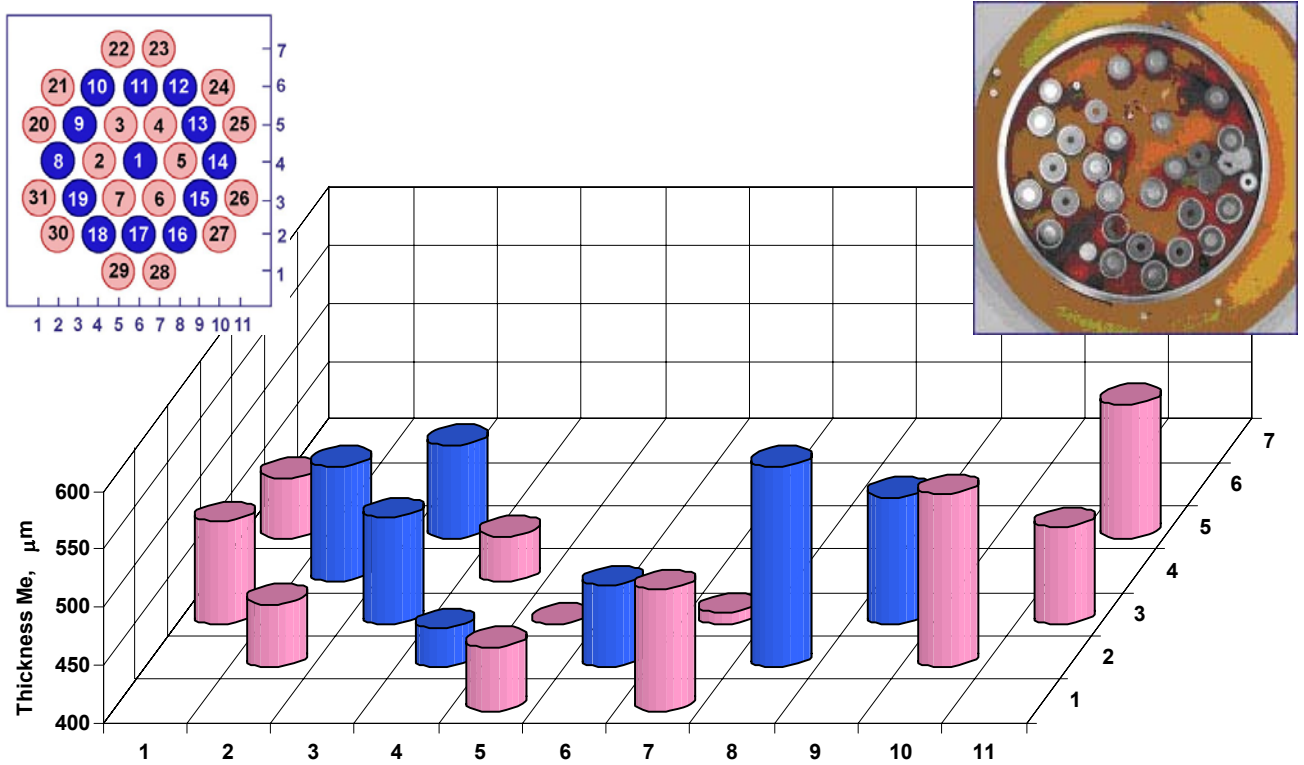
Fig. 8. Diagram of change in the thickness of metal part of the simulator claddings in section 854 mm.

The given section differs from the sections described above by essentially greater simulator cladding oxidation. The temperature measured by TC located on the claddings during preliminary oxidation was equal to 1250-1350 °C. Melt drops are observed in the gap between the simulators. The maximum temperature measured in this section before quenching made up 1900 °C that is close to the melting temperature of α -Zr (O) phase (1970 °C). However, no melt is observed in this section (metallographic examinations show that all the metal phase in this section consists of α Zr(O)). The simulator claddings have through-wall cracks. Part of the claddings completely failed and crumbled. Two simulators without a tungsten rod in the centre of the pellets are destroyed in this section. It is necessary to note, that the surfaces of the cracks in the simulator claddings are not oxidized,

that testifies to the fact that their damage occurred at the reflood stage. Absence of the cracks surface oxidation also points at the fact that the process of their damage does not make essential contribution to hydrogen production at the reflood stage. Results of examinations of this section are summarized in Table 4 and Fig. 8 and 9.

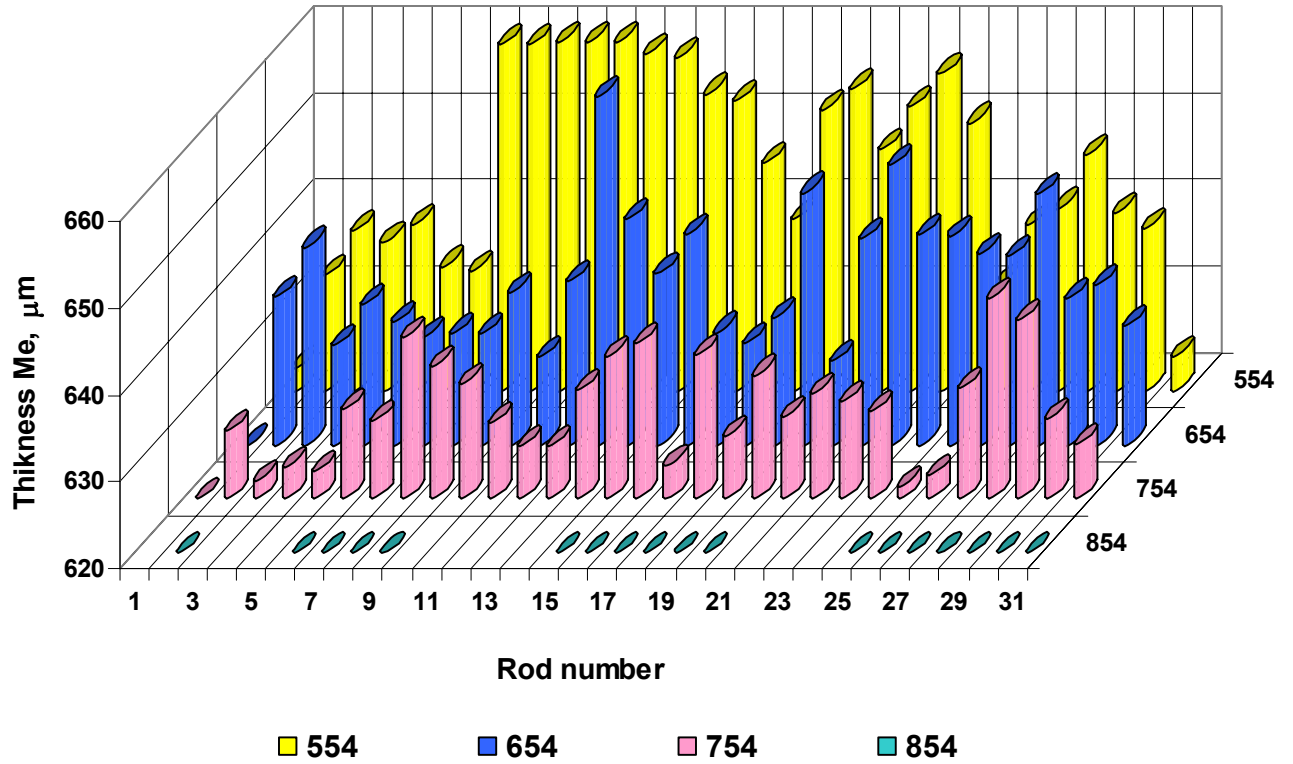
Fig. 13. Diagram of changes in the thickness of the metal part of the simulator claddings in the examined sections.

By the results of examination of five sections it is possible to conclude that the most reasonable parameter to assess the claddings oxidation level is the results of measurement of the residual metal layer thickness. In the lower sections (554 and 654 mm) we observe non-uniformity of oxidation, which is apparently caused by a radial thermal gradient in the direction of 180°. In section 754 mm the claddings oxidation is more uniform across the section, thermal gradient may also be observed in the direction of 180°. Section 854 mm exhibits essential non-uniformity of the claddings oxidation presumably owing to a strong radial thermal gradient in the direction of 315°. Fig.13 demonstrates a diagram of thickness of the residual cladding metal part of all the examined sections. Fig.14 shows a diagram of the α -Zr (O) layers thickness in the investigated sections that exhibits similar periodicity of thickness changes in the sections. However, it is necessary to note smaller reliability of these data because of difficulty in identification of the layer boundaries and thorough transformation of the cladding metal to α -Zr (O) in the top sections.

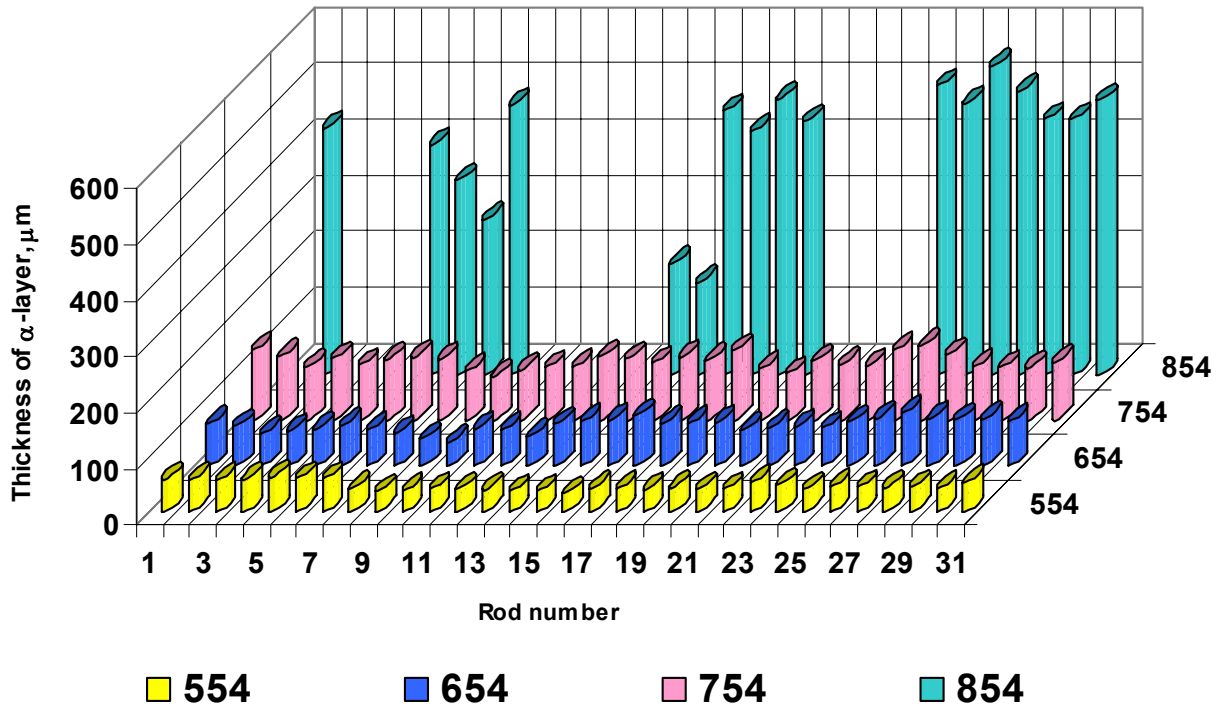
Fig. 14. Diagram of α -Zr(O) thickness change in the examined sections.
