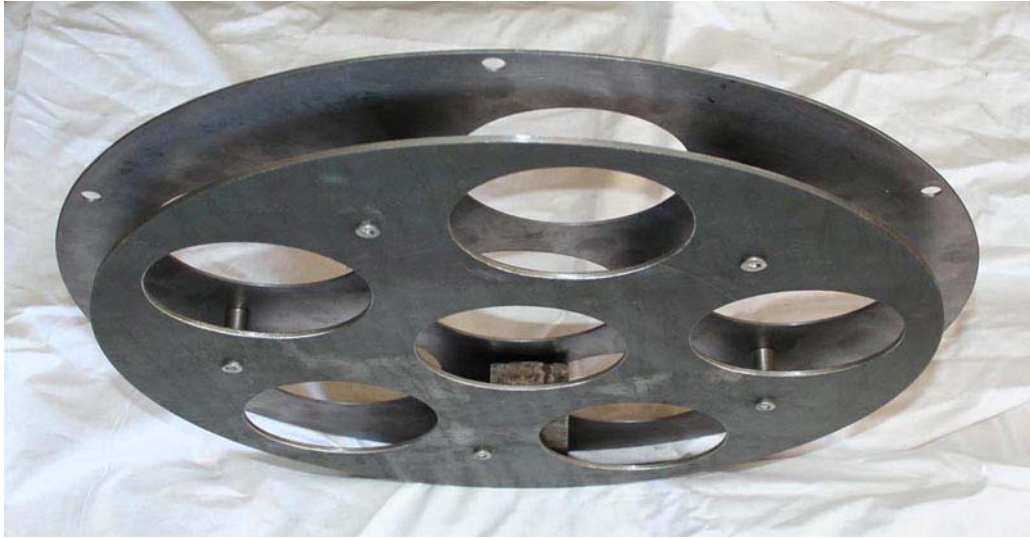
Fig. 1 – Tantalum screen with additional steel plate before test

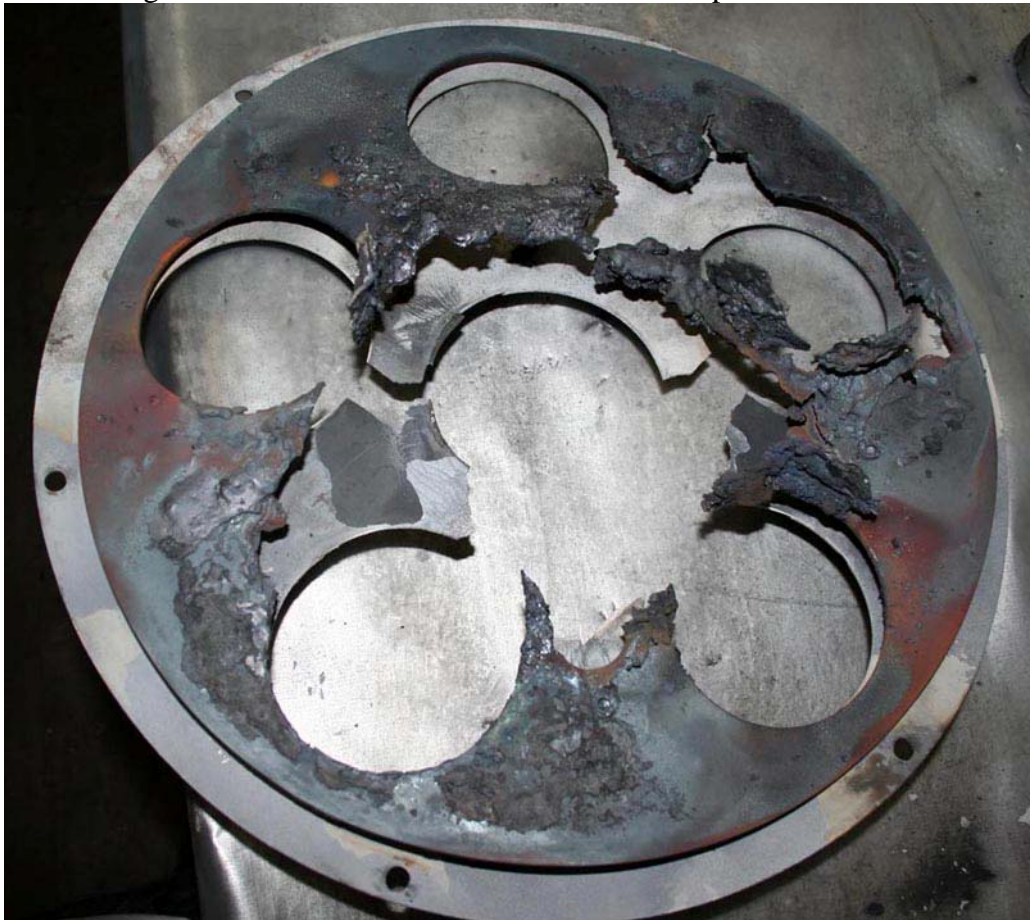
Fig. 2 - Tantalum screen with additional steel plate after test (view from the site of steel plate)

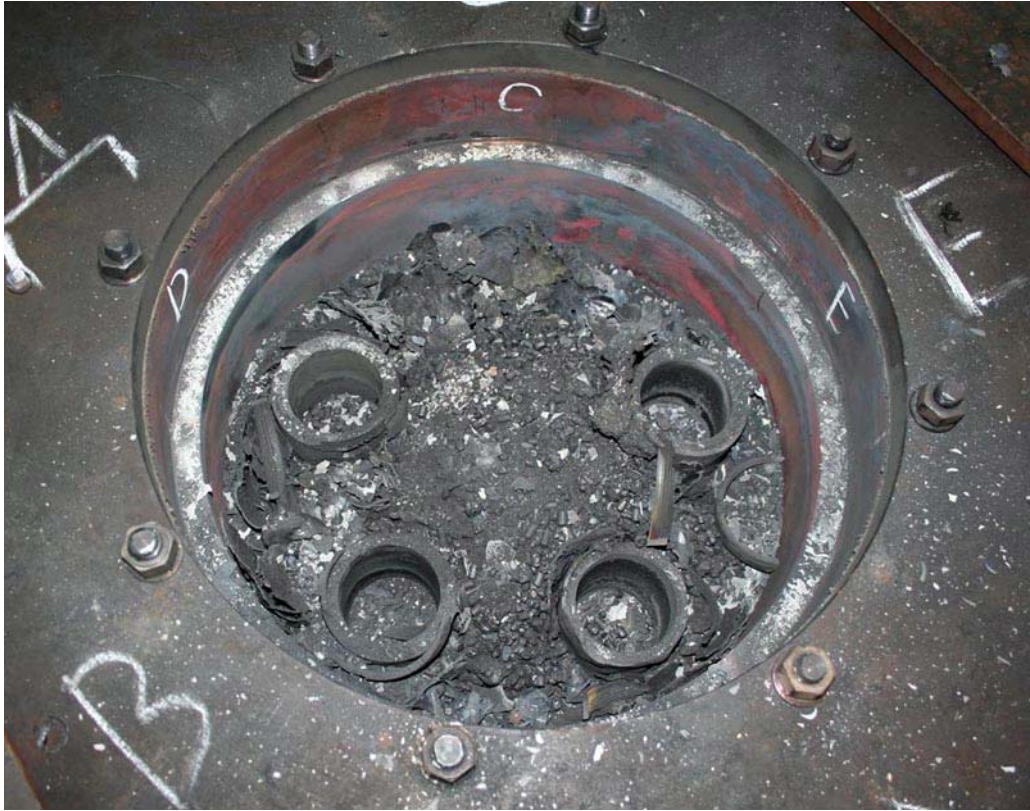
Fig. 3 – View of test section after test (thermal screen and top parts of plasmatrons have been removed)

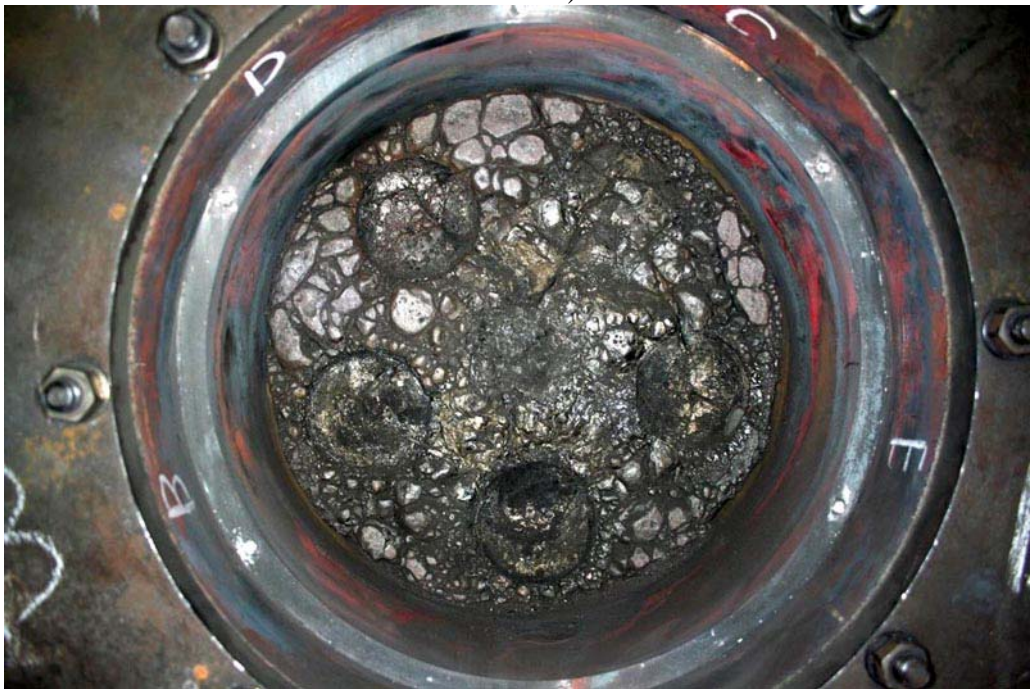
Fig. 4 – View of test section after test (fragmented debris bed and plasmatrons nozzles have been removed)

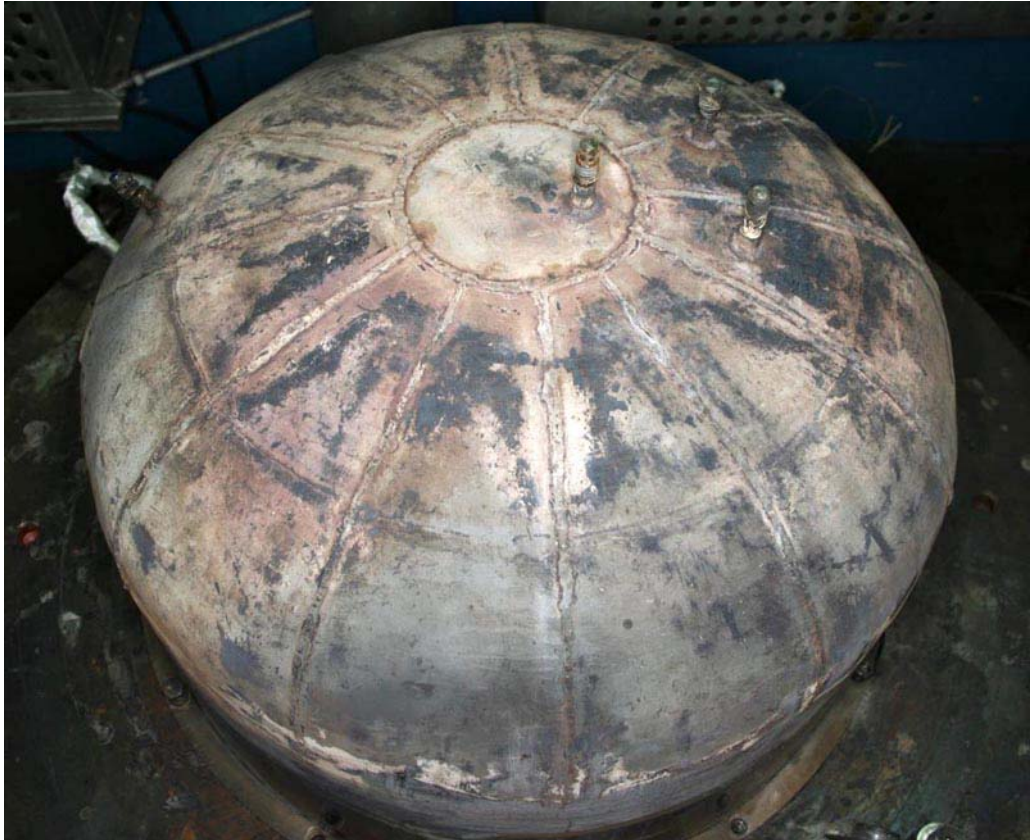
Fig. 5 – View of stainless steel housing outside graphite felt on the outer surface of RPV model

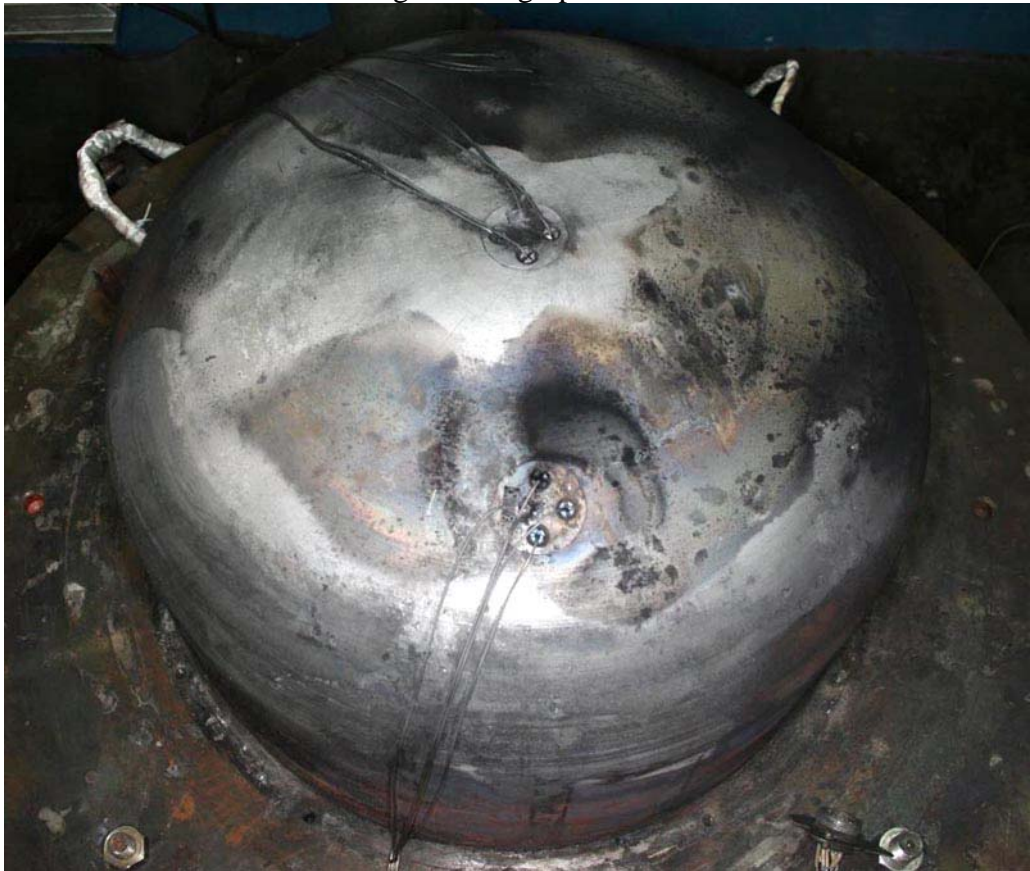
Fig 6 – View of RPV model outer surface (graphite felt has been removed)

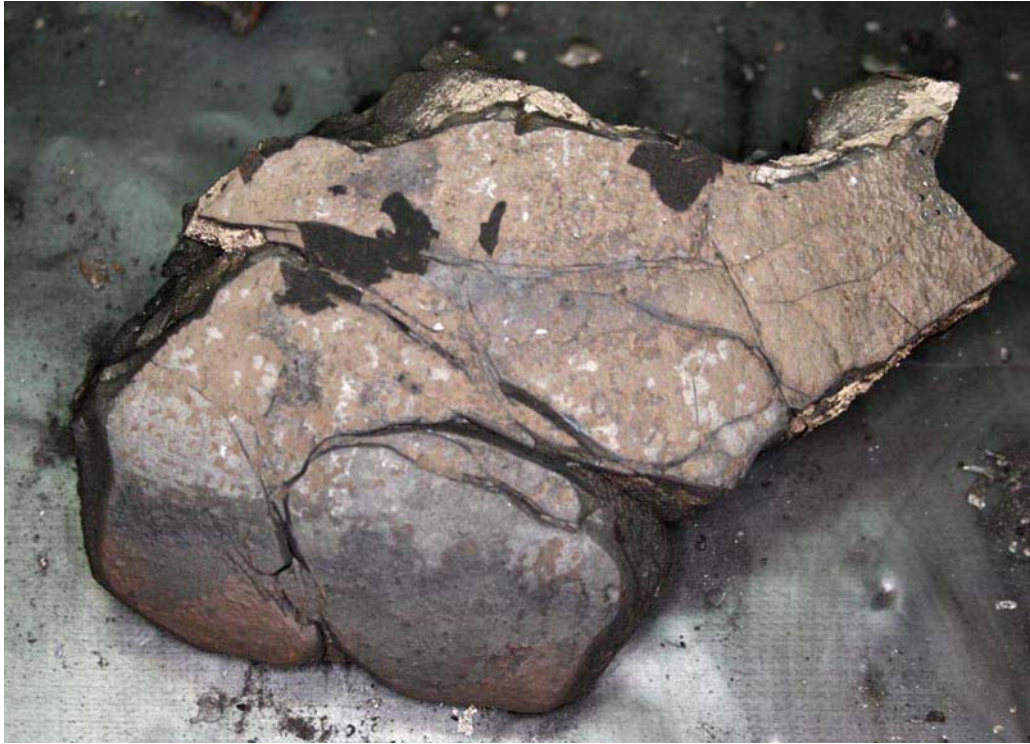
Fig. 7 – Fragment of corium ingot (view from the surface contacted with RPV model wall)

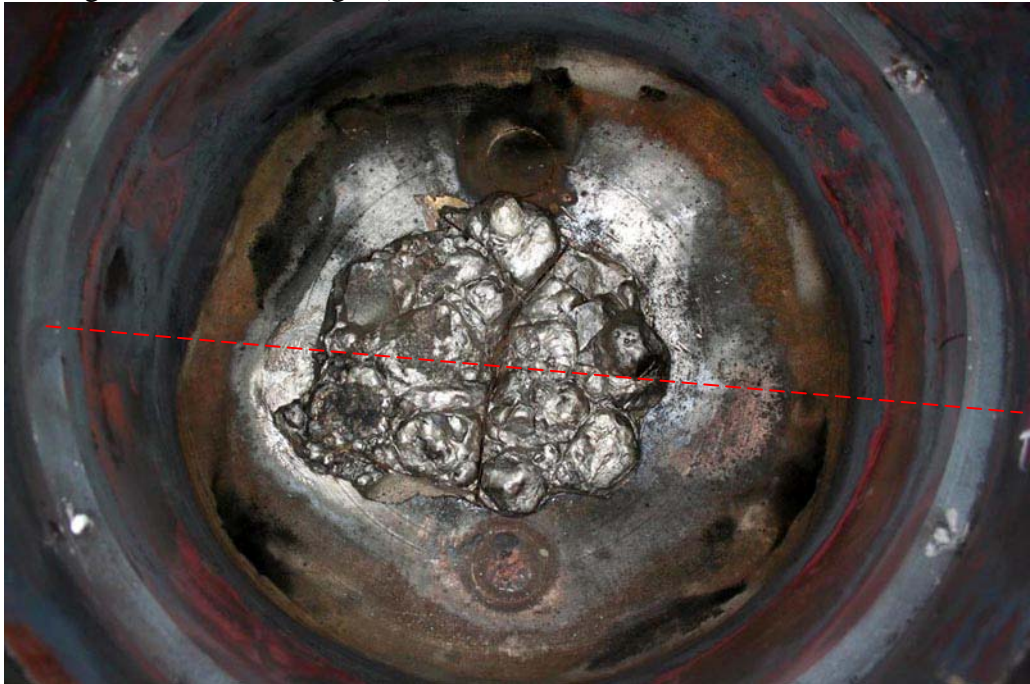
Fig. 8 – View of RPV model with corium ingot adhered to the RPV model wall
(will be cut along the red line)
