Fig. 6 – RPV model after test INVECOR-3 (cone for melt discharging has been removed)

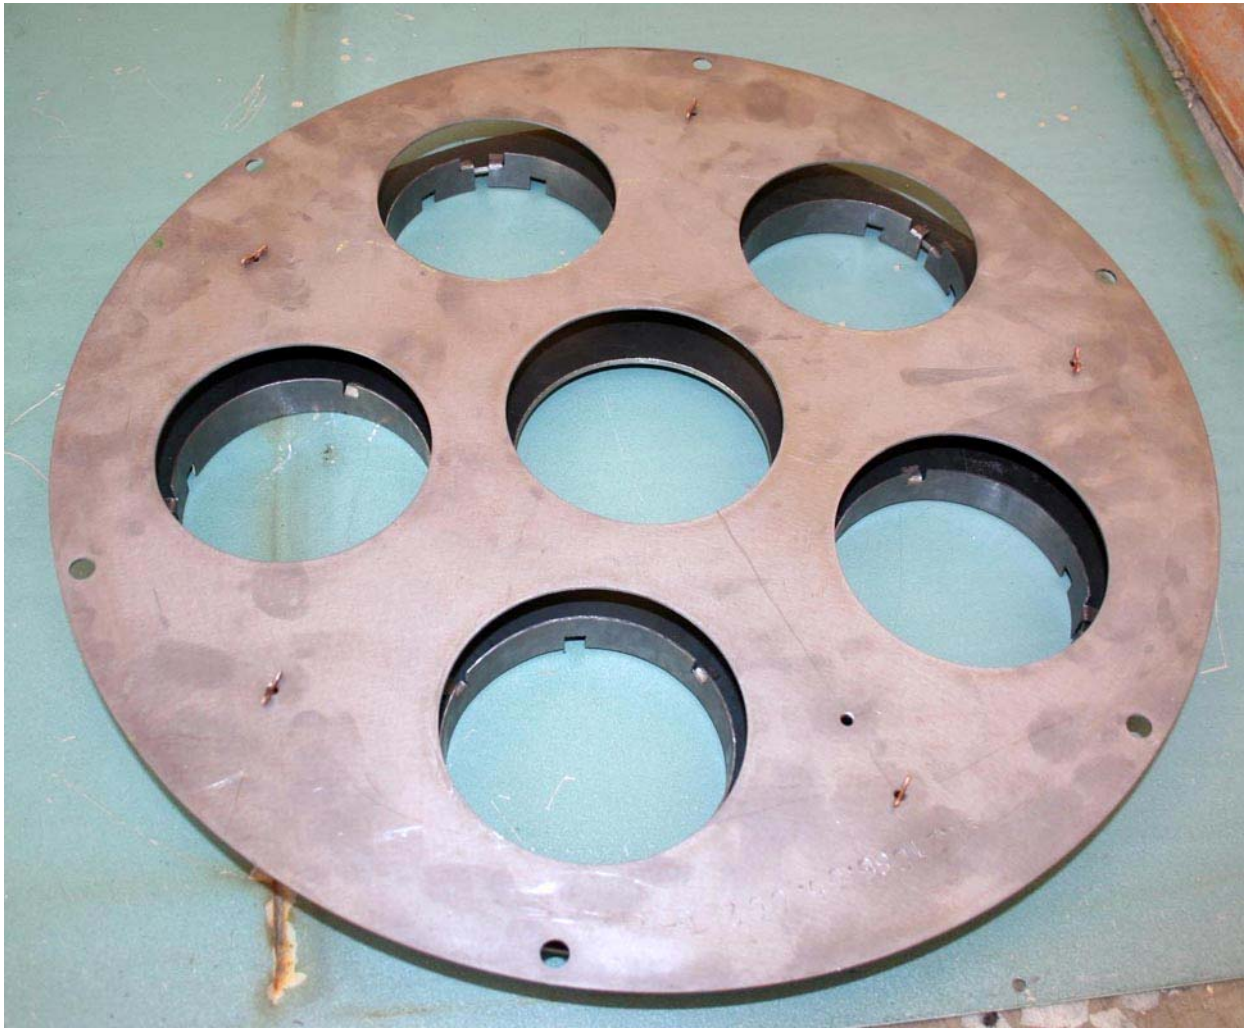
Fig. 1 – Top thermal screen (view from the tantalum plate)

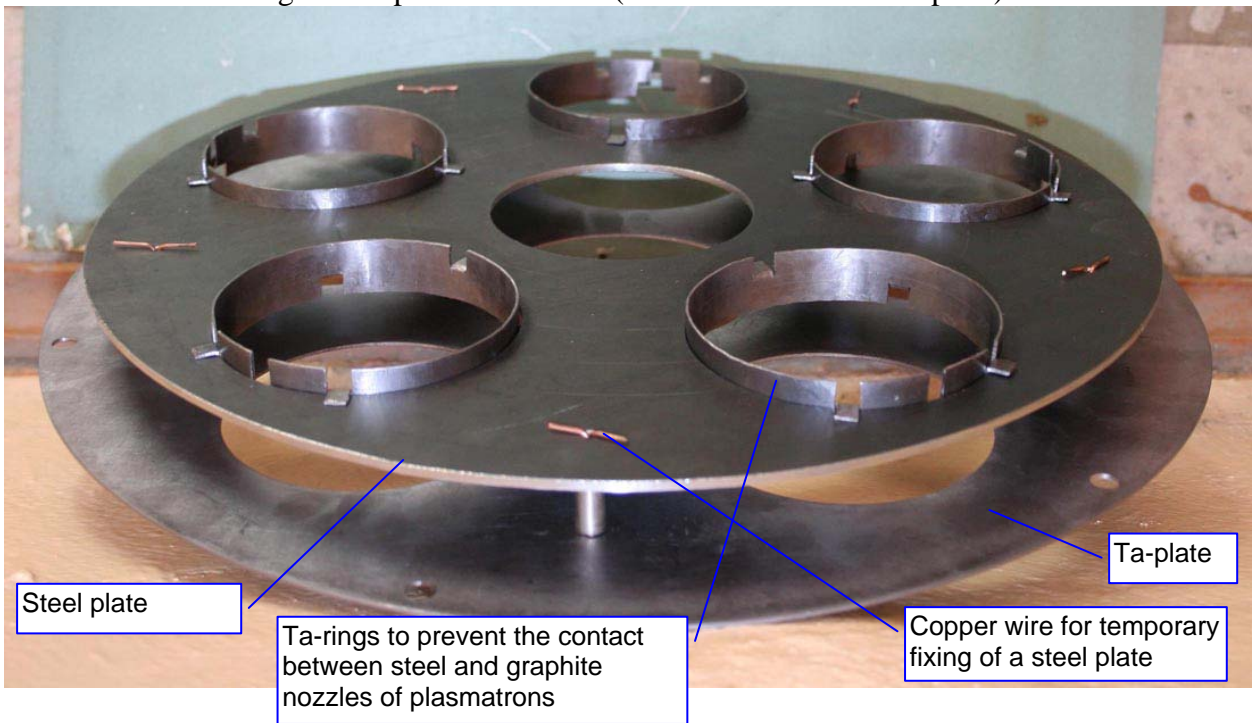
Fig. 2 – Top thermal screen (view from the steel plate)

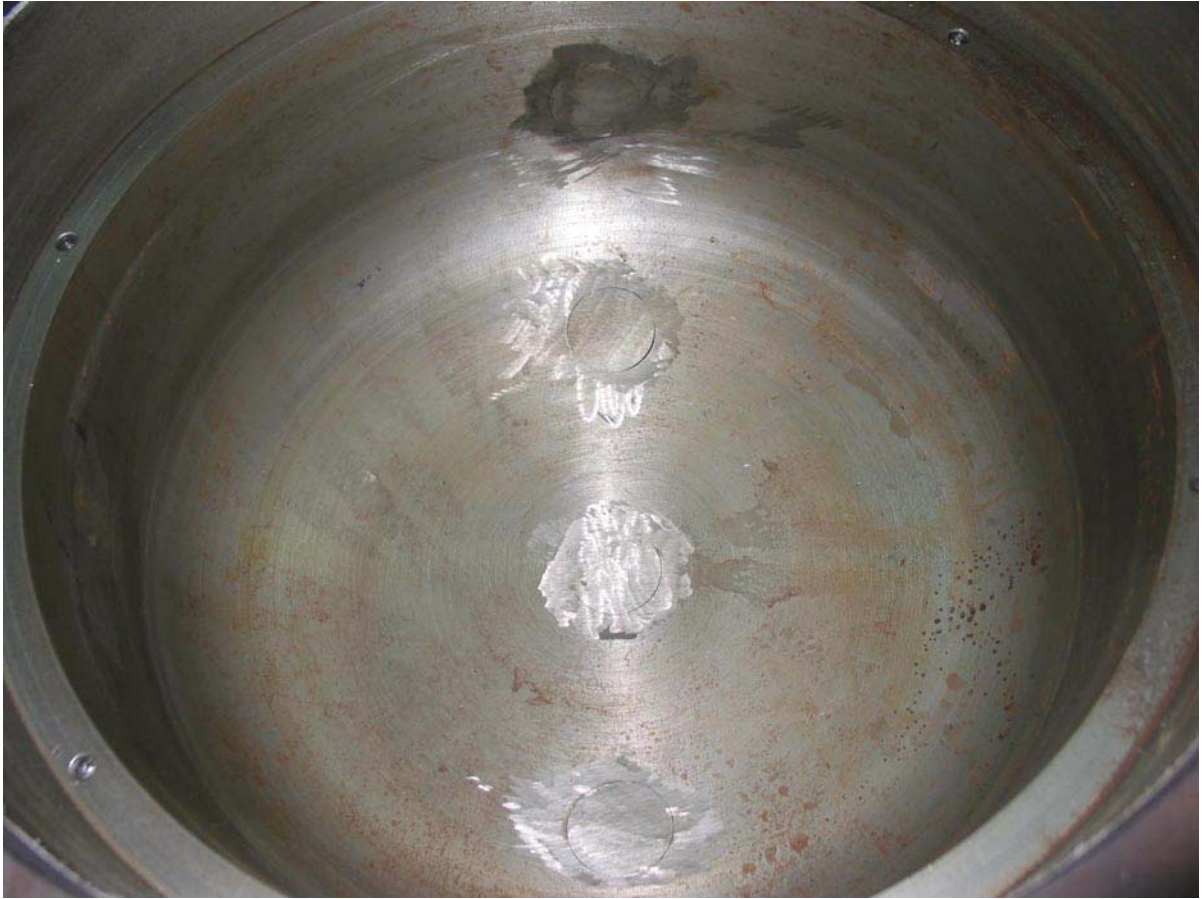
Fig. 3 – Initial inner surface of RPV model

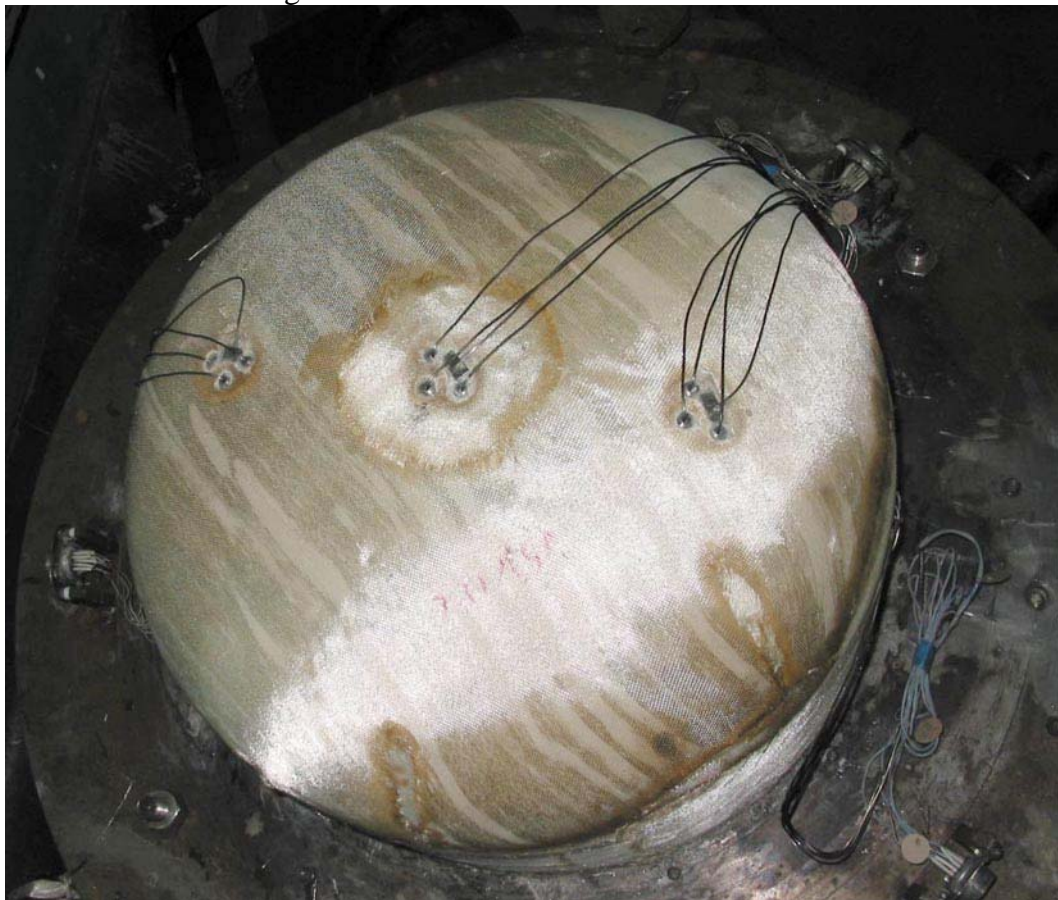
Fig. 4 – Initial outer surface of RPV model lined with glass cloth

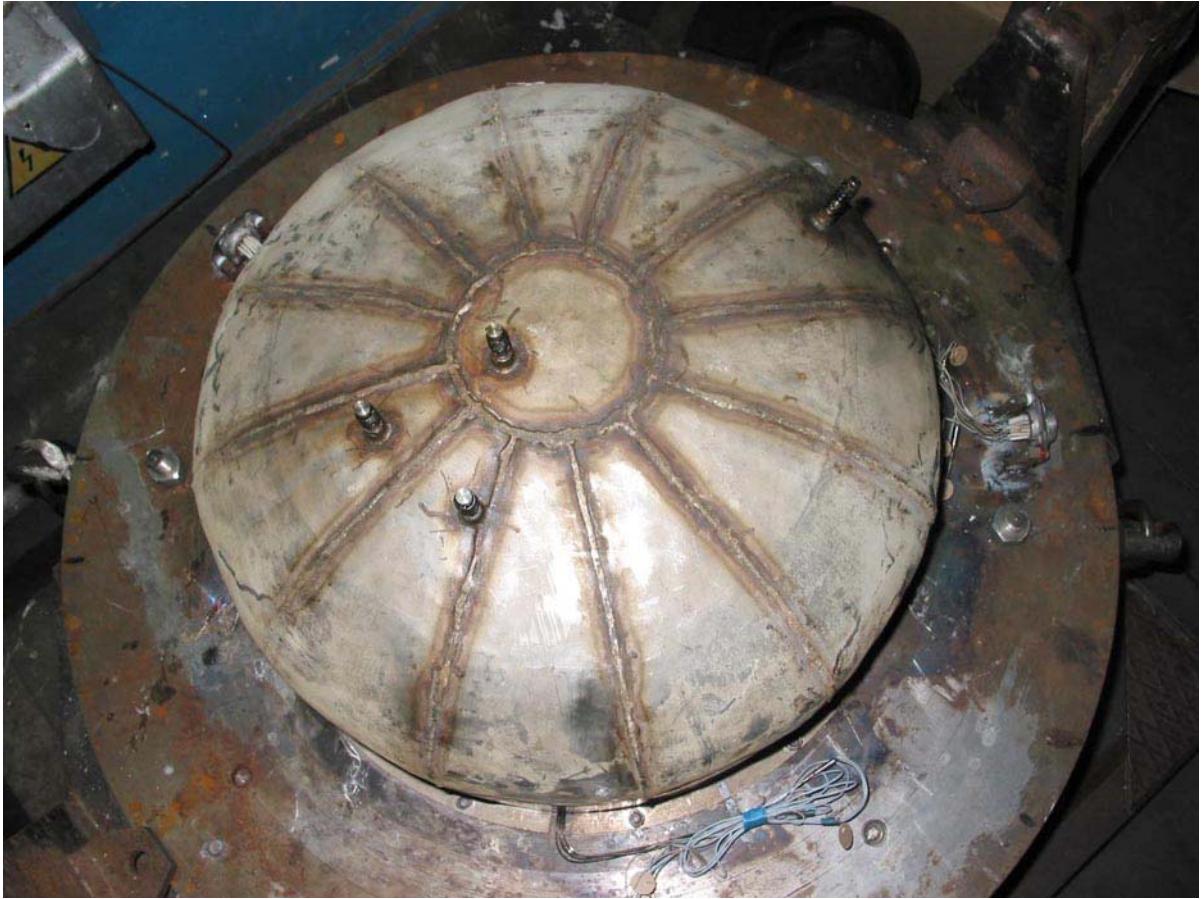
Fig.5 – Outer surface of RPV model covered with glass cloth and SS sheet

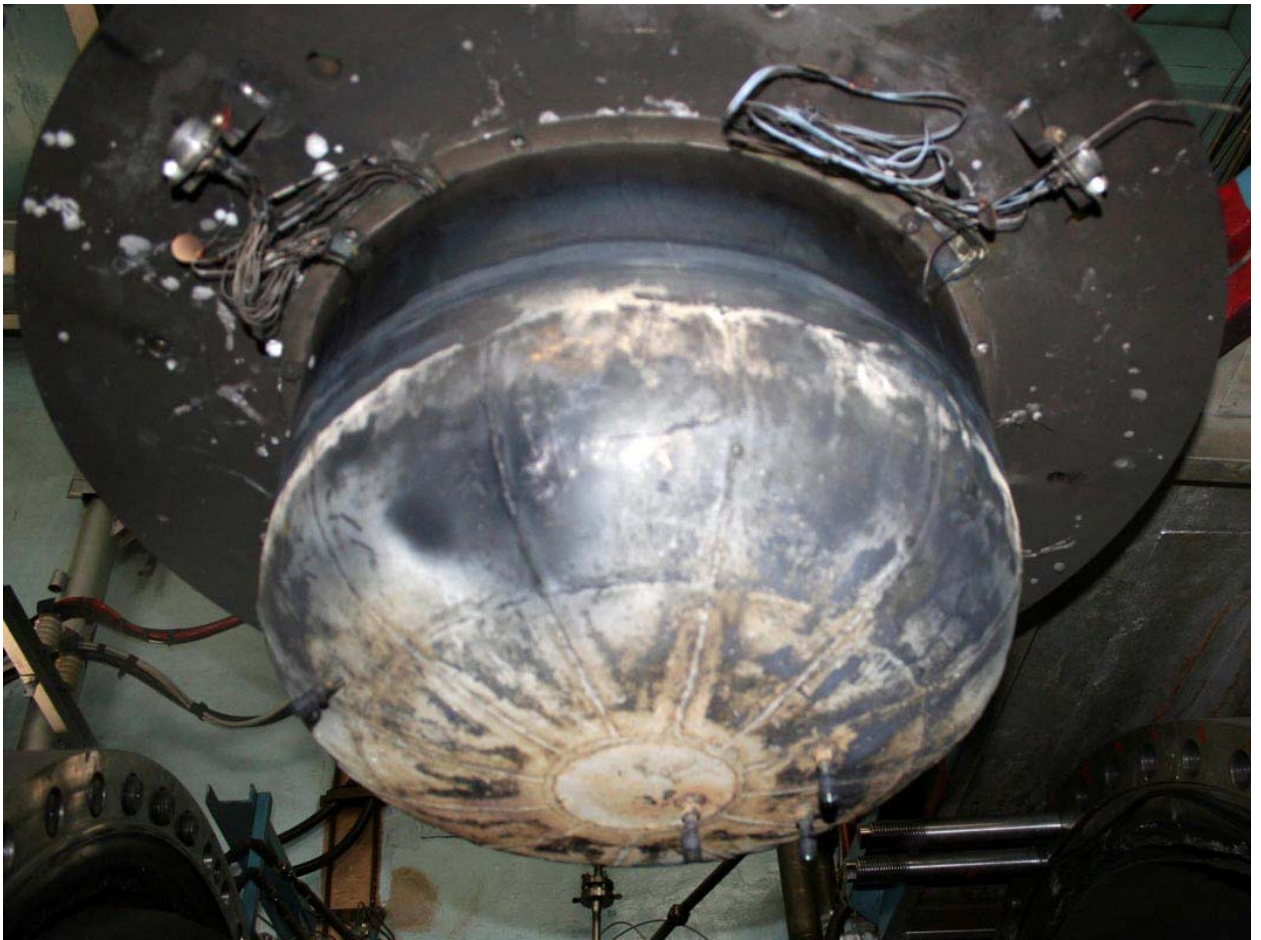
Fig. 7 SS sheet outside of RPV model after test

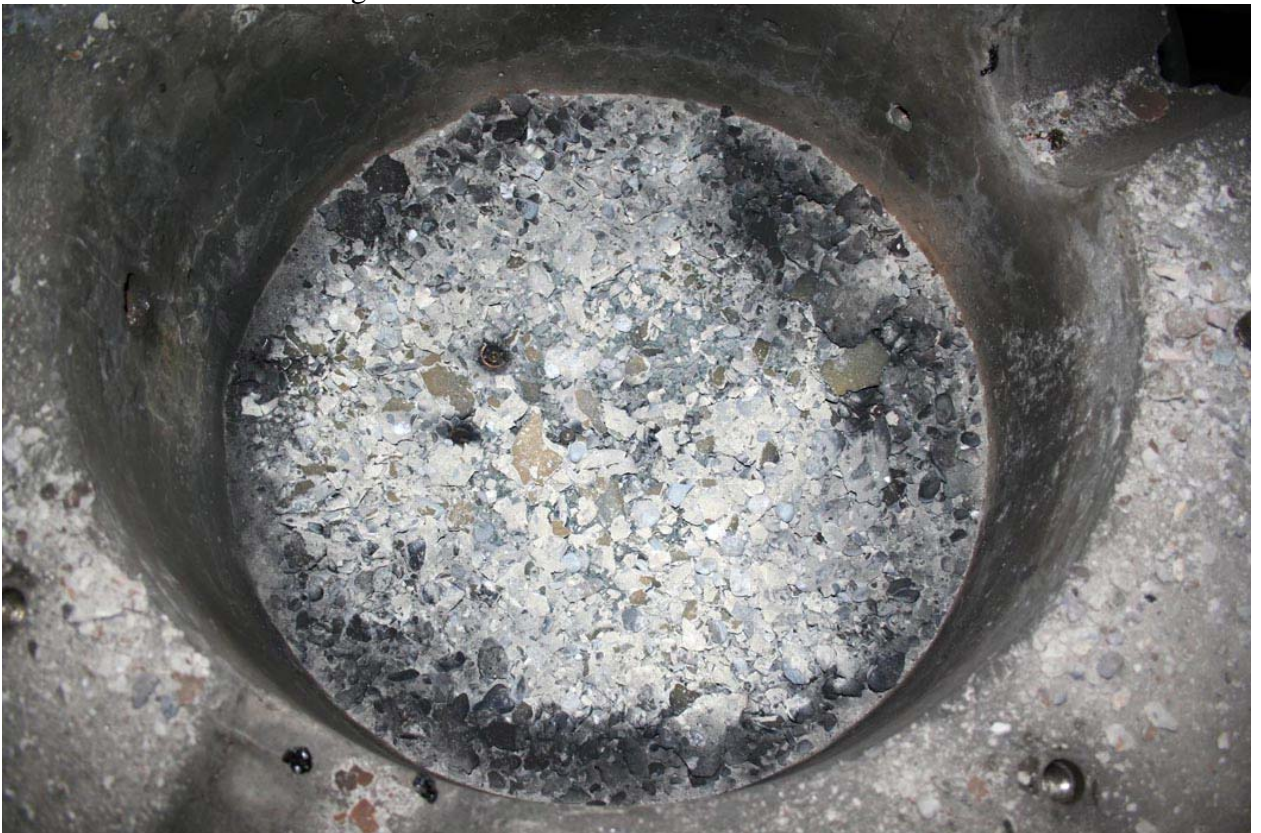
Fig. 8 – Degraded surface of concrete base under RPV model

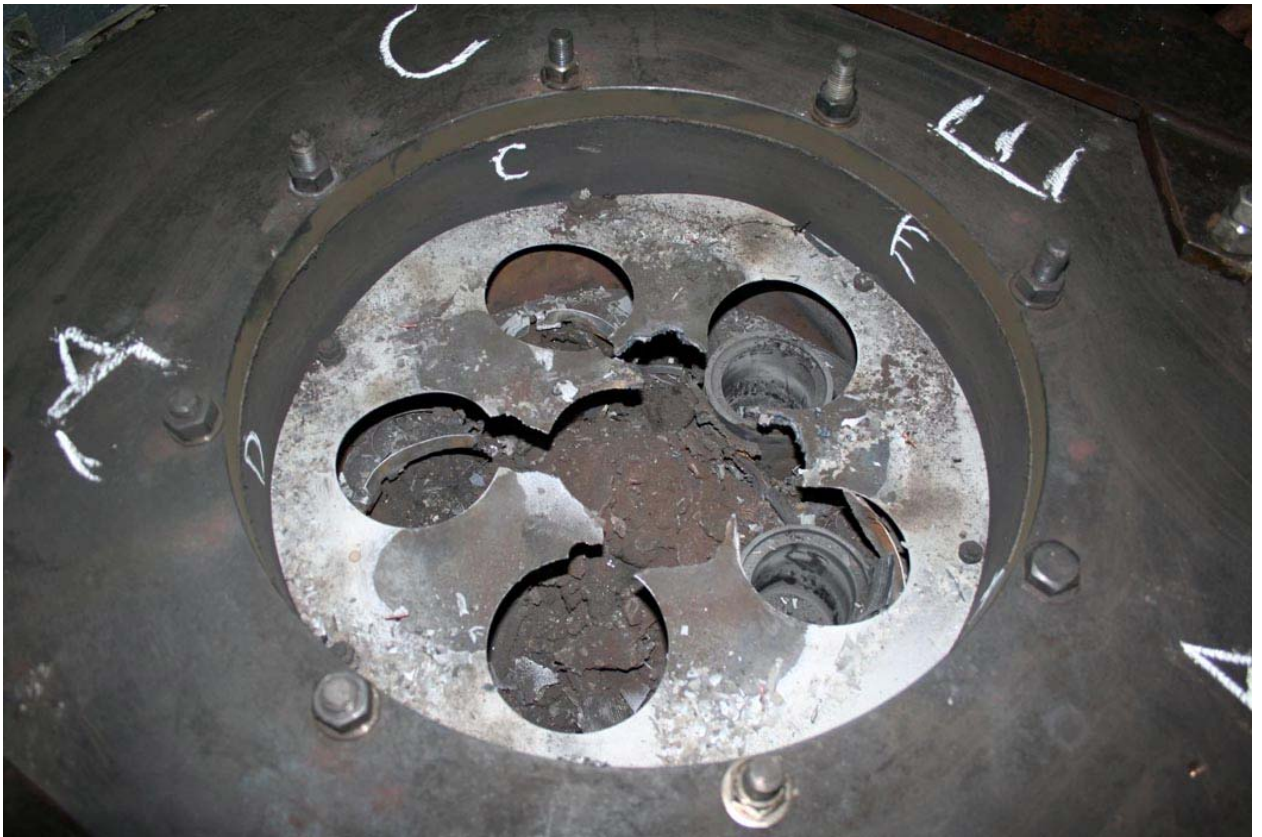
Fig. 9 – RPV model after plasmatrons removal

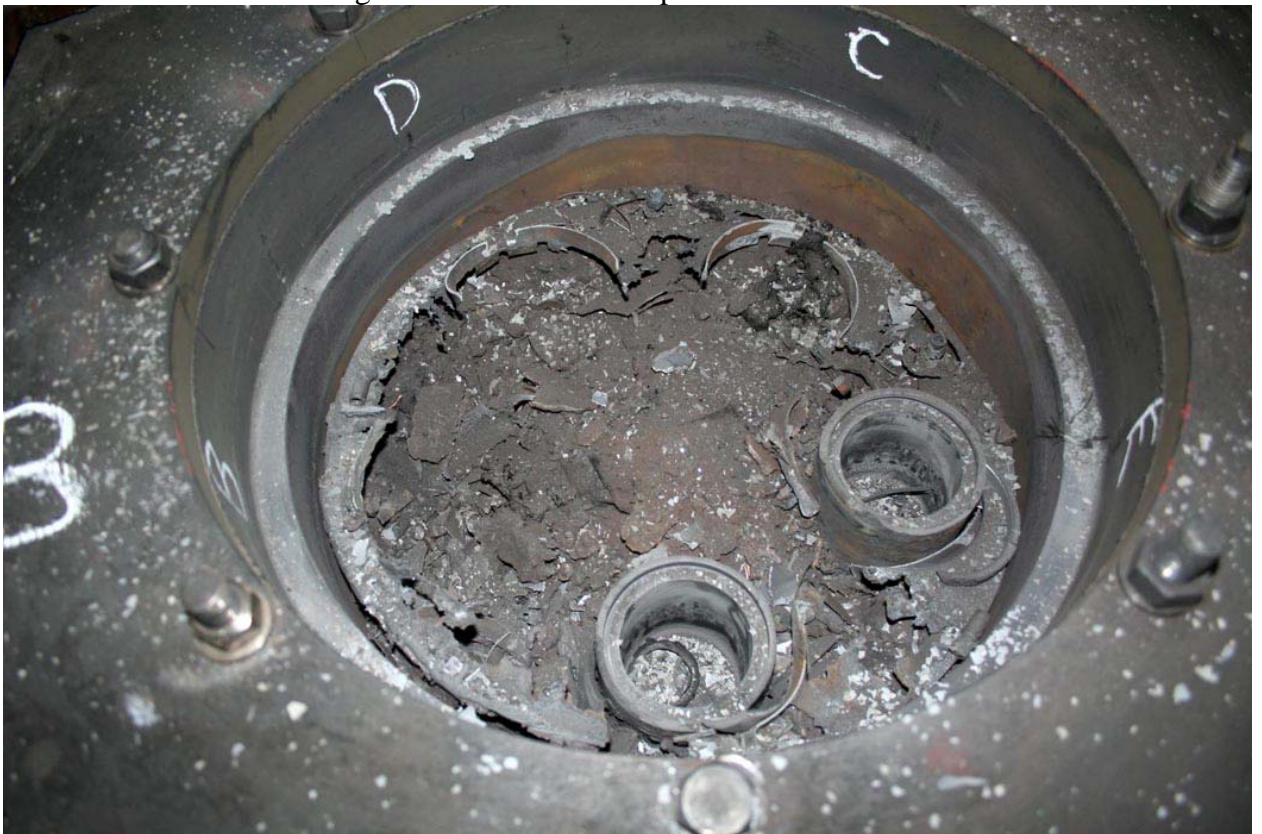
Fig. 10 – RPV model after Ta-plate removal

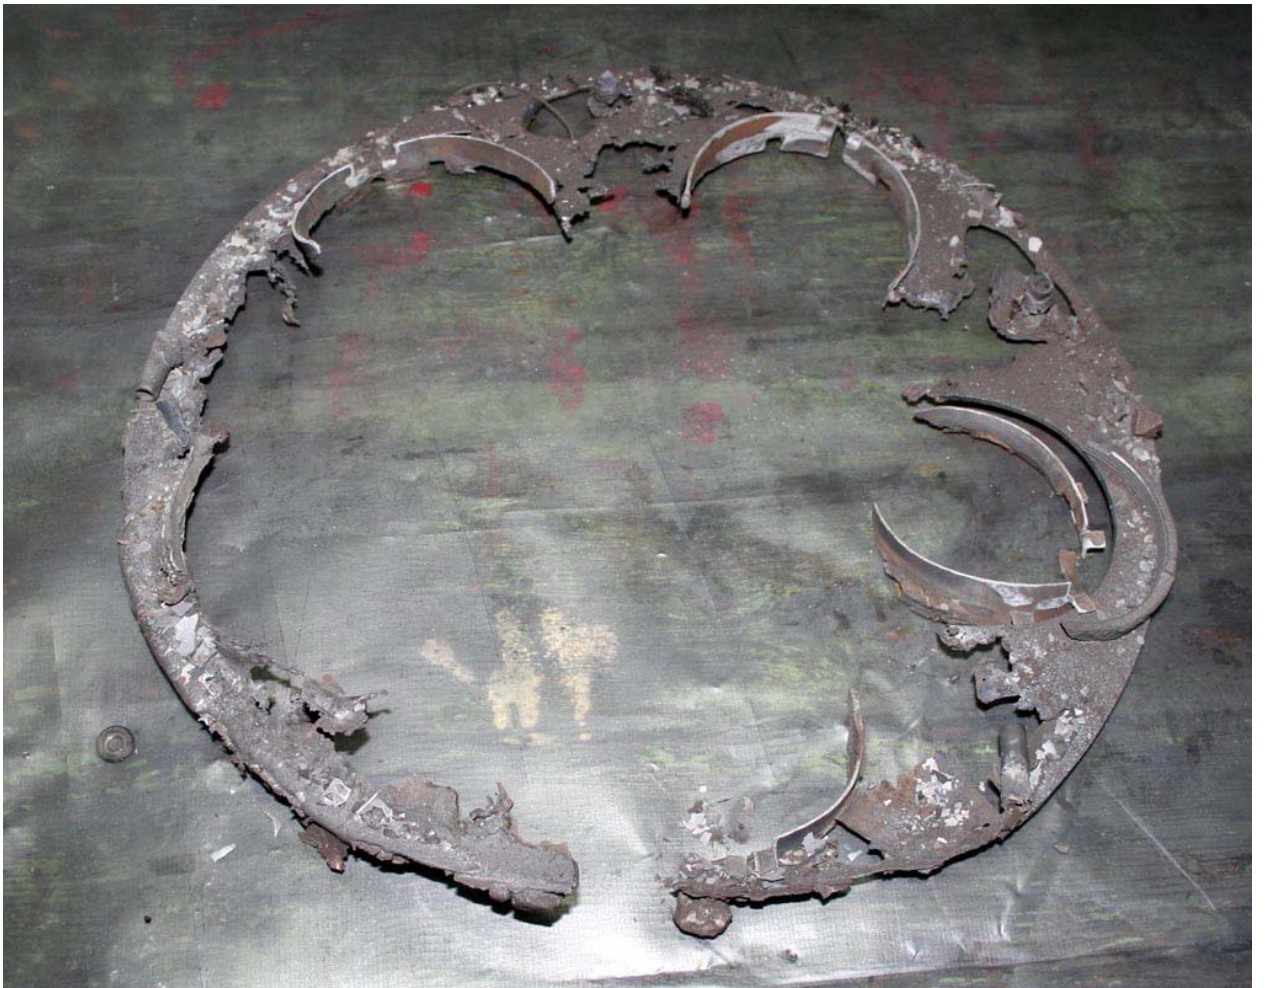
Fig. 11 – Remains of steel plate

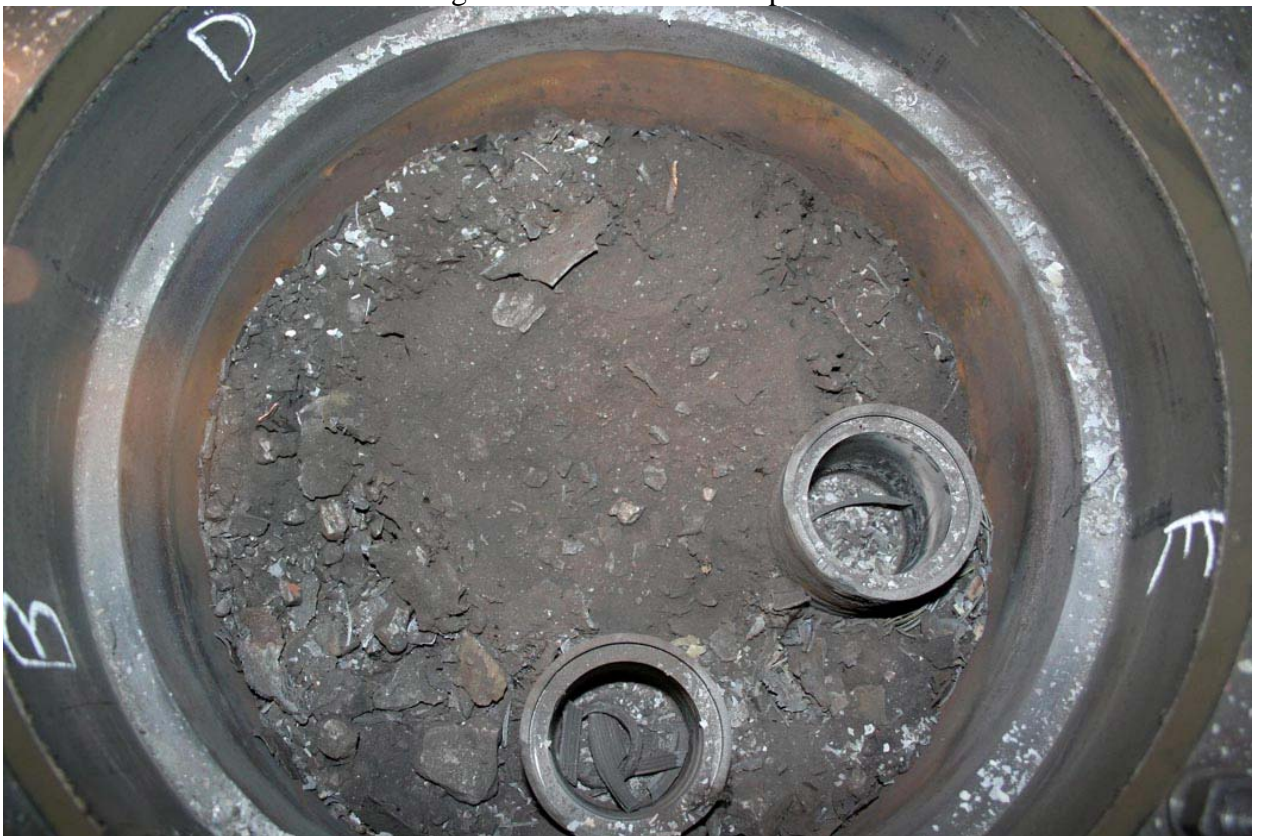
Fig. 12 - RPV model with corium after steel plate removal

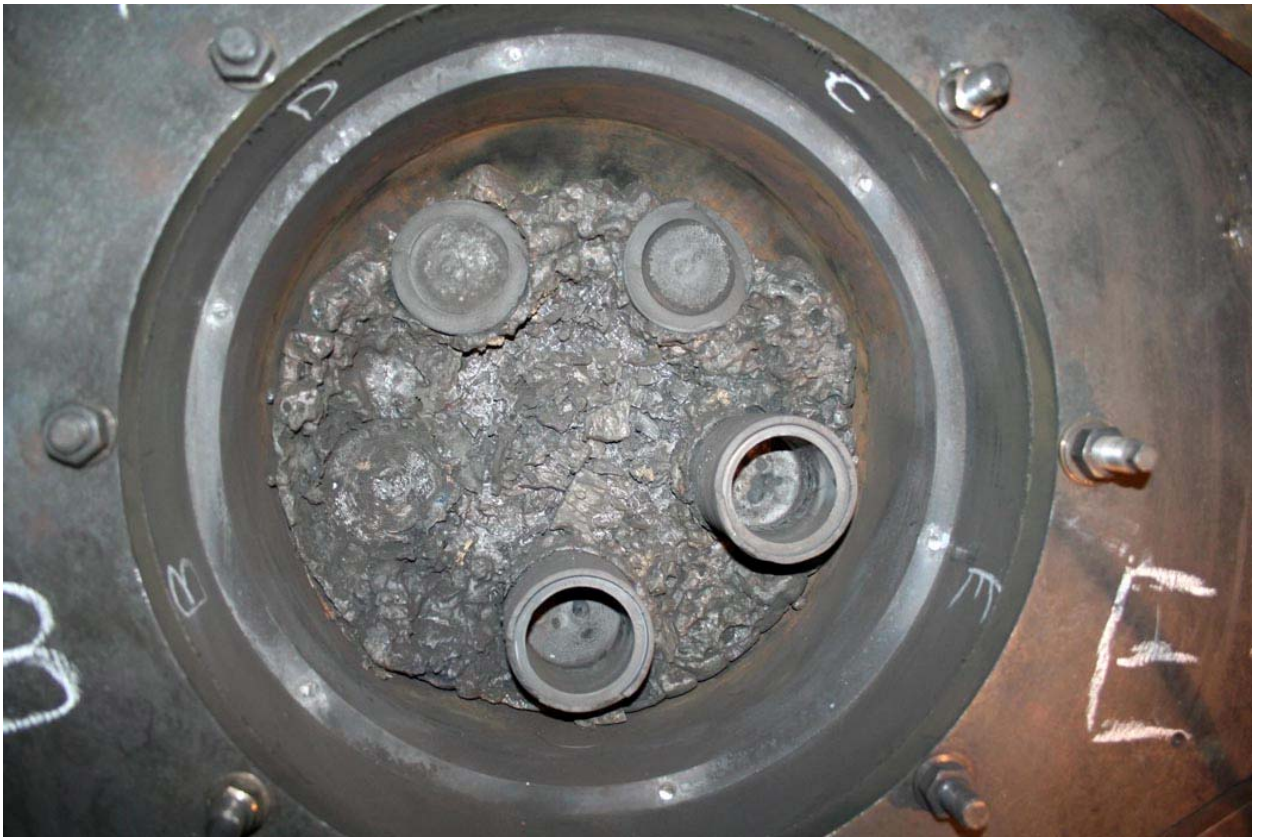
Fig. 13 – Top view of corium ingot after fragmented debris bed removal

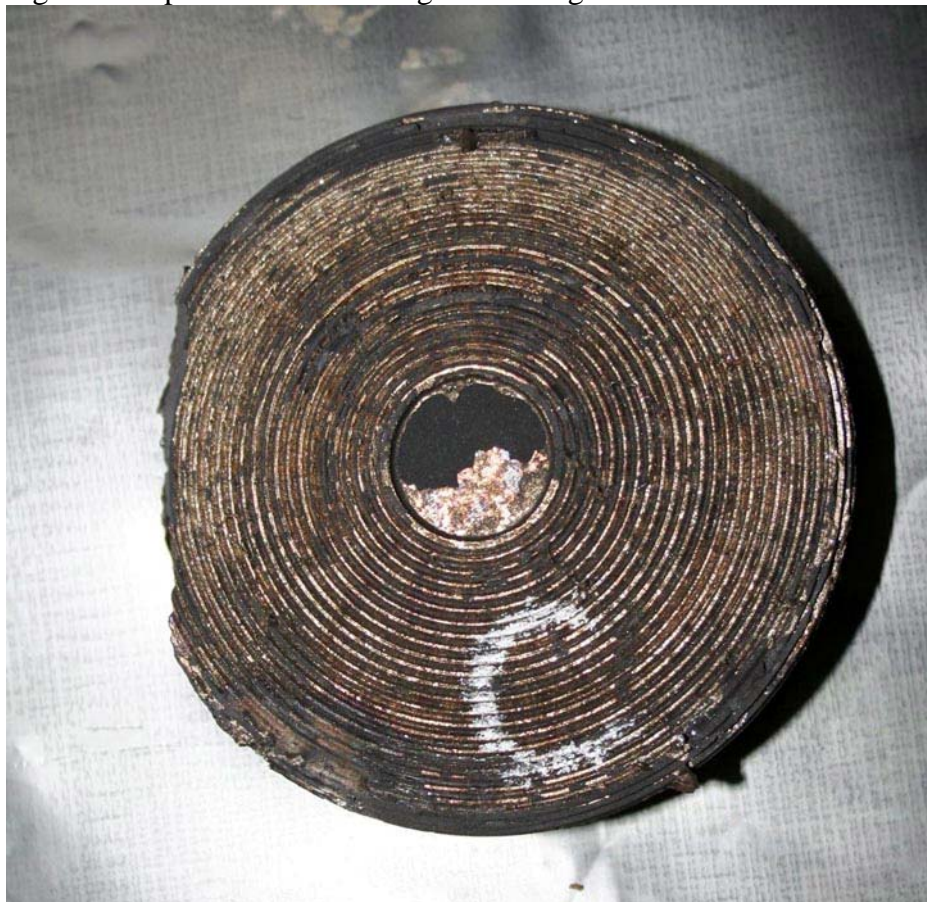
Fig. 14 – Upper view of plasmatron nozzle with remains of protective coating

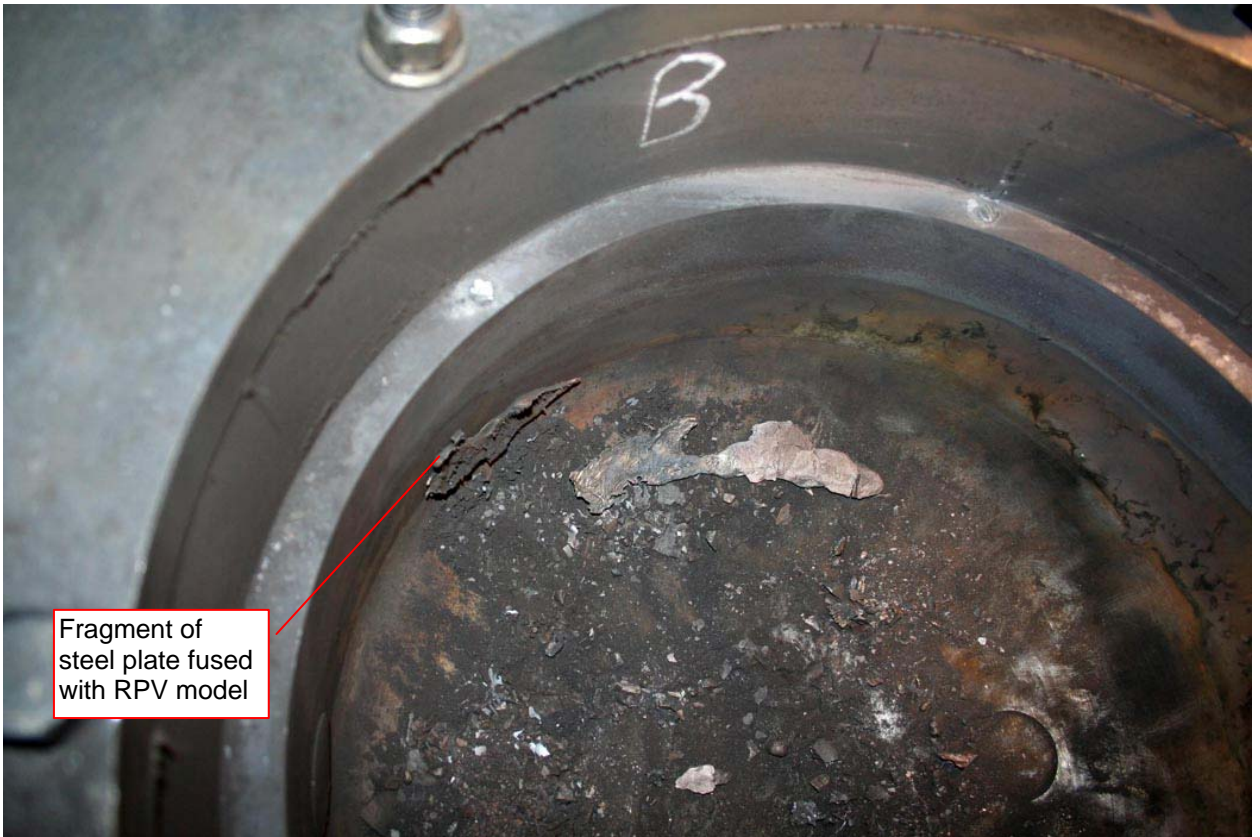
Fragment of  
steel plate fused  
with RPV model

Fig. 15 – View of RPV model after corium removal

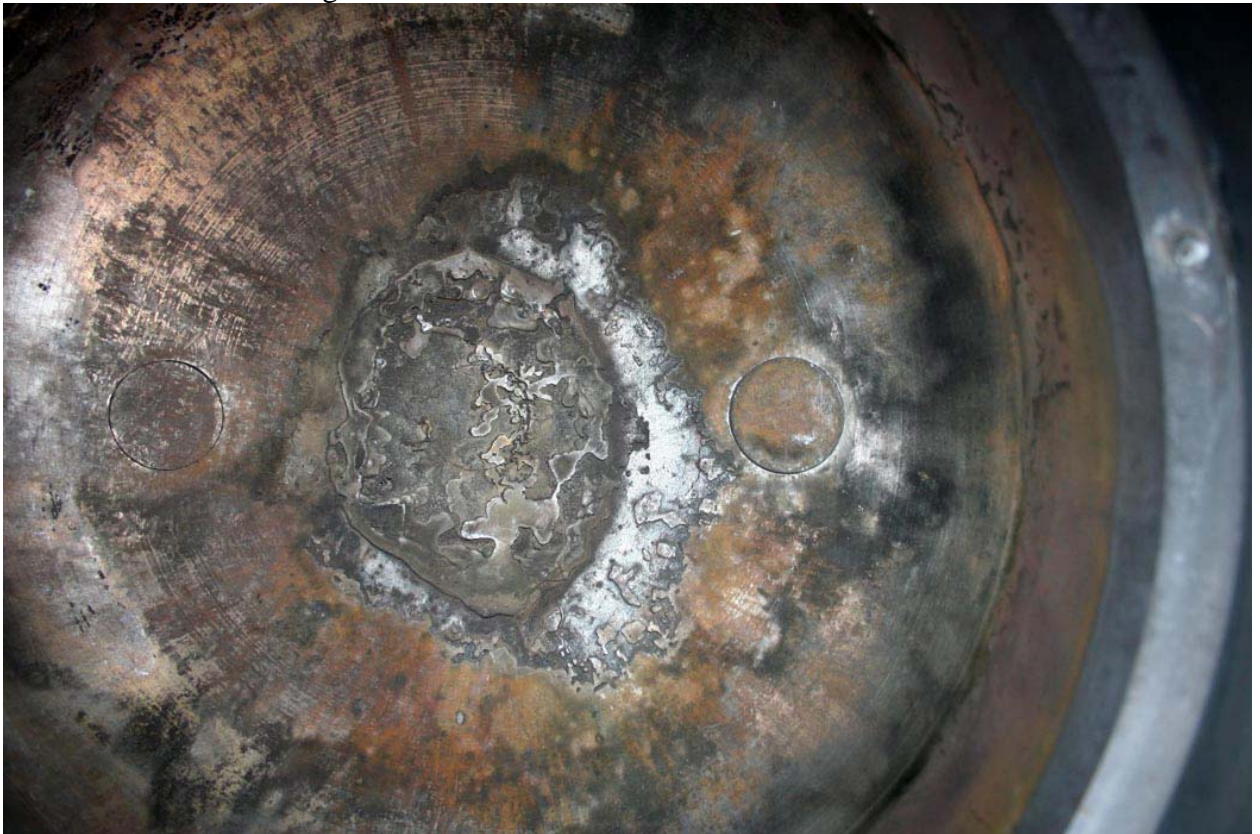
Fig. 16 – Inner surface of RPV model after corium ingot removal

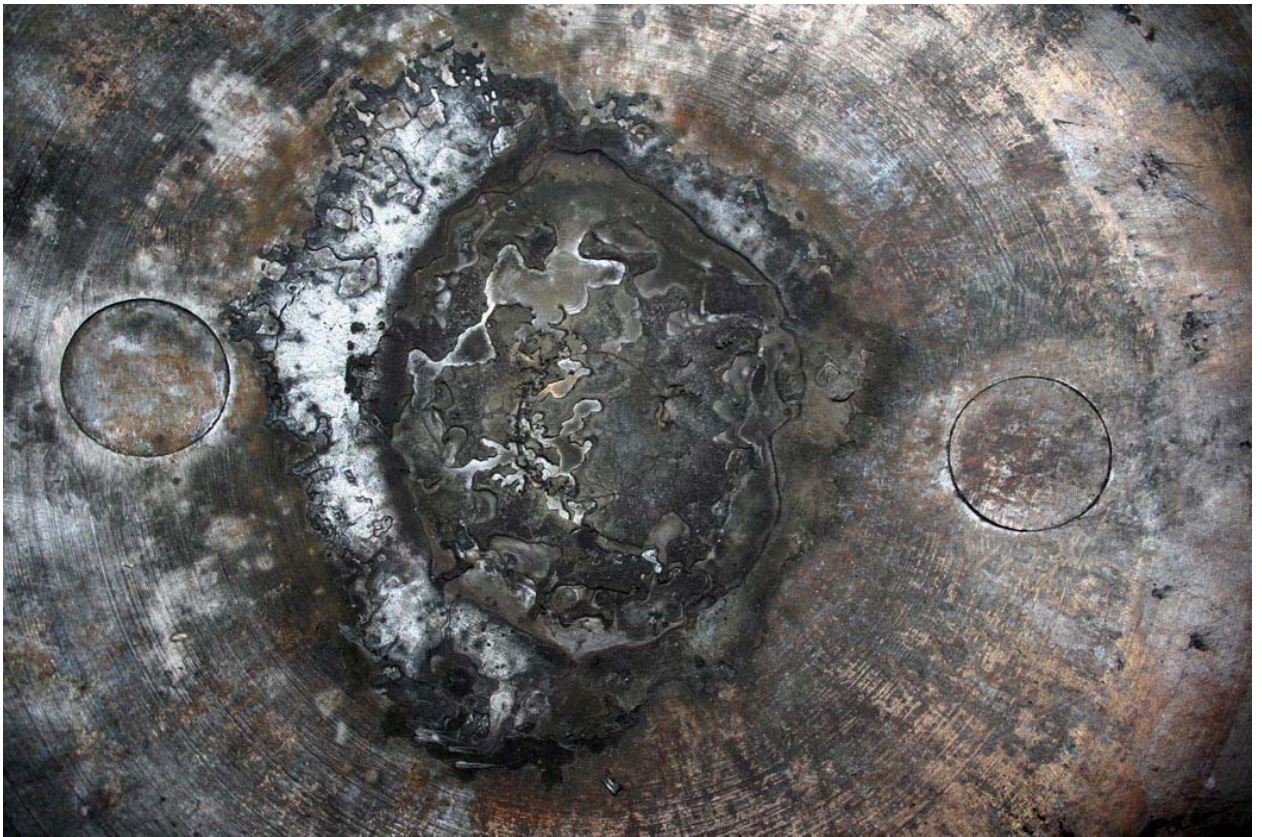
Fig. 17 - Inner surface of RPV model after corium ingot removal (close-up view of fused zone)

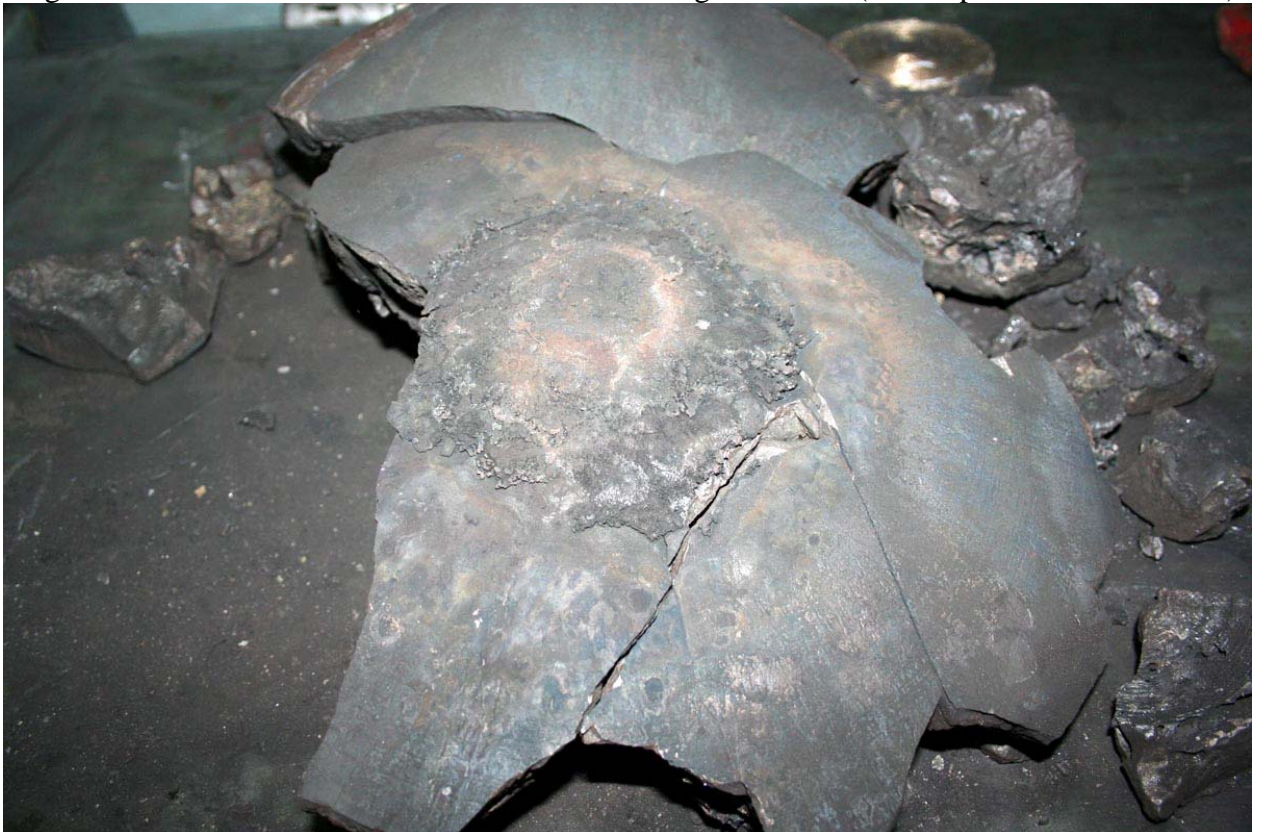
Fig. 18 – Upper view of corium ingot (from the site of contact with RPV bottom)

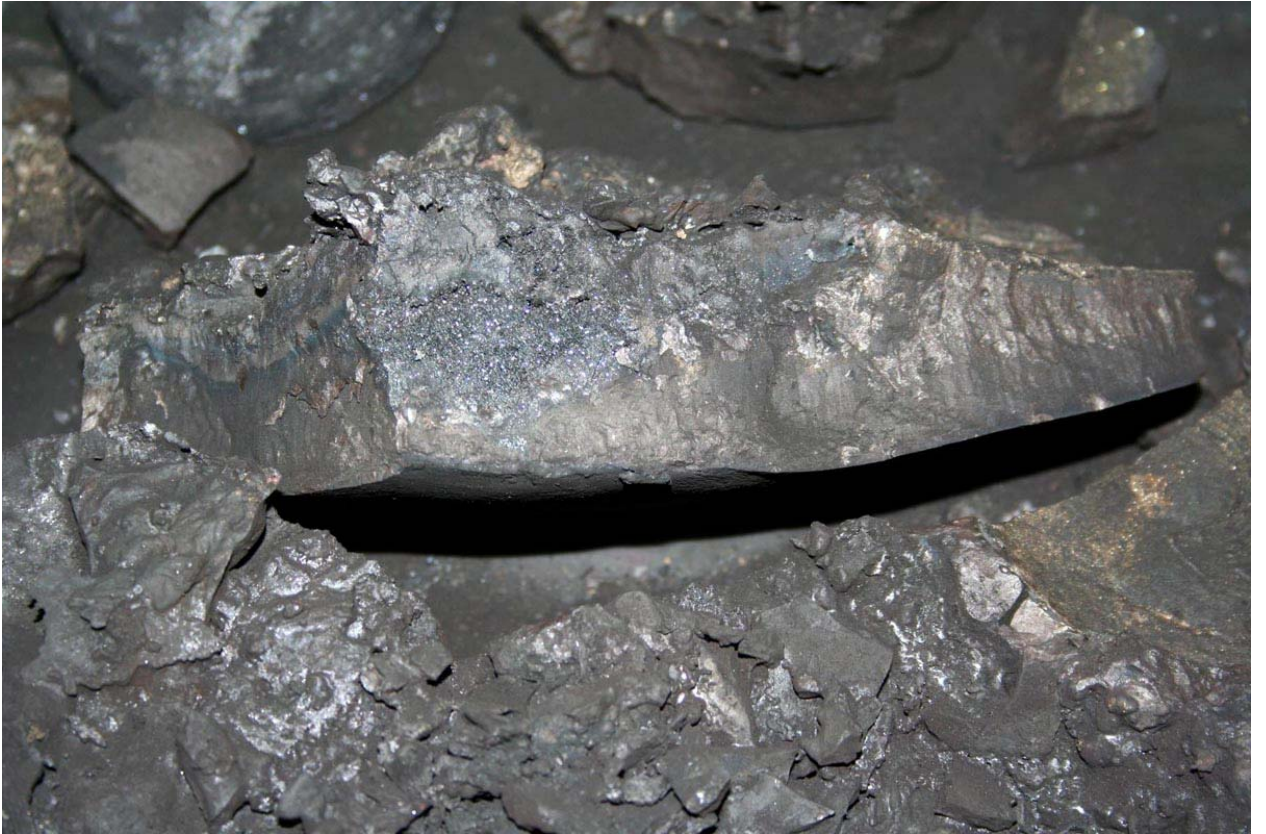
Fig. 19 – Fragment of corium ingot breaking surface

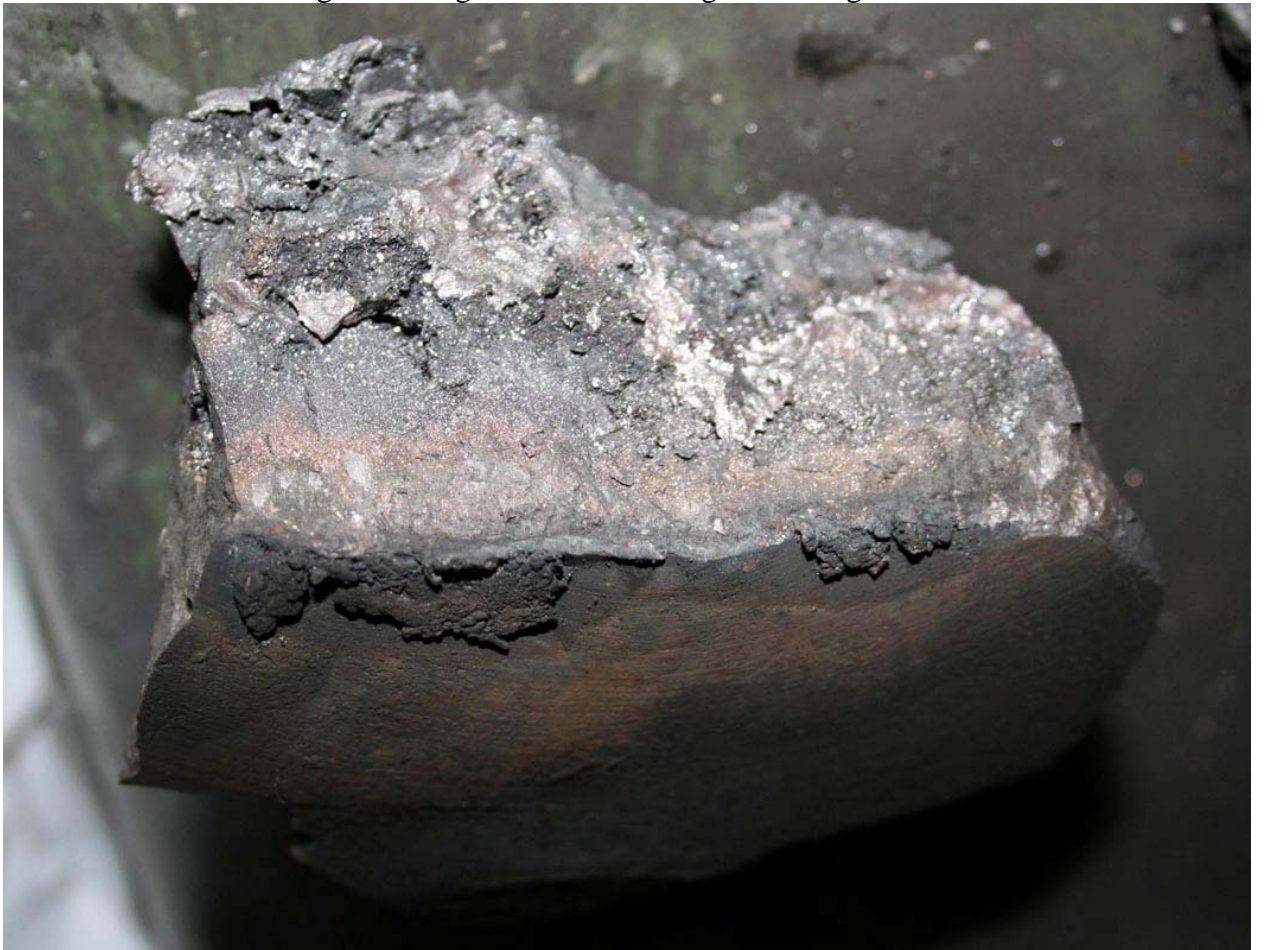
Fig. 20 – Fragment of corium ingot breaking surface

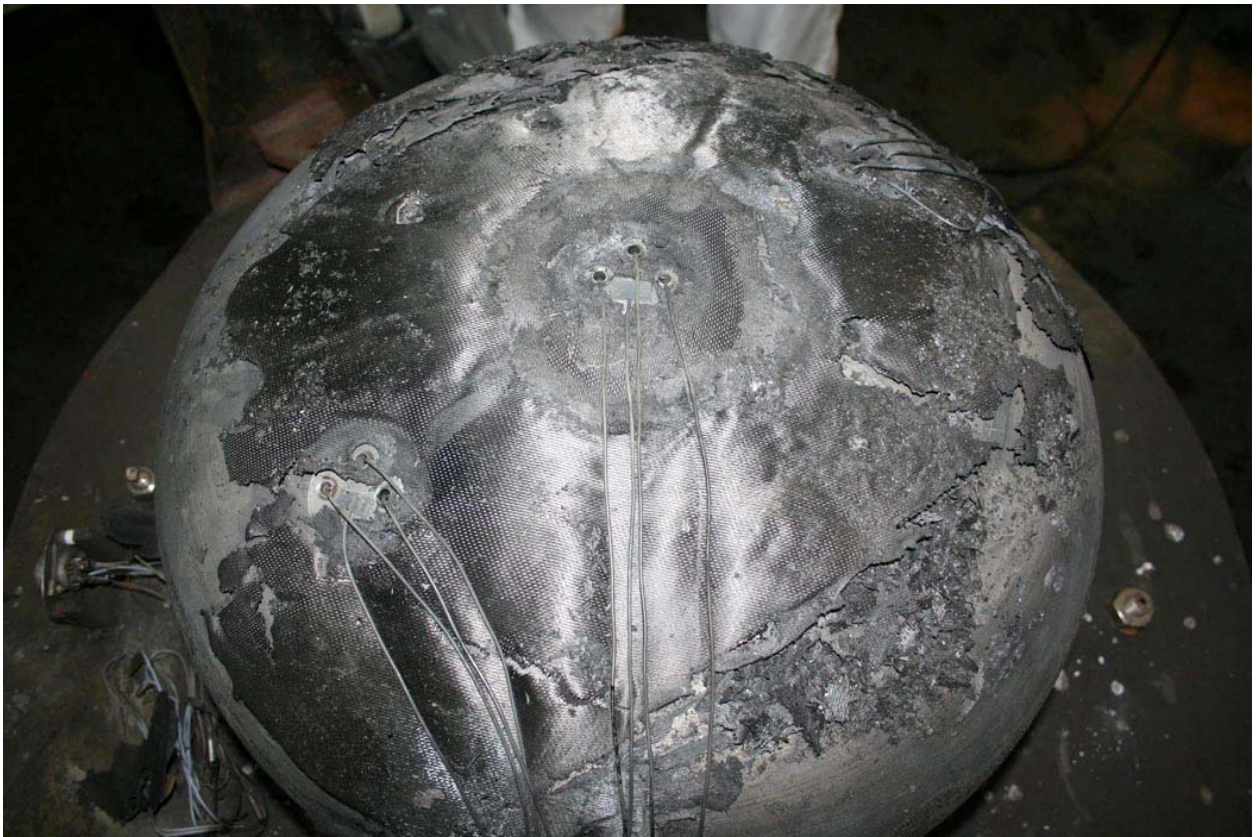
Fig. 21 – Remains of glass cloth on the outer surface of RPV model after SS-sheet removal)

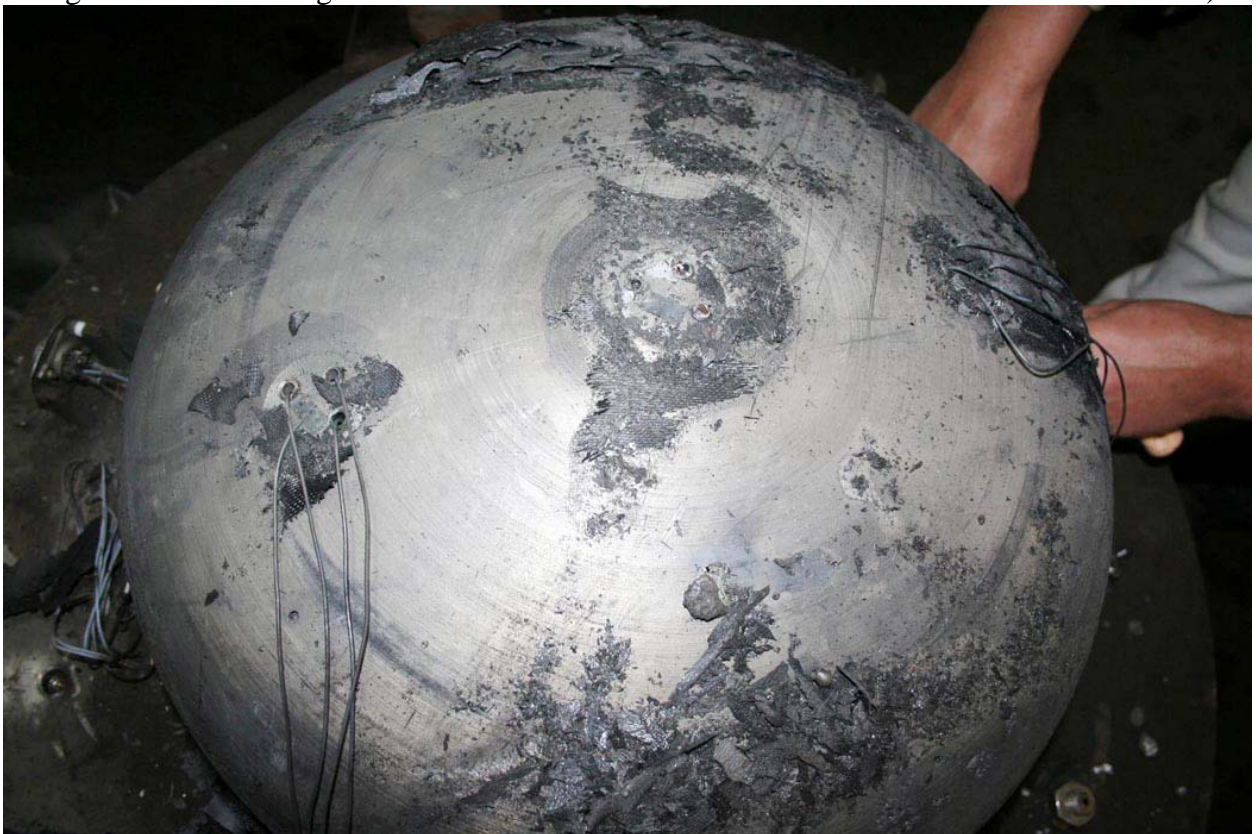
Fig. 22 – Outer surface of RPV model after thermal insulation removal
